**South Kramer Avenue Landslide:  
Jacobs Circle to Emmons Street  
Sitka, Alaska**

February 2, 2016

**RE: SOUTH KRAMER AVENUE LANDSLIDE: JACOBS CIRCLE TO  
EMMONS STREET, SITKA, ALASKA**

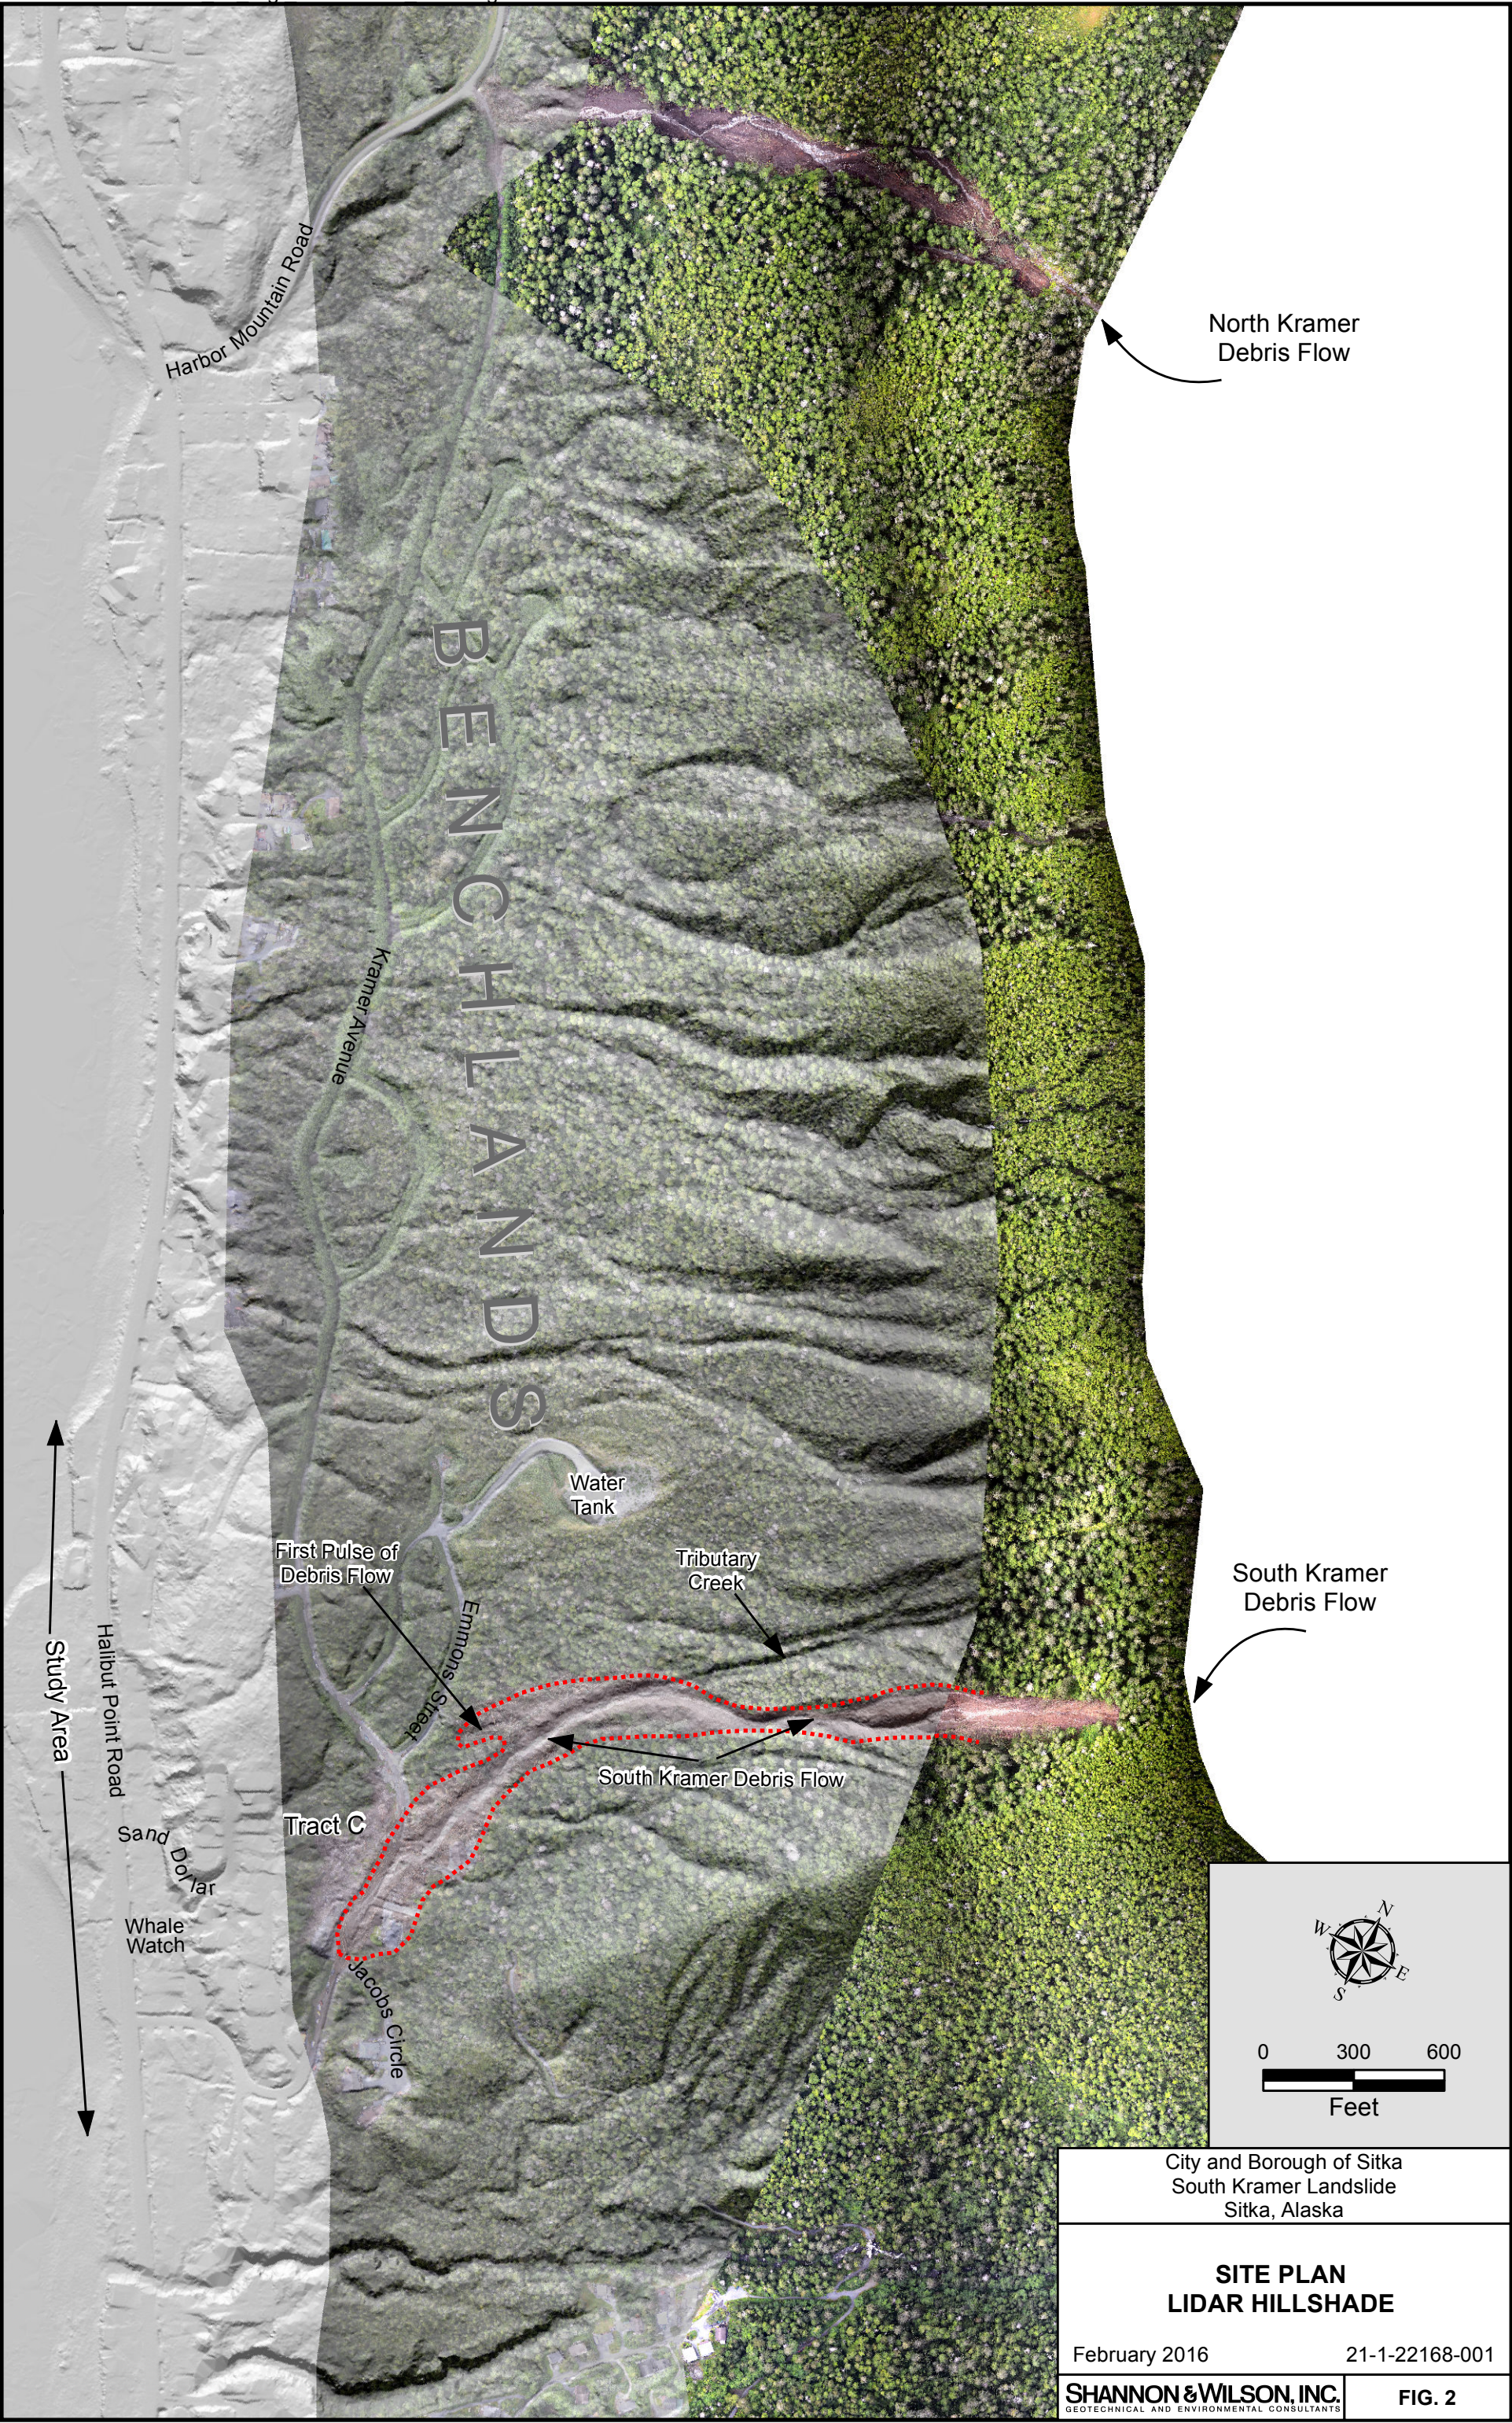
From aerial photographs and from field observations, it appears that the first pulse of the debris flow left the channel and plowed into the woods near elevation 240 feet, as indicated in Figures 2 and 3. This was likely the result of an upslope, straight segment of the channel and the debris wanting to maintain a straight line. After the first pulse, the bulk of the debris followed the existing channel that was directed toward the residence at 430 Kramer Avenue. The debris killed three people, and destroyed one residence and damaged another. Upon reaching Kramer Avenue, the debris encountered a low berm on the south side of the road that appears from photographs to have been 2 to 3 feet higher than Kramer Avenue. Farther south along the western side of Kramer Avenue, fill was mounded 8 to 10 feet high in an earthfill berm. When the debris flow encountered these berms, it turned southward down the road. It came to a stop about 400 feet from the point at which it reached Kramer Avenue, as shown in Figures 2, 3, and 6.

The Light Detection and Ranging (LiDAR) hillshade image (Figure 2) of the study area is informative but enigmatic. On a very broad scale, it has been suggested by others that the west-facing slope of Harbor Mountain collapsed in ancient times, spreading landslide debris into the ocean, one remnant of which is a shoreline protrusion. There is no evidence in outcrop or exposure of debris of such a widespread event, and the LiDAR image does not unequivocally support such a hypothesis.

The LiDAR image does support the hypothesis that the Benchlands is, in part, constructed of landslide materials supplied by repeated debris flows along several discrete chutes that originate on Harbor Mountain. The depositional distribution of the landslide debris also supports this idea. No landslide debris is observed or reported to the west of Kramer Avenue.

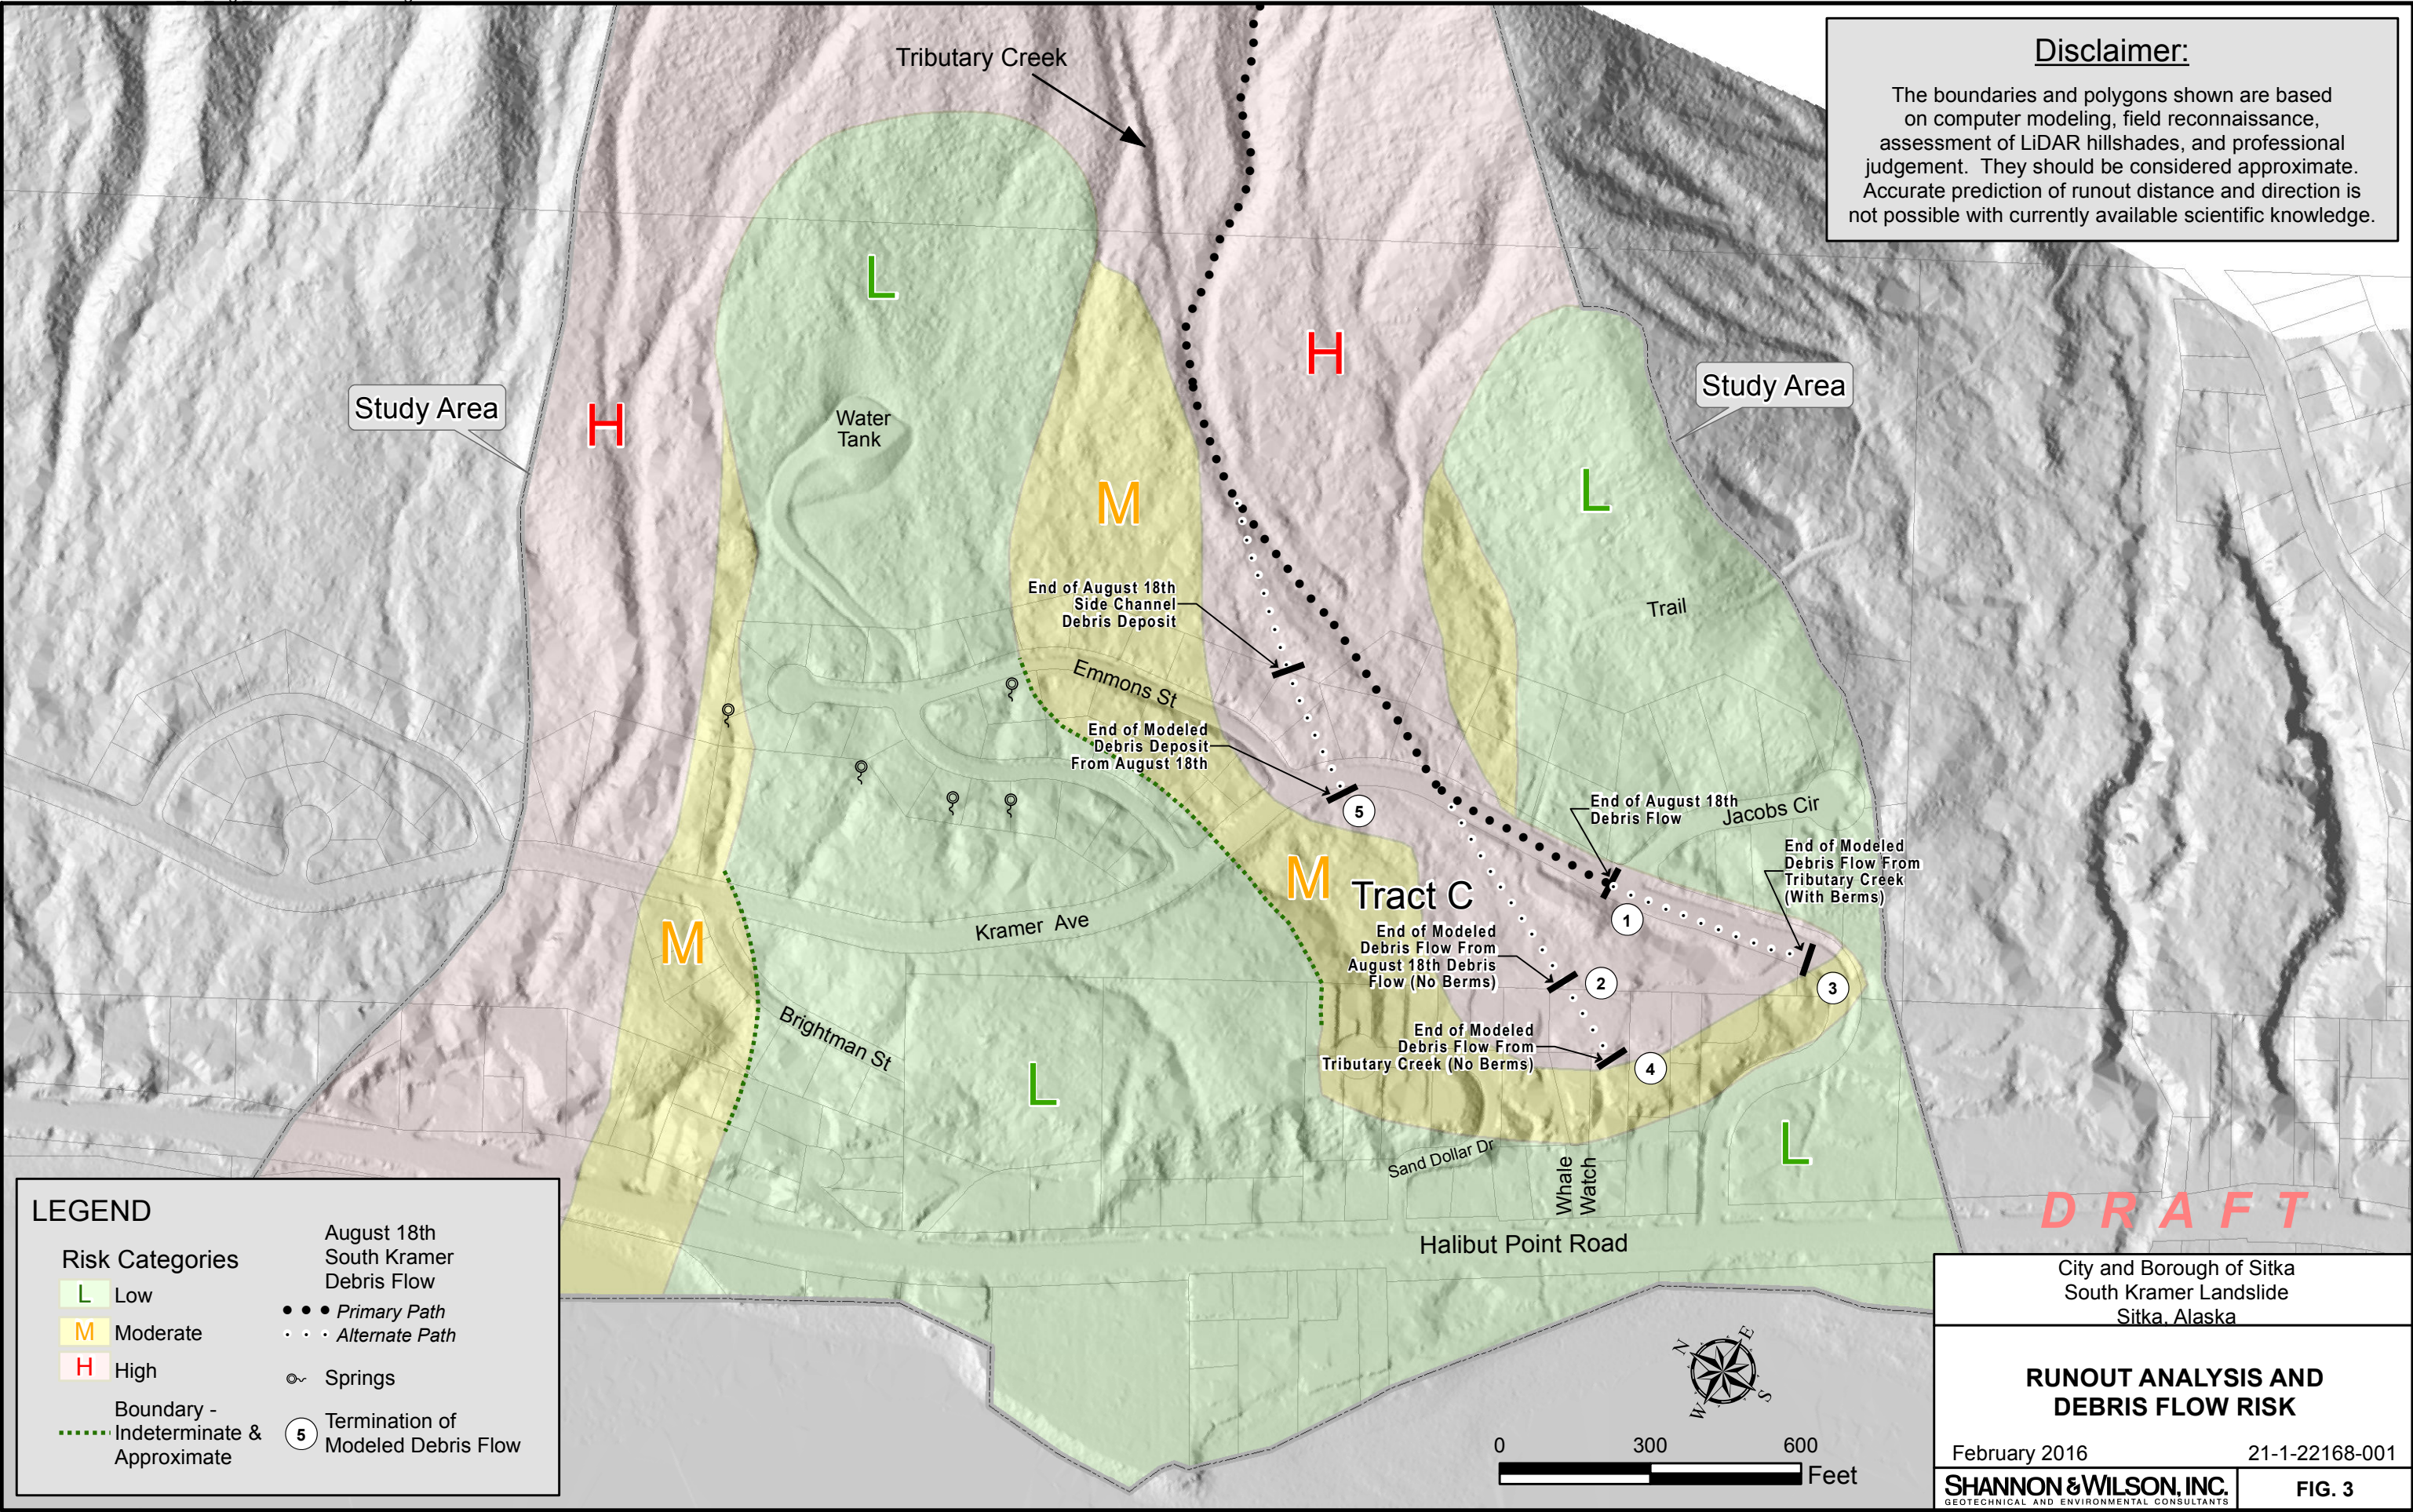
Groundwater is perched in this area. In the Golder report, groundwater levels ranged from 1.5 to 8.5 feet below ground surface. Numerous springs, as noted in Figure 3, emerge from the hillside. In some cases, they form the heads of through-going surface streams. In other cases, they infiltrate back into the ground and pop out farther downslope. In some areas, such as Tract C, most of the ground is covered with standing water, likely perched on ash or till.

The locations of the distal ends of the modeled runouts are presented in Figure 3. Modeling indicated that another debris flow along the August 18 alignment would end up in the same place as before, assuming that the berms on the west side of Kramer Avenue were left in place. If the berms were not in place on August 18, the debris could potentially have runout into Tract C about 400 feet southwest of Kramer Avenue. If the August 18 debris flow deposit had continued straight westward through the woods, as shown in Figures 2 and 3, it could have reached Kramer Avenue. Modeling of this side branch of the debris flow showed that once the debris flow material leaves the channelized section of the creek and becomes a uniform unchannelized slope, the debris slows and deposits relatively quickly, as shown in Figure 3. The modeling does not

The bedrock hollow in the August 18 initiation zone has mostly emptied out and the channel below has been scoured, so the future hazard from that source is likely low; however, a tributary creek/hollow to the north that extends to the top of Harbor Mountain has the potential to fail and recreate a similar or larger debris flow than the August 18 event. This bedrock hollow is about 700 feet higher in elevation than the initiation zone of the August 18 debris flow.

If this higher bedrock hollow failed in a manner similar to the August 18 debris flow, the model predicts that it would flow down Kramer Avenue about 400 feet beyond the Kramer Avenue debris deposit, assuming the berms were in place. Without the berms in place, this modeled debris flow would move about 580 feet southwest of Kramer Avenue, reaching residences on the eastern side of Whale Watch Drive and Sand Dollar Drive.

Based on our assessment of the modeling, field observations, and LiDAR images, we have created three categories of risk in the Jacobs Circle/Emmons Street area for debris flows originating on Harbor Mountain. The three categories described below range from high to low. There are **no** no-risk zones in the study area.

Three moderate risk zones were identified, as shown in Figure 3. They are either buffer areas between high- and low-risk zones, or areas that offer slightly higher risk than low, as discussed below. One is the buffer zone adjacent to the debris chute high-risk zone on the northern edge of the study area. Another buffer zone is located downhill (west) of Tract C. Another moderate zone is located uphill of Emmons Street where there appear to be deposits of ancient, relict debris flows. The channel that originally supplied debris to this area is presently incapable of delivering debris to this same area, in our opinion; however, if the adjacent incised creek/swale should become blocked during a debris flow, the relict channel could potentially deliver debris to this area again. If any new development or redevelopment is contemplated for these areas, a geotechnical evaluation should be performed and reviewed in the same manner as recommended above for high-risk zones.

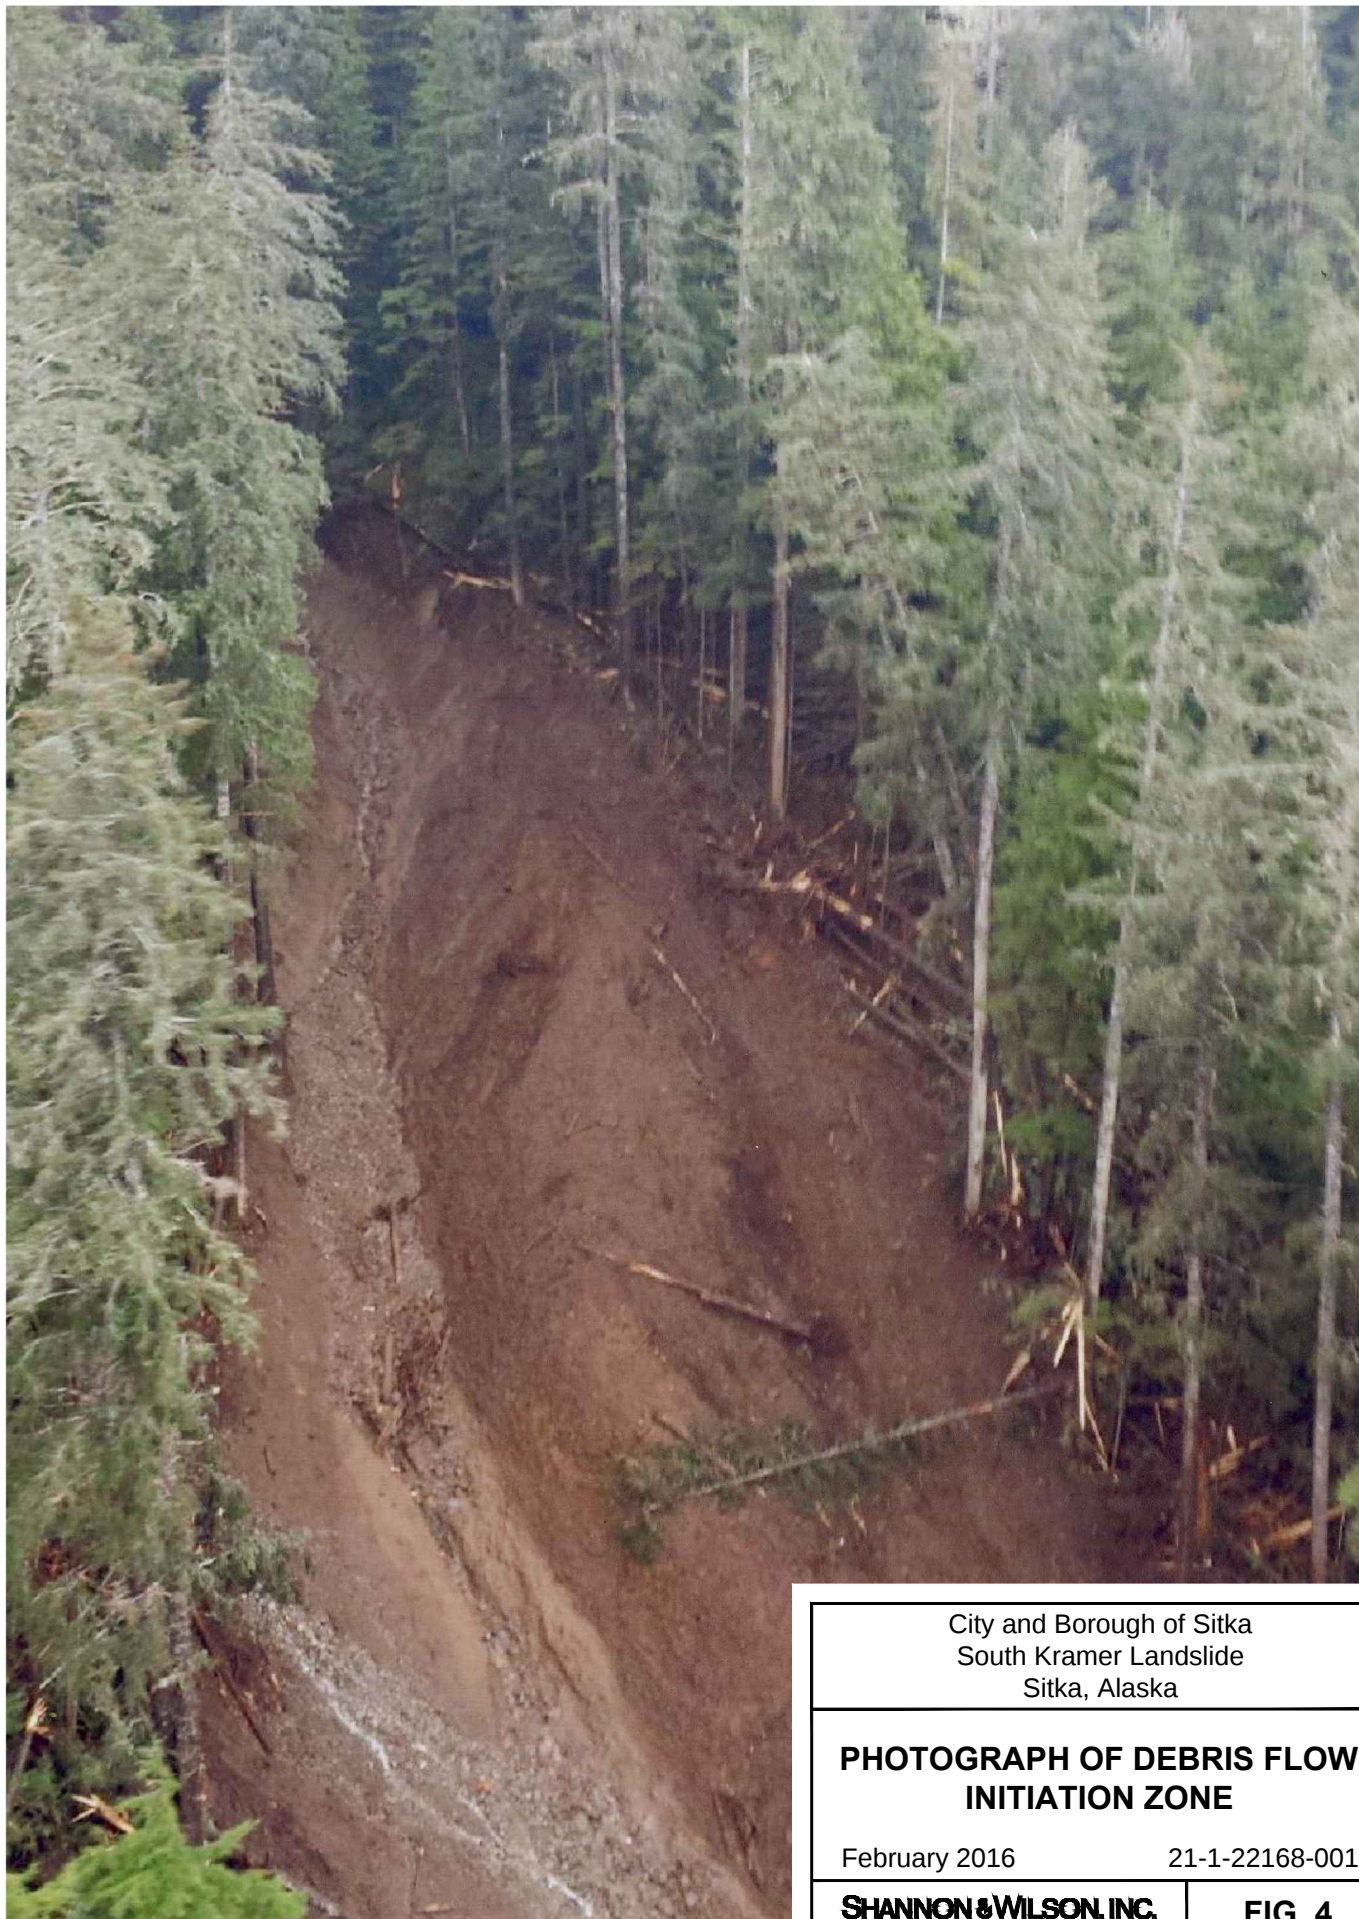
**FIG. 4**

Bedrock hollows, areas where the topography is convergent, are at particular risk of failure because they are capable of concentrating groundwater, thereby lowering the stability of accumulated soils in the swale.

The soils in the headwall of the debris flow consisted of colluvium, ash, and glacial till. The colluvium is weak because it accumulated from sloughing of surrounding formations. The ash is also weak because it was never overridden and compacted by glacial ice and has low strength. Ash soils are also typically hydrophylic and impermeable creating perched water and can cause an elevated groundwater level in the soil above it.

**PHOTOGRAPH OF DEBRIS FLOW  
INITIATION ZONE**

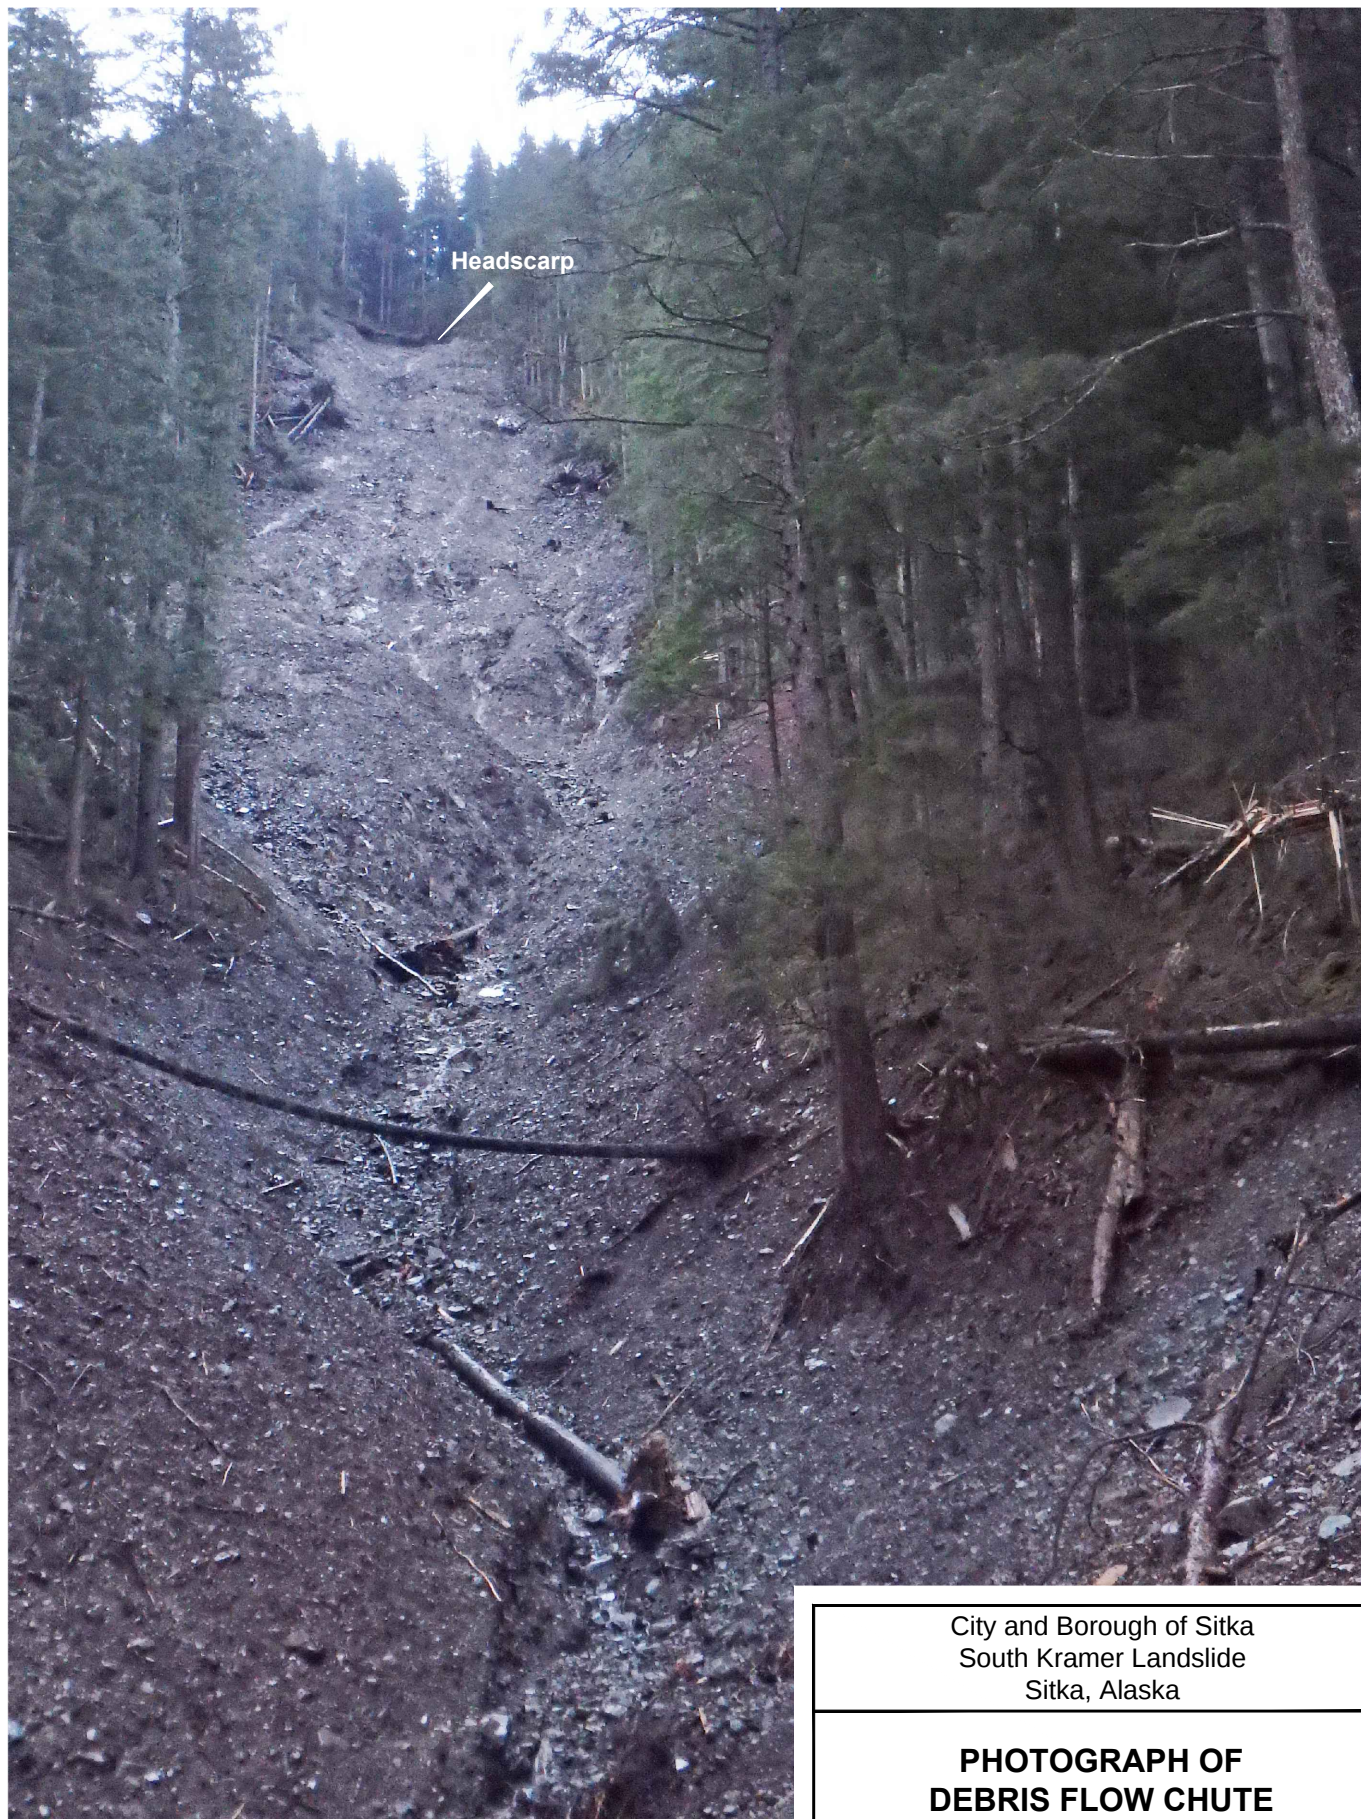
**FIG. 5**

**PHOTOGRAPH OF  
DEBRIS FLOW CHUTE**

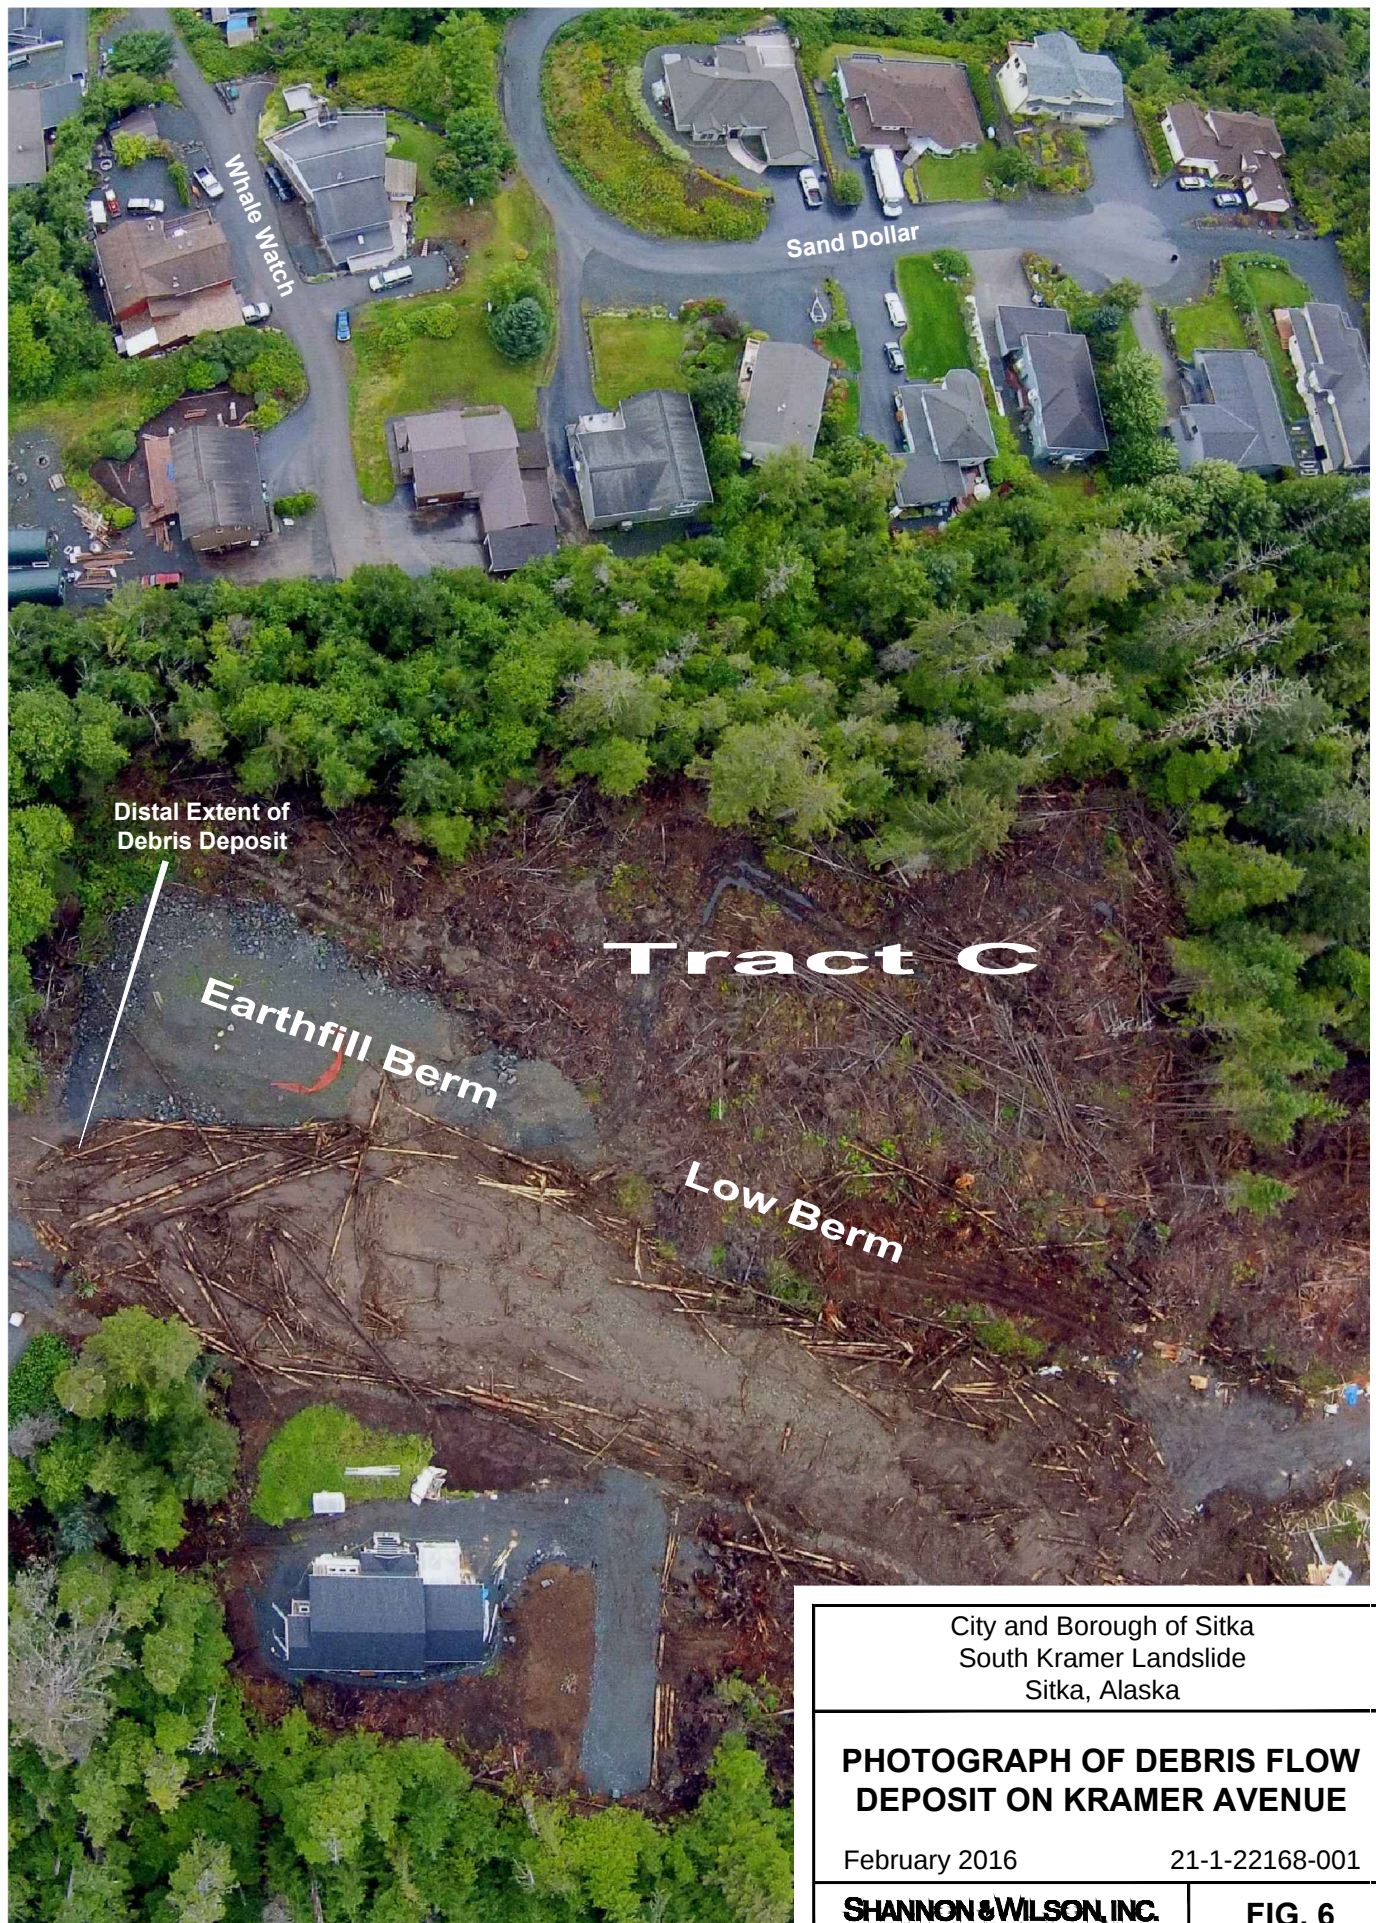
**FIG. 6**

We understand that the more southerly earthfill berm (Figure 6) is a temporary stockpile of soil that was placed by the development contractor for future site grading in Tract C.

**PHOTOGRAPH OF DEBRIS FLOW  
DEPOSIT ON KRAMER AVENUE**
