# MARINE SERVICES CENTER BULKHEAD CONDITION ASSESSMENT

Prepared for:  
The City & Borough of Sitka  
Department of Public Works  
100 Lincoln Street  
Sitka, AK 99835

October 2011 Update

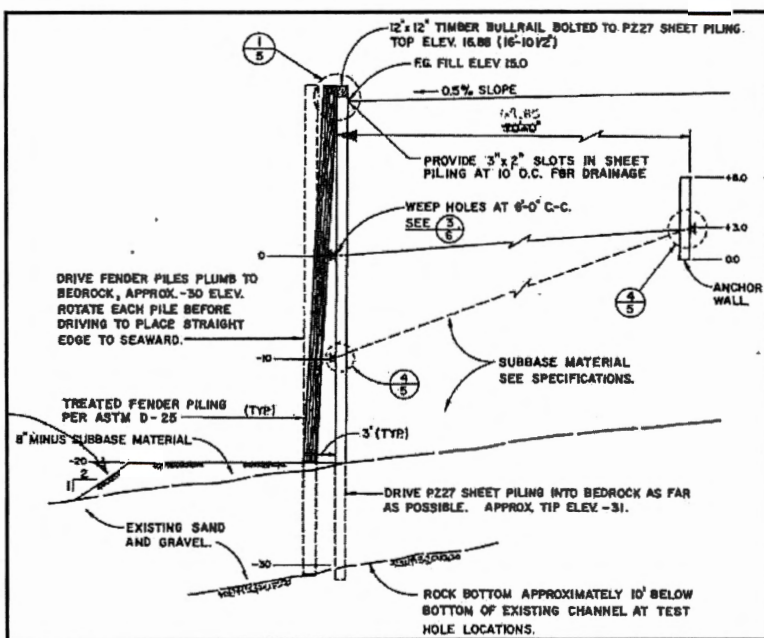
(Figure 1 – Typical bulkhead wall section)

The Marine Services Center sheet pile bulkhead dock was originally constructed in 1976. The tie-back wall structure is approximately 36-ft high (from mudline) by 356-ft long along the face, with approximately 10-ft long end/return walls at each end of the bulkhead. The PZ27 sheet piles are driven approximately 10-ft to underlying bedrock, and are laterally restrained by exterior, MC8x22.8 walers located at elevations 0.0 ft (MLLW) and -10.0 ft. Each waler is connected via tie-rods to a sheet pile anchor wall approximately 70-ft behind the bulkhead face. The steel, round bar tie-rods are 2 1/2-inch diameter, with ends upset to 3 1/4-inch diameter. They are spaced at 6-ft on-center, with the upper tie-rods being offset from the lower tie-rods by 3-ft. The walers and tie-rods are of ASTM A36 chemistry while the sheet piles are of ASTM A690 material. Creosote-treated timber fender piles protect the face of the bulkhead and a 12x12 timber bullrail caps the top of the wall. Steel pipe bollards and access ladders are positioned at varied spacing along the dock face.
