February 2, 2016

21-1-22168-001

**RE: SOUTH KRAMER AVENUE LANDSLIDE: JACOBS CIRCLE TO
EMMONS STREET, SITKA, ALASKA**

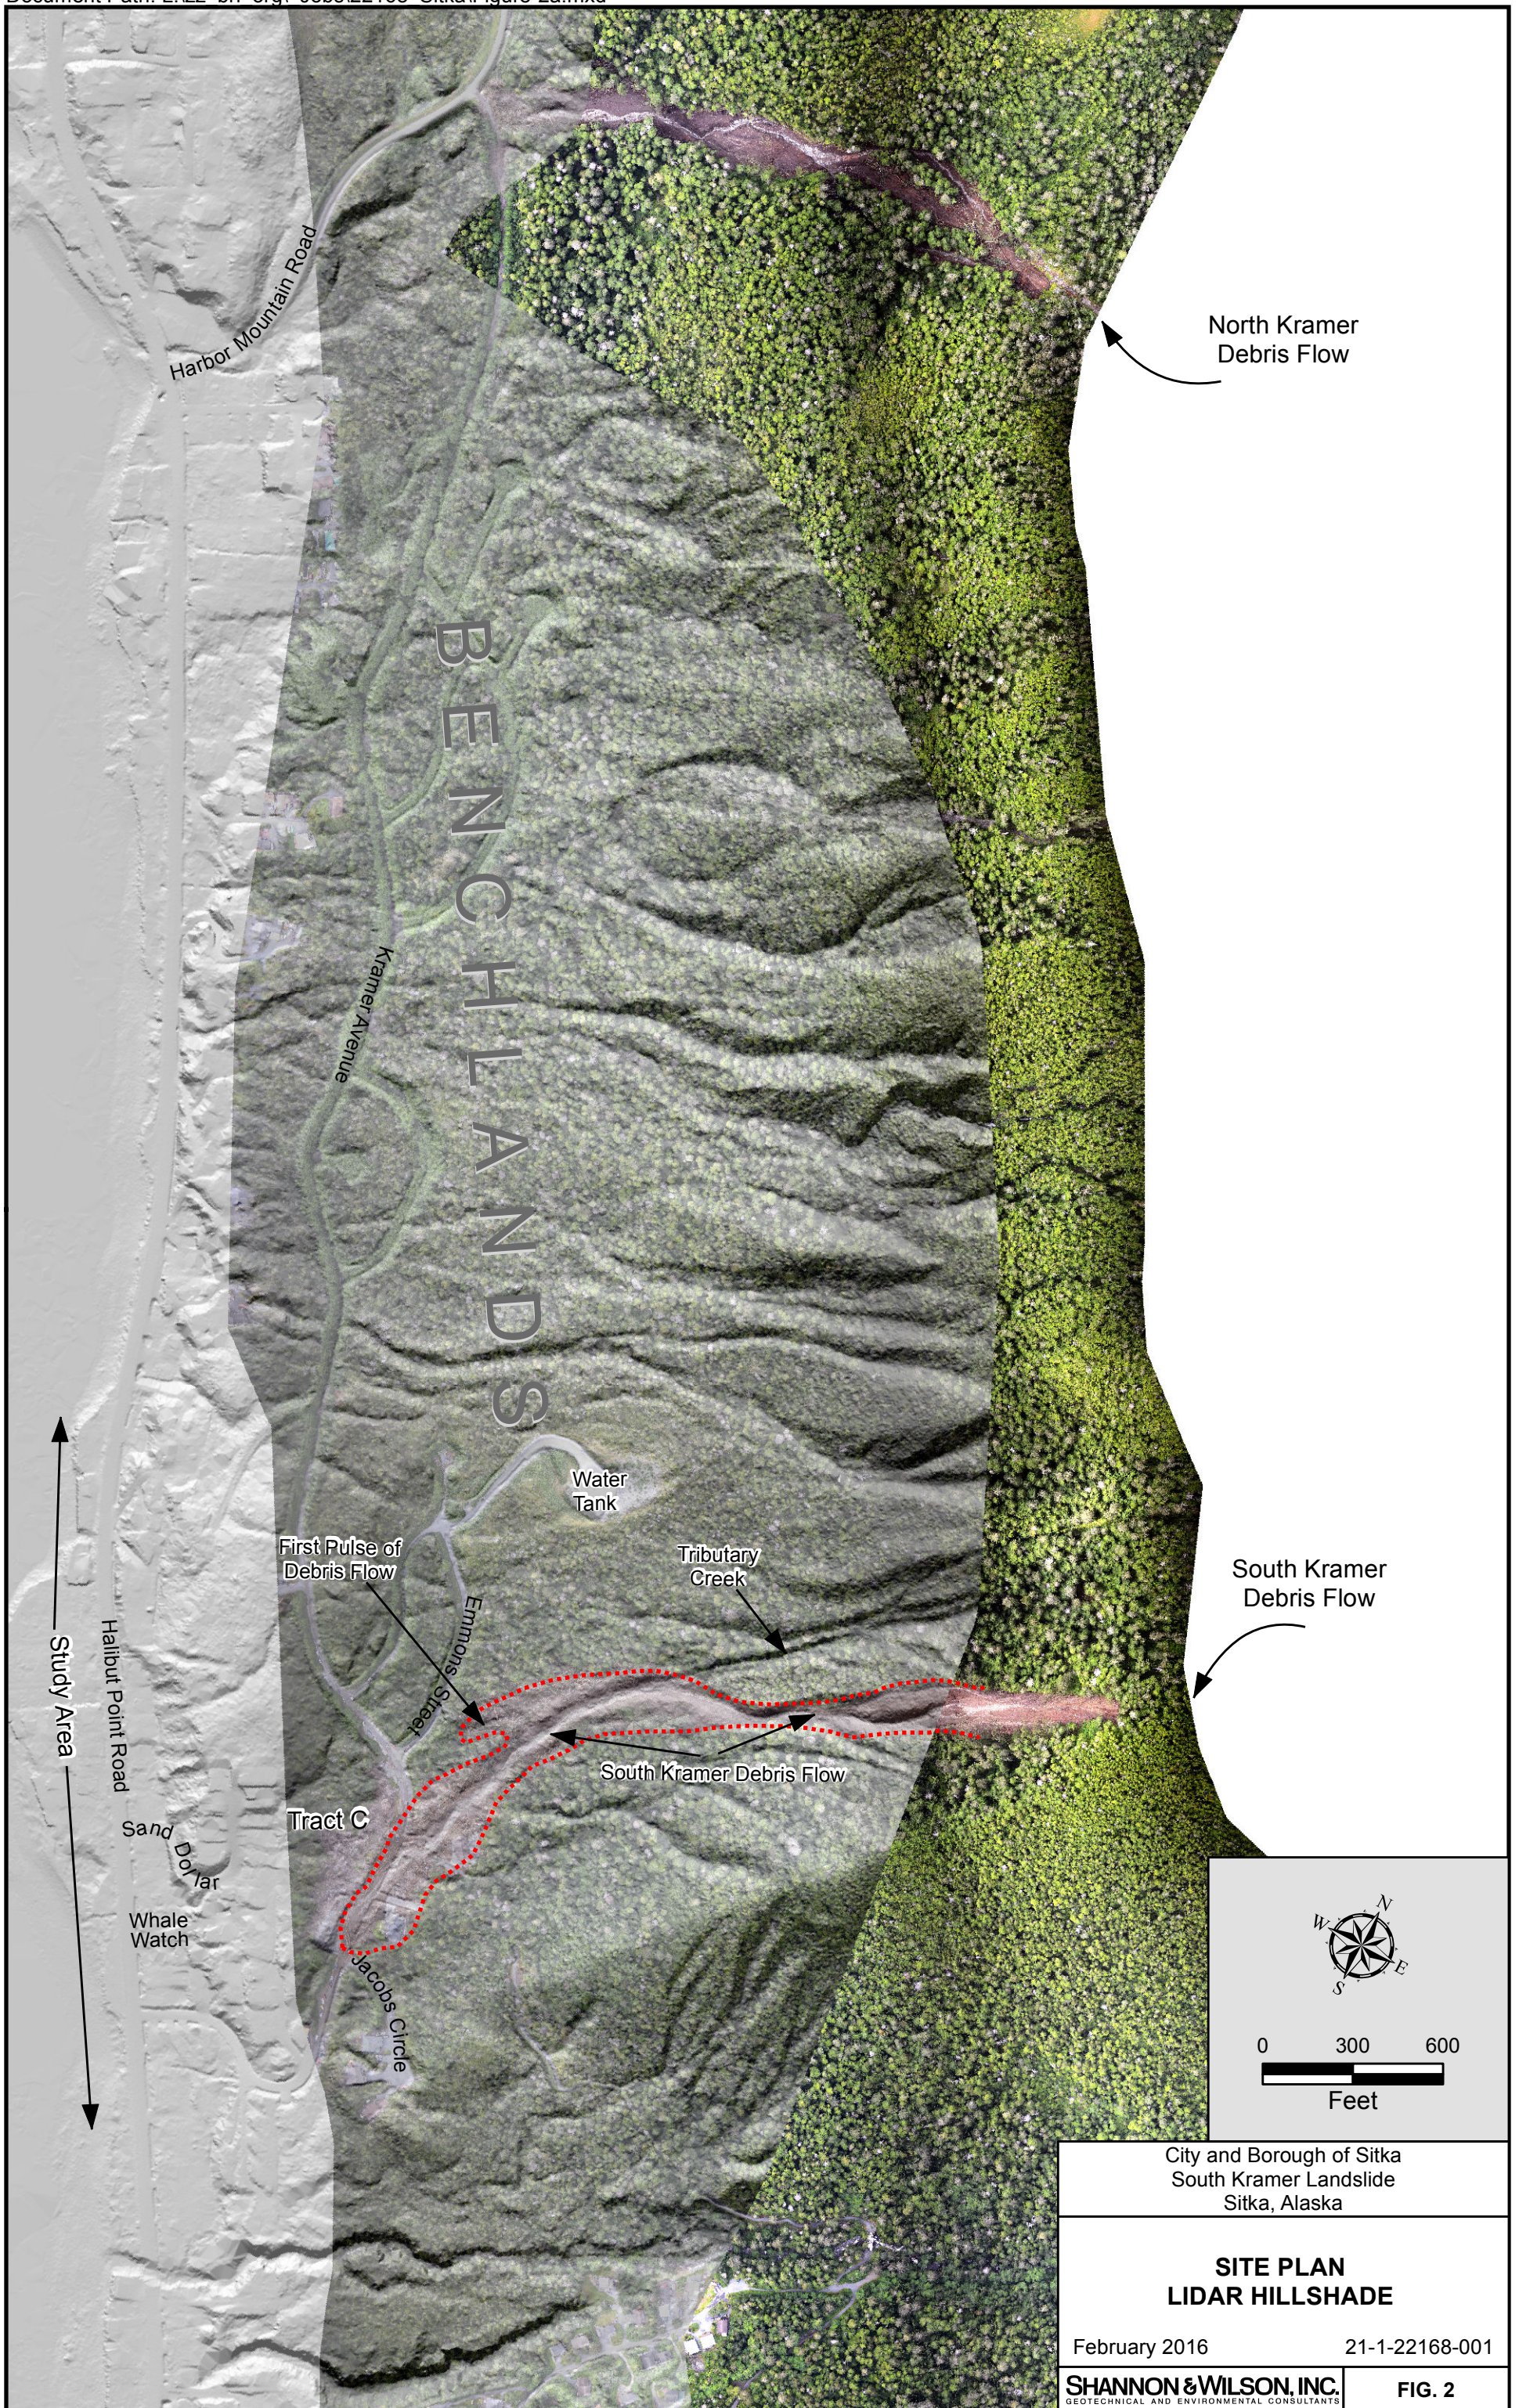
From aerial photographs and from field observations, it appears that the first pulse of the debris flow left the channel and plowed into the woods near elevation 240 feet, as indicated in Figures 2 and 3. This was likely the result of an upslope, straight segment of the channel and the debris wanting to maintain a straight line. After the first pulse, the bulk of the debris followed the existing channel that was directed toward the residence at 430 Kramer Avenue. The debris killed three people, and destroyed one residence and damaged another. Upon reaching Kramer Avenue, the debris encountered a low berm on the south side of the road that appears from photographs to have been 2 to 3 feet higher than Kramer Avenue. Farther south along the western side of Kramer Avenue, fill was mounded 8 to 10 feet high in an earthfill berm. When the debris flow encountered these berms, it turned southward down the road. It came to a stop about 400 feet from the point at which it reached Kramer Avenue, as shown in Figures 2, 3, and 6.

Groundwater is perched in this area. In the Golder report, groundwater levels ranged from 1.5 to 8.5 feet below ground surface. Numerous springs, as noted in Figure 3, emerge from the hillside. In some cases, they form the heads of through-going surface streams. In other cases, they infiltrate back into the ground and pop out farther downslope. In some areas, such as Tract C, most of the ground is covered with standing water, likely perched on ash or till.

The Light Detection and Ranging (LiDAR) hillshade image (Figure 2) of the study area is informative but enigmatic. On a very broad scale, it has been suggested by others that the west-facing slope of Harbor Mountain collapsed in ancient times, spreading landslide debris into the ocean, one remnant of which is a shoreline protrusion. There is no evidence in outcrop or exposure of debris of such a widespread event, and the LiDAR image does not unequivocally support such a hypothesis.

The LiDAR image does support the hypothesis that the Benchlands is, in part, constructed of landslide materials supplied by repeated debris flows along several discrete chutes that originate on Harbor Mountain. The depositional distribution of the landslide debris also supports this idea. No landslide debris is observed or reported to the west of Kramer Avenue.

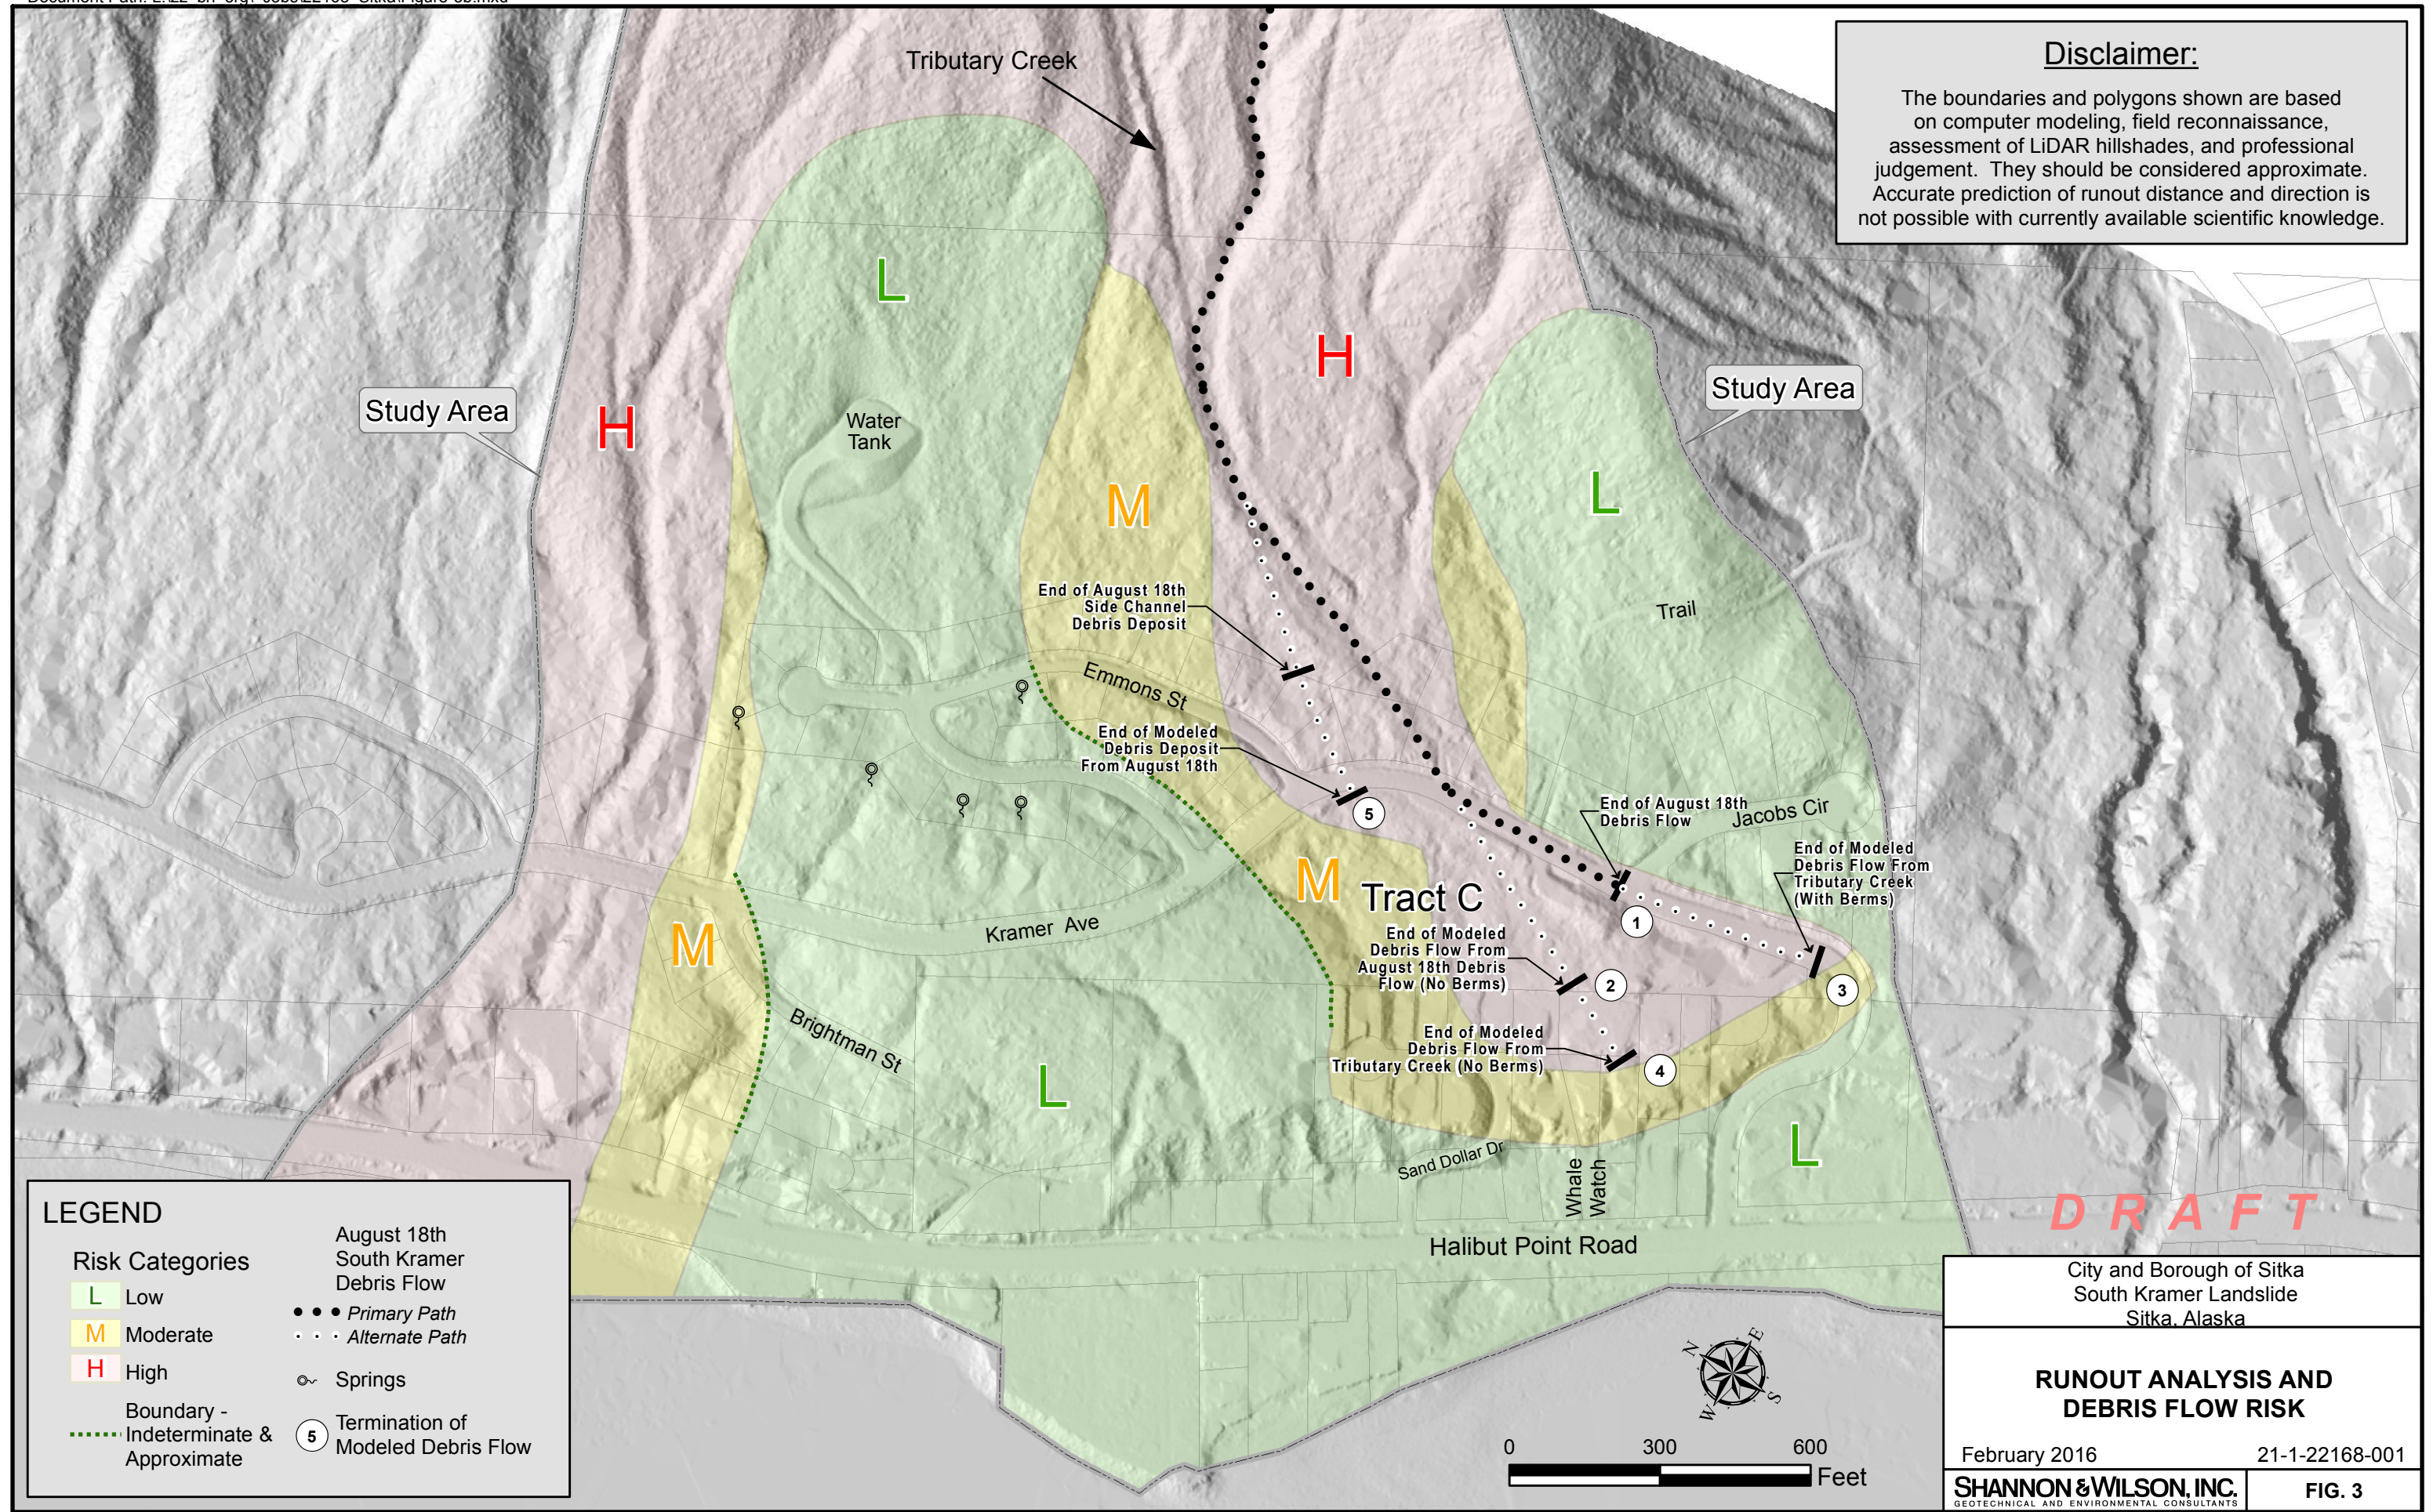
FIG. 3

The locations of the distal ends of the modeled runouts are presented in Figure 3. Modeling indicated that another debris flow along the August 18 alignment would end up in the same place as before, assuming that the berms on the west side of Kramer Avenue were left in place. If the berms were not in place on August 18, the debris could potentially have runout into Tract C about 400 feet southwest of Kramer Avenue. If the August 18 debris flow deposit had continued straight westward through the woods, as shown in Figures 2 and 3, it could have reached Kramer Avenue. Modeling of this side branch of the debris flow showed that once the debris flow material leaves the channelized section of the creek and becomes a uniform unchannelized slope, the debris slows and deposits relatively quickly, as shown in Figure 3. The modeling does not

The bedrock hollow in the August 18 initiation zone has mostly emptied out and the channel below has been scoured, so the future hazard from that source is likely low; however, a tributary creek/hollow to the north that extends to the top of Harbor Mountain has the potential to fail and recreate a similar or larger debris flow than the August 18 event. This bedrock hollow is about 700 feet higher in elevation than the initiation zone of the August 18 debris flow.

If this higher bedrock hollow failed in a manner similar to the August 18 debris flow, the model predicts that it would flow down Kramer Avenue about 400 feet beyond the Kramer Avenue debris deposit, assuming the berms were in place. Without the berms in place, this modeled debris flow would move about 580 feet southwest of Kramer Avenue, reaching residences on the eastern side of Whale Watch Drive and Sand Dollar Drive.

Based on our assessment of the modeling, field observations, and LiDAR images, we have created three categories of risk in the Jacobs Circle/Emmons Street area for debris flows originating on Harbor Mountain. The three categories described below range from high to low. There are **no** no-risk zones in the study area.

The high-risk zone is in and adjacent to the recent debris flow path and two other debris flow paths that were identified in the field and on the LiDAR hillshade image. They have incised channels and uneven, hummocky, and lobate topography. We recommend no new residential development or transportation and utility corridors through this area without extensive study and protective measures. If any new development or redevelopment is contemplated for these areas, a geotechnical evaluation should be performed by a licensed civil engineer specializing in

Three moderate risk zones were identified, as shown in Figure 3. They are either buffer areas between high- and low-risk zones, or areas that offer slightly higher risk than low, as discussed below. One is the buffer zone adjacent to the debris chute high-risk zone on the northern edge of the study area. Another buffer zone is located downhill (west) of Tract C. Another moderate zone is located uphill of Emmons Street where there appear to be deposits of ancient, relict debris flows. The channel that originally supplied debris to this area is presently incapable of delivering debris to this same area, in our opinion; however, if the adjacent incised creek/swale should become blocked during a debris flow, the relict channel could potentially deliver debris to this area again. If any new development or redevelopment is contemplated for these areas, a geotechnical evaluation should be performed and reviewed in the same manner as recommended above for high-risk zones.

**RUNOUT ANALYSIS AND
 DEBRIS FLOW RISK**

geotechnical practice or professional geologist experienced in mass wasting processes. The evaluation should include subsurface explorations, evaluation of the hazard and risk from debris flows, and design of debris flow mitigation or protective measures. Such reports should be reviewed by a third-party for completeness and appropriateness.

Some existing residences are in the high-risk zone. Although this report does not attempt to assess or predict the risk to any individual parcel or structure, it may be prudent for those property owners to evaluate their exposure, obtain professional assistance, and take protective action, as discussed above.

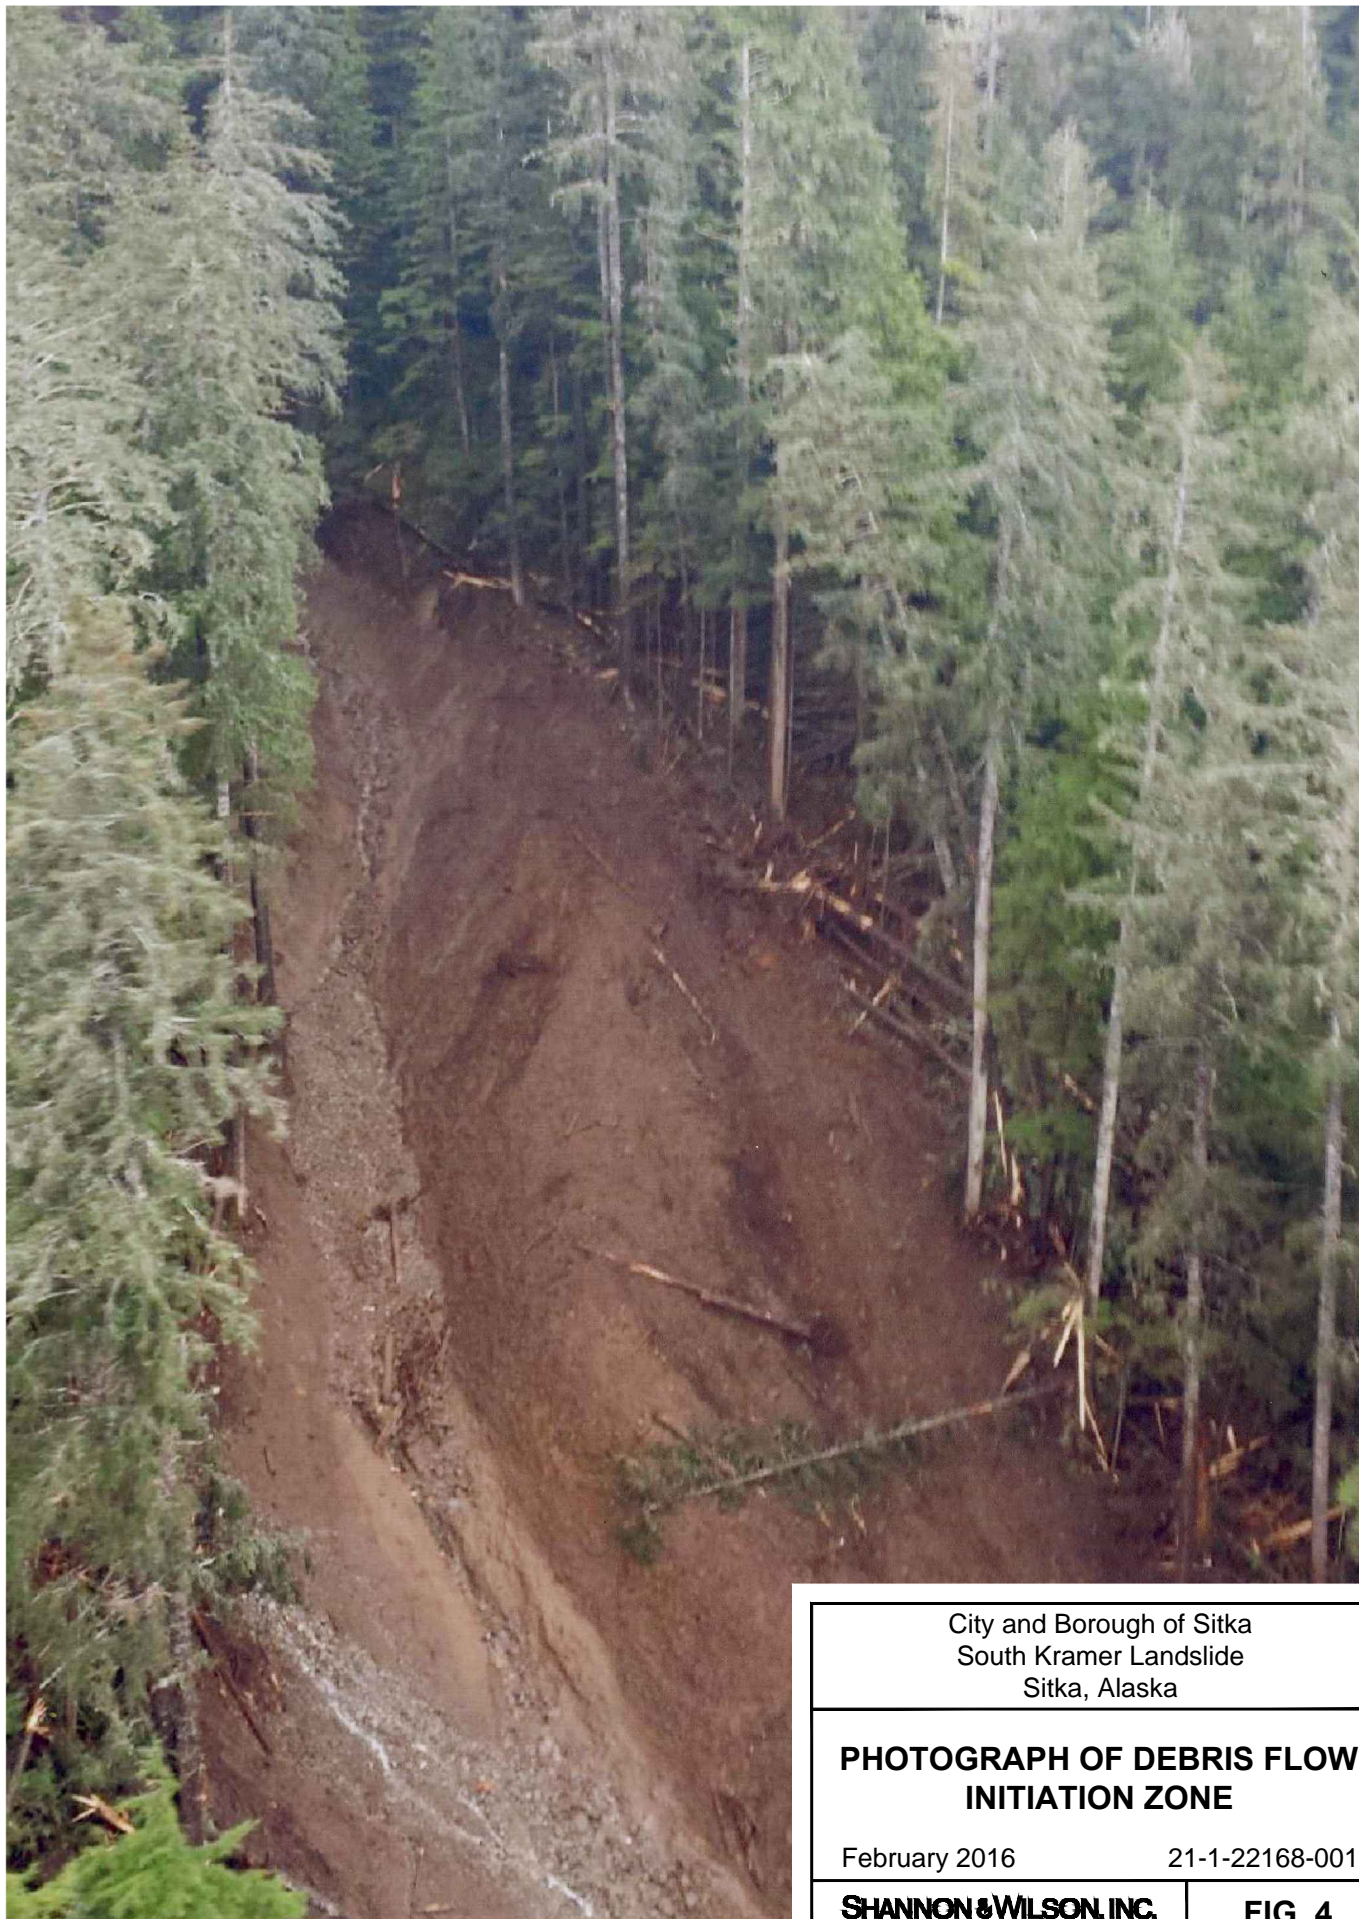
FIG. 4

contributing factors that appear to have influenced this mass wasting event are: (a) above-normal precipitation in the 2½ months prior to August 18, (b) very steep slopes in the initiation zone, (c) a bedrock hollow that concentrated groundwater and channeled failed soil to the bottom of the slope, (d) weak soil in the initiation zone, and (e) exposure to high winds on the initiation ridge.

Bedrock hollows, areas where the topography is convergent, are at particular risk of failure because they are capable of concentrating groundwater, thereby lowering the stability of accumulated soils in the swale.

The soils in the headwall of the debris flow consisted of colluvium, ash, and glacial till. The colluvium is weak because it accumulated from sloughing of surrounding formations. The ash is also weak because it was never overridden and compacted by glacial ice and has low strength. Ash soils are also typically hydrophylic and impermeable creating perched water and can cause an elevated groundwater level in the soil above it.

**PHOTOGRAPH OF DEBRIS FLOW
INITIATION ZONE**

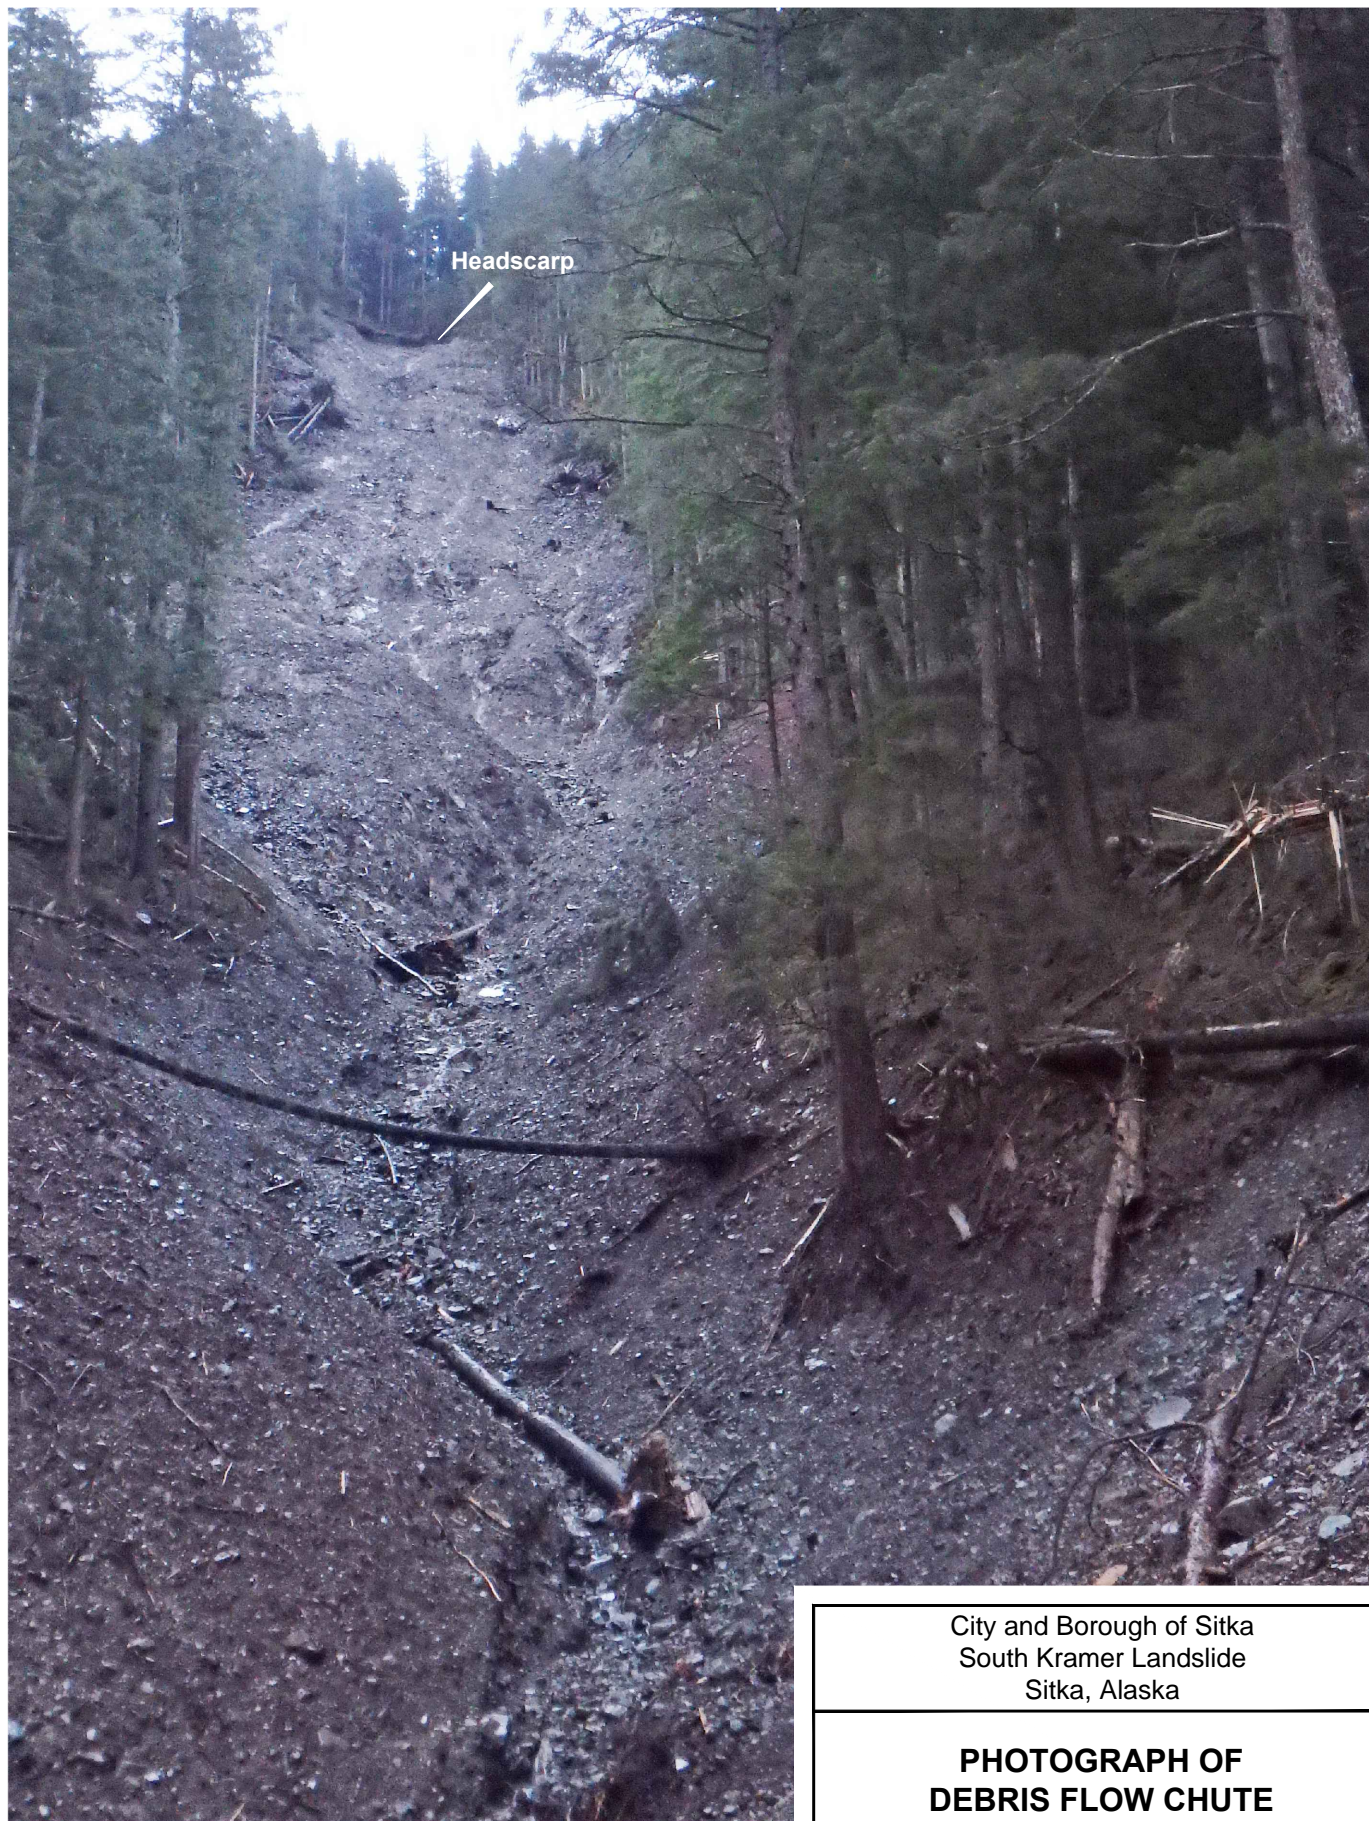
FIG. 5

**PHOTOGRAPH OF
DEBRIS FLOW CHUTE**
