South Kramer Avenue Landslide:  
Jacobs Circle to Emmons Street  
Sitka, Alaska

February 2, 2016

**RE: SOUTH KRAMER AVENUE LANDSLIDE: JACOBS CIRCLE TO  
EMMONS STREET, SITKA, ALASKA**

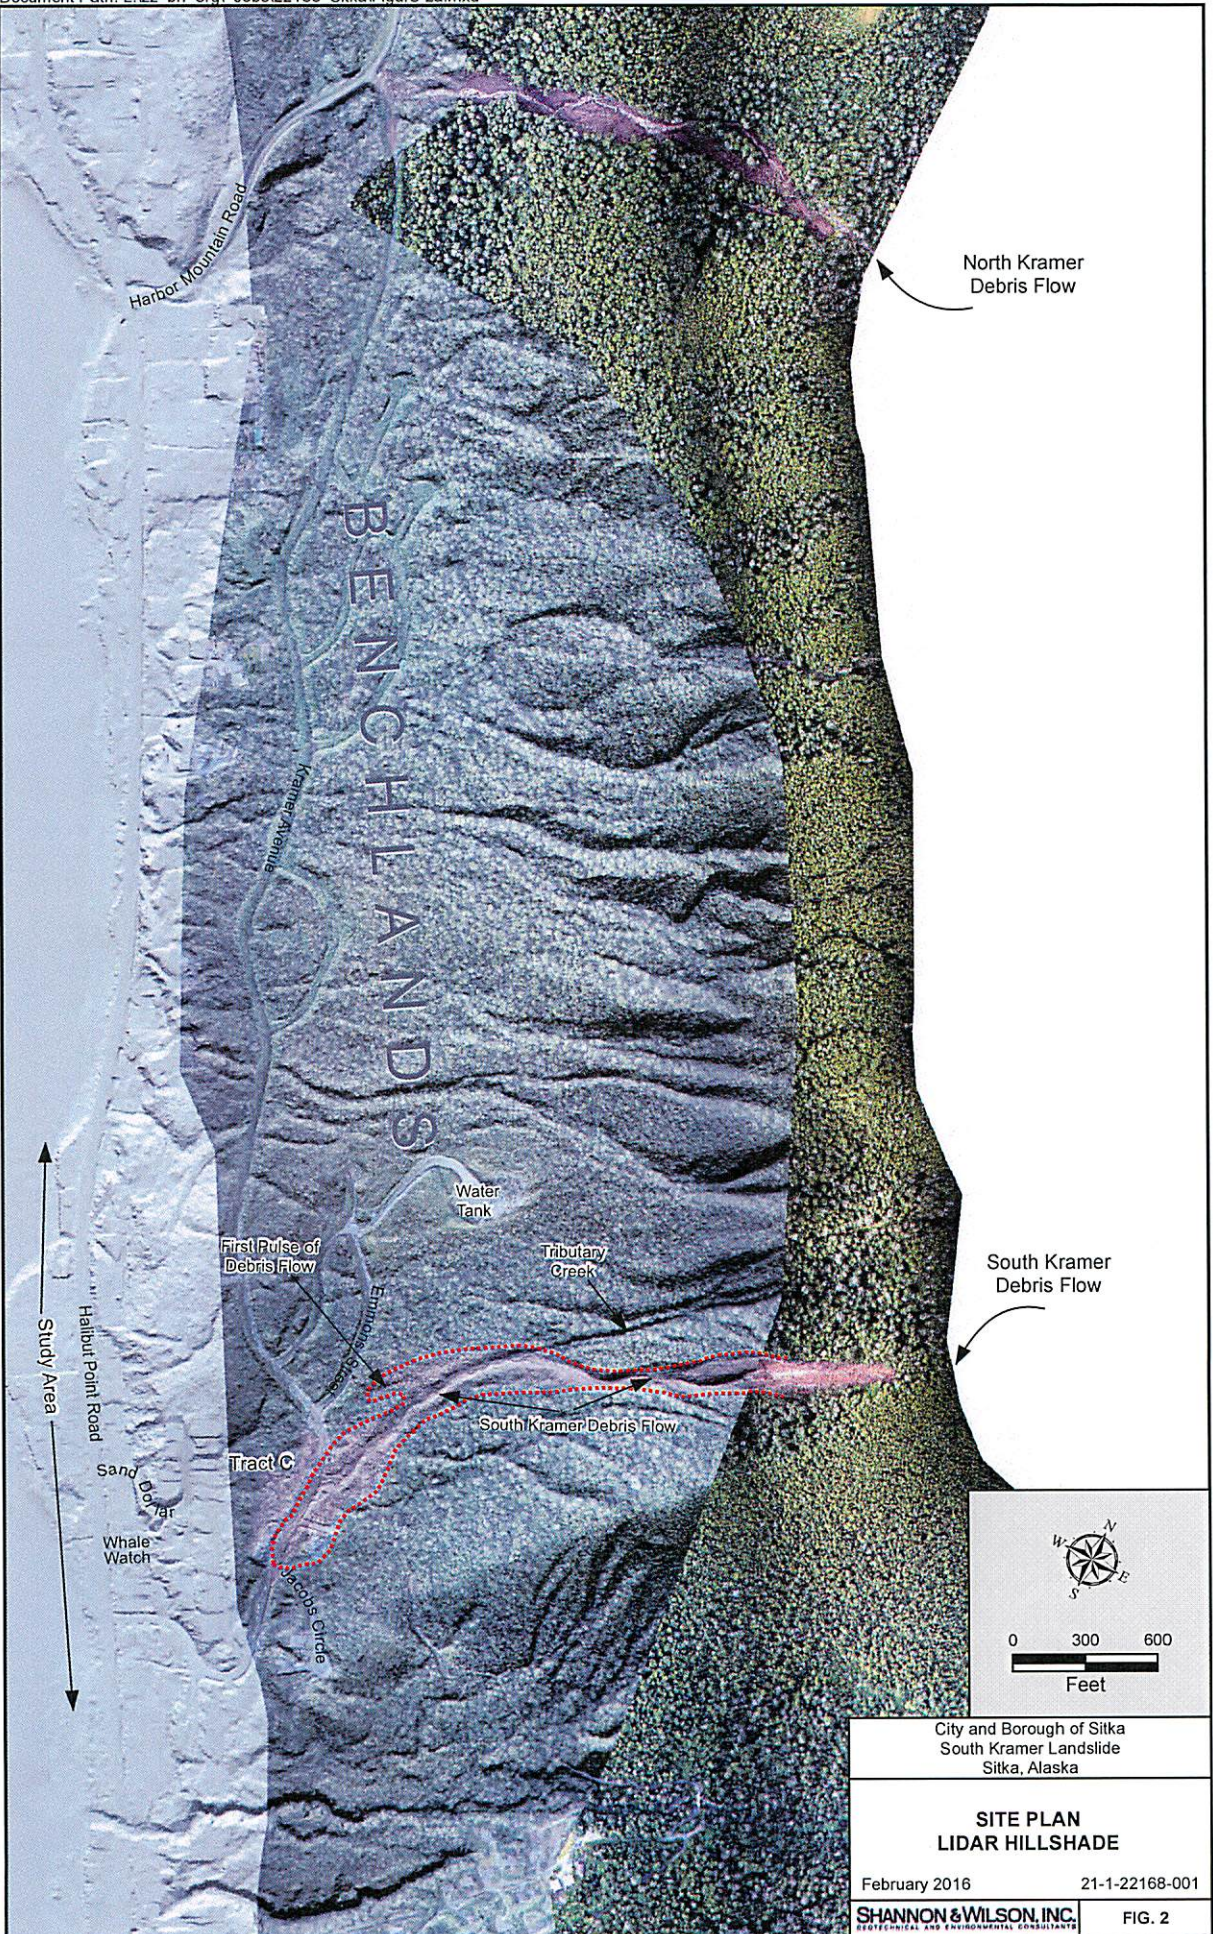
FIG. 2

The South Kramer landslide is located north of downtown Sitka on the western flank of Harbor Mountain, as shown in the Vicinity Map, Figure 1. It initiated near the top of a ridge, at the southern end of the west-facing slope of Harbor Mountain. The debris from the debris flow came to rest near the southern end of Kramer Avenue, as shown in Figure 2.

Kramer Avenue is located on a terrace that is about 400 to 600 feet wide and is continuous for about one and a quarter miles (Figure 2). This area is locally known as the "Benchlands." From the western edge of the Benchlands, the slope steepens down through the residential areas of Sand Dollar Drive and Whale Watch Drive. Another terrace is located to the west of these streets. Halibut Point Road is situated on this lower bench, a raised marine terrace. The sea is directly west of Halibut Point Road.

From aerial photographs and from field observations, it appears that the first pulse of the debris flow left the channel and plowed into the woods near elevation 240 feet, as indicated in Figures 2 and 3. This was likely the result of an upslope, straight segment of the channel and the debris wanting to maintain a straight line. After the first pulse, the bulk of the debris followed the existing channel that was directed toward the residence at 430 Kramer Avenue. The debris killed three people, and destroyed one residence and damaged another. Upon reaching Kramer Avenue, the debris encountered a low berm on the south side of the road that appears from photographs to have been 2 to 3 feet higher than Kramer Avenue. Farther south along the western side of Kramer Avenue, fill was mounded 8 to 10 feet high in an earthfill berm. When the debris flow encountered these berms, it turned southward down the road. It came to a stop about 400 feet from the point at which it reached Kramer Avenue, as shown in Figures 2, 3, and 6.

The Light Detection and Ranging (LiDAR) hillshade image (Figure 2) of the study area is informative but enigmatic. On a very broad scale, it has been suggested by others that the west-facing slope of Harbor Mountain collapsed in ancient times, spreading landslide debris into the ocean, one remnant of which is a shoreline protrusion. There is no evidence in outcrop or exposure of debris of such a widespread event, and the LiDAR image does not unequivocally support such a hypothesis.

The LiDAR image does support the hypothesis that the Benchlands is, in part, constructed of landslide materials supplied by repeated debris flows along several discrete chutes that originate on Harbor Mountain. The depositional distribution of the landslide debris also supports this idea. No landslide debris is observed or reported to the west of Kramer Avenue.

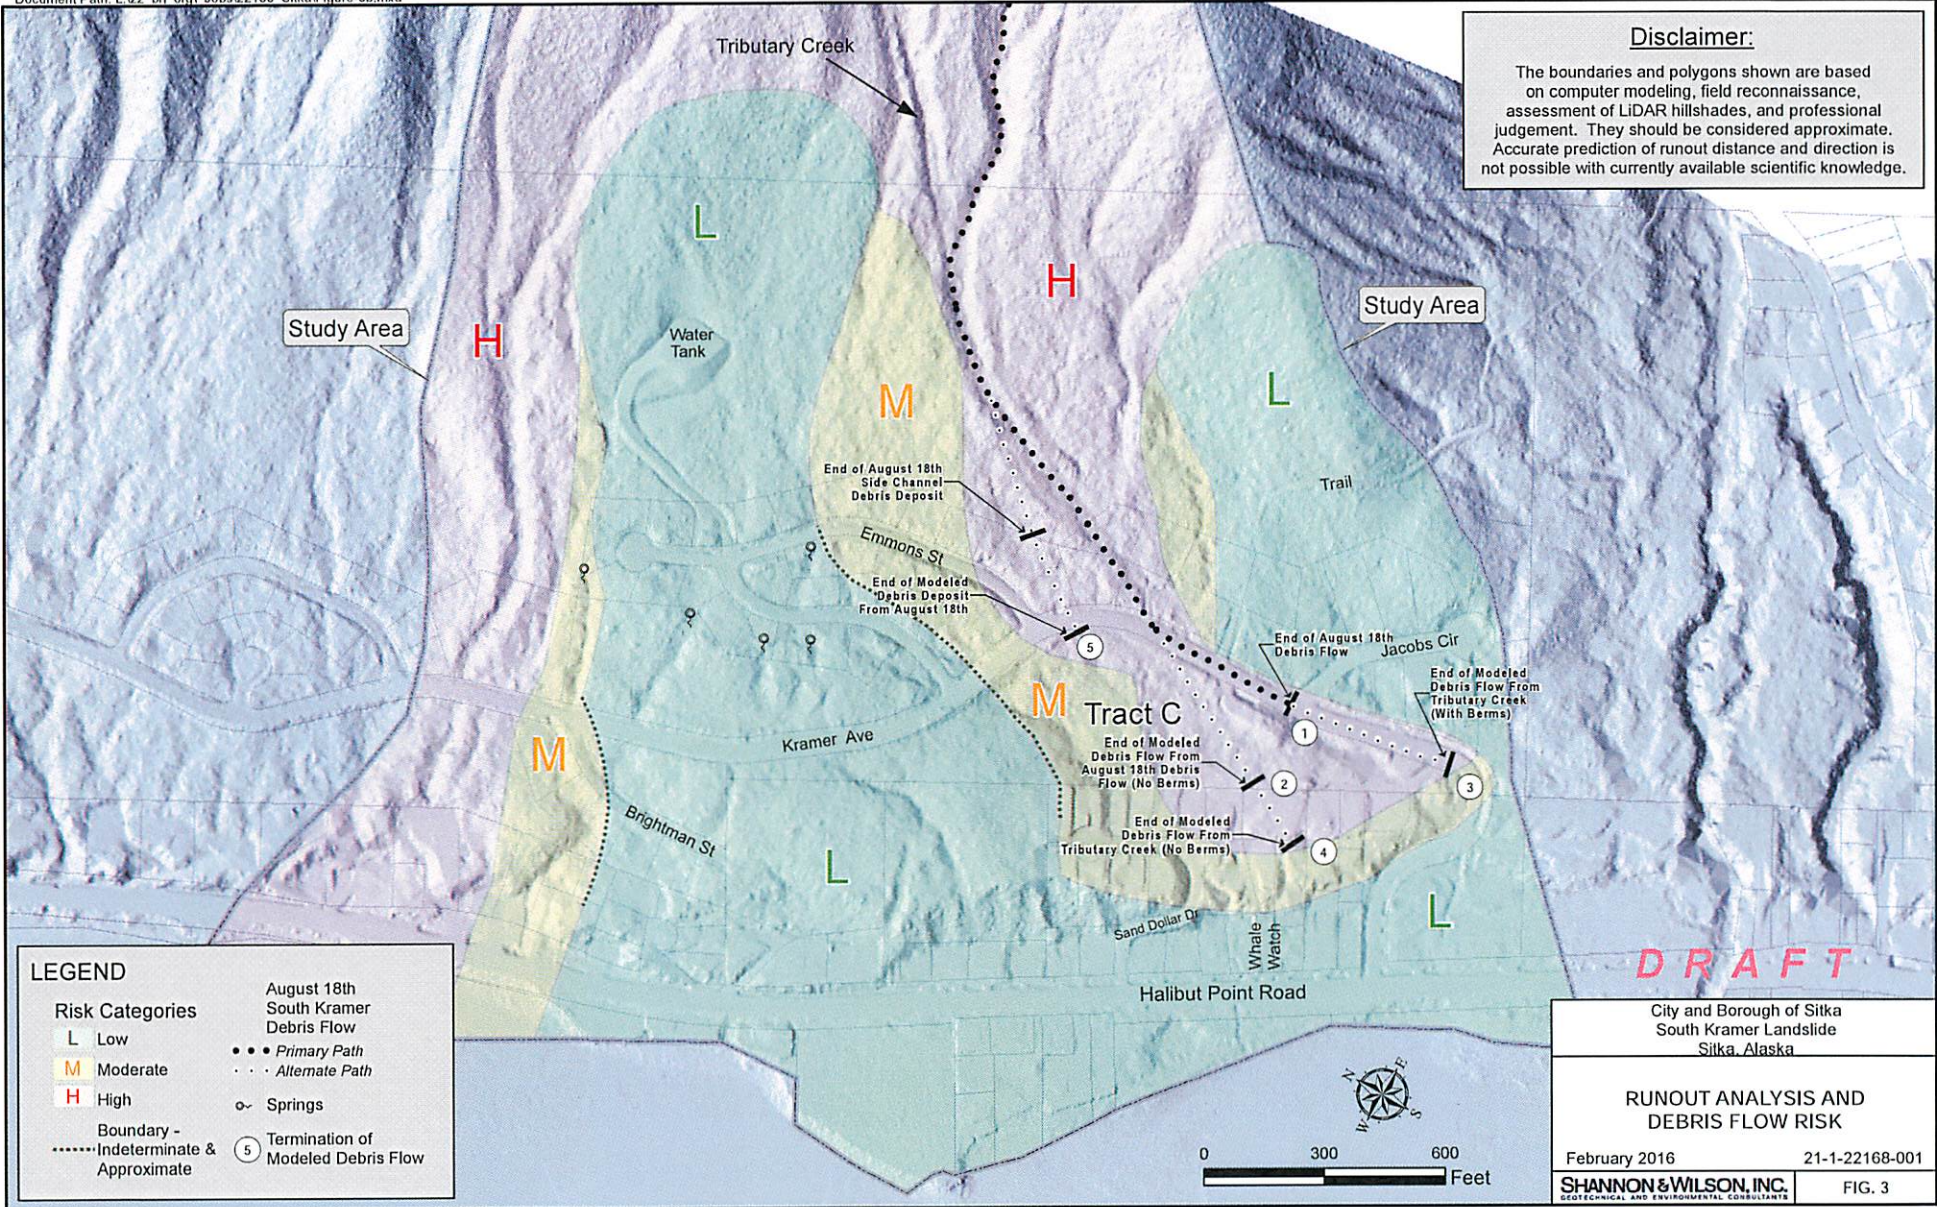
**SHANNON & WILSON, INC.** FIG. 3  
GEOTECHNICAL AND ENVIRONMENTAL CONSULTANTS

Little of Kramer Avenue is presently developed. Roads along the Benchlands are in place. A water tank is constructed on the slope above the northern end of Emmons Street (Figure 3), and distribution is established to the south of it. A sewer main extends from the southern end of Kramer Avenue northward to the Emmons/Kramer intersection. The only part of Kramer Avenue on which residences have been built is the southern end. One of these houses was destroyed by the landslide; another was damaged. Several other houses further south were undamaged.

Groundwater is perched in this area. In the Golder report, groundwater levels ranged from 1.5 to 8.5 feet below ground surface. Numerous springs, as noted in Figure 3, emerge from the hillside. In some cases, they form the heads of through-going surface streams. In other cases, they infiltrate back into the ground and pop out farther downslope. In some areas, such as Tract C, most of the ground is covered with standing water, likely perched on ash or till.

We performed several iterations of the model to calibrate it, and then ran five scenarios (see Figure 3):

1. The full length of the channel along which the August 18 debris flow moved, deflected by the berms on the west side of Kramer Avenue (Terminus 1).
2. The full length of the channel along which the August 18 debris flow moved, if the berms along the west side of Kramer Avenue had not been in place (Terminus 2).
3. The northern tributary chute originating at the top of Harbor Mountain, deflected by the berms on the west side of Kramer Avenue (Terminus 3).
4. The northern tributary chute originating at the top of Harbor Mountain without the berms on the west side of Kramer Avenue (Terminus 4).
5. The northern branch of the August 18 debris flow that ended in the woods uphill from Kramer Avenue (Terminus 5).

The locations of the distal ends of the modeled runouts are presented in Figure 3. Modeling indicated that another debris flow along the August 18 alignment would end up in the same place as before, assuming that the berms on the west side of Kramer Avenue were left in place. If the berms were not in place on August 18, the debris could potentially have runout into Tract C about 400 feet southwest of Kramer Avenue. If the August 18 debris flow deposit had continued straight westward through the woods, as shown in Figures 2 and 3, it could have reached Kramer Avenue. Modeling of this side branch of the debris flow showed that once the debris flow material leaves the channelized section of the creek and becomes a uniform unchannelized slope, the debris slows and deposits relatively quickly, as shown in Figure 3. The modeling does not

Three moderate risk zones were identified, as shown in Figure 3. They are either buffer areas between high- and low-risk zones, or areas that offer slightly higher risk than low, as discussed below. One is the buffer zone adjacent to the debris chute high-risk zone on the northern edge of the study area. Another buffer zone is located downhill (west) of Tract C. Another moderate zone is located uphill of Emmons Street where there appear to be deposits of ancient, relict debris flows. The channel that originally supplied debris to this area is presently incapable of delivering debris to this same area, in our opinion; however, if the adjacent incised creek/swale should become blocked during a debris flow, the relict channel could potentially deliver debris to this area again. If any new development or redevelopment is contemplated for these areas, a geotechnical evaluation should be performed and reviewed in the same manner as recommended above for high-risk zones.

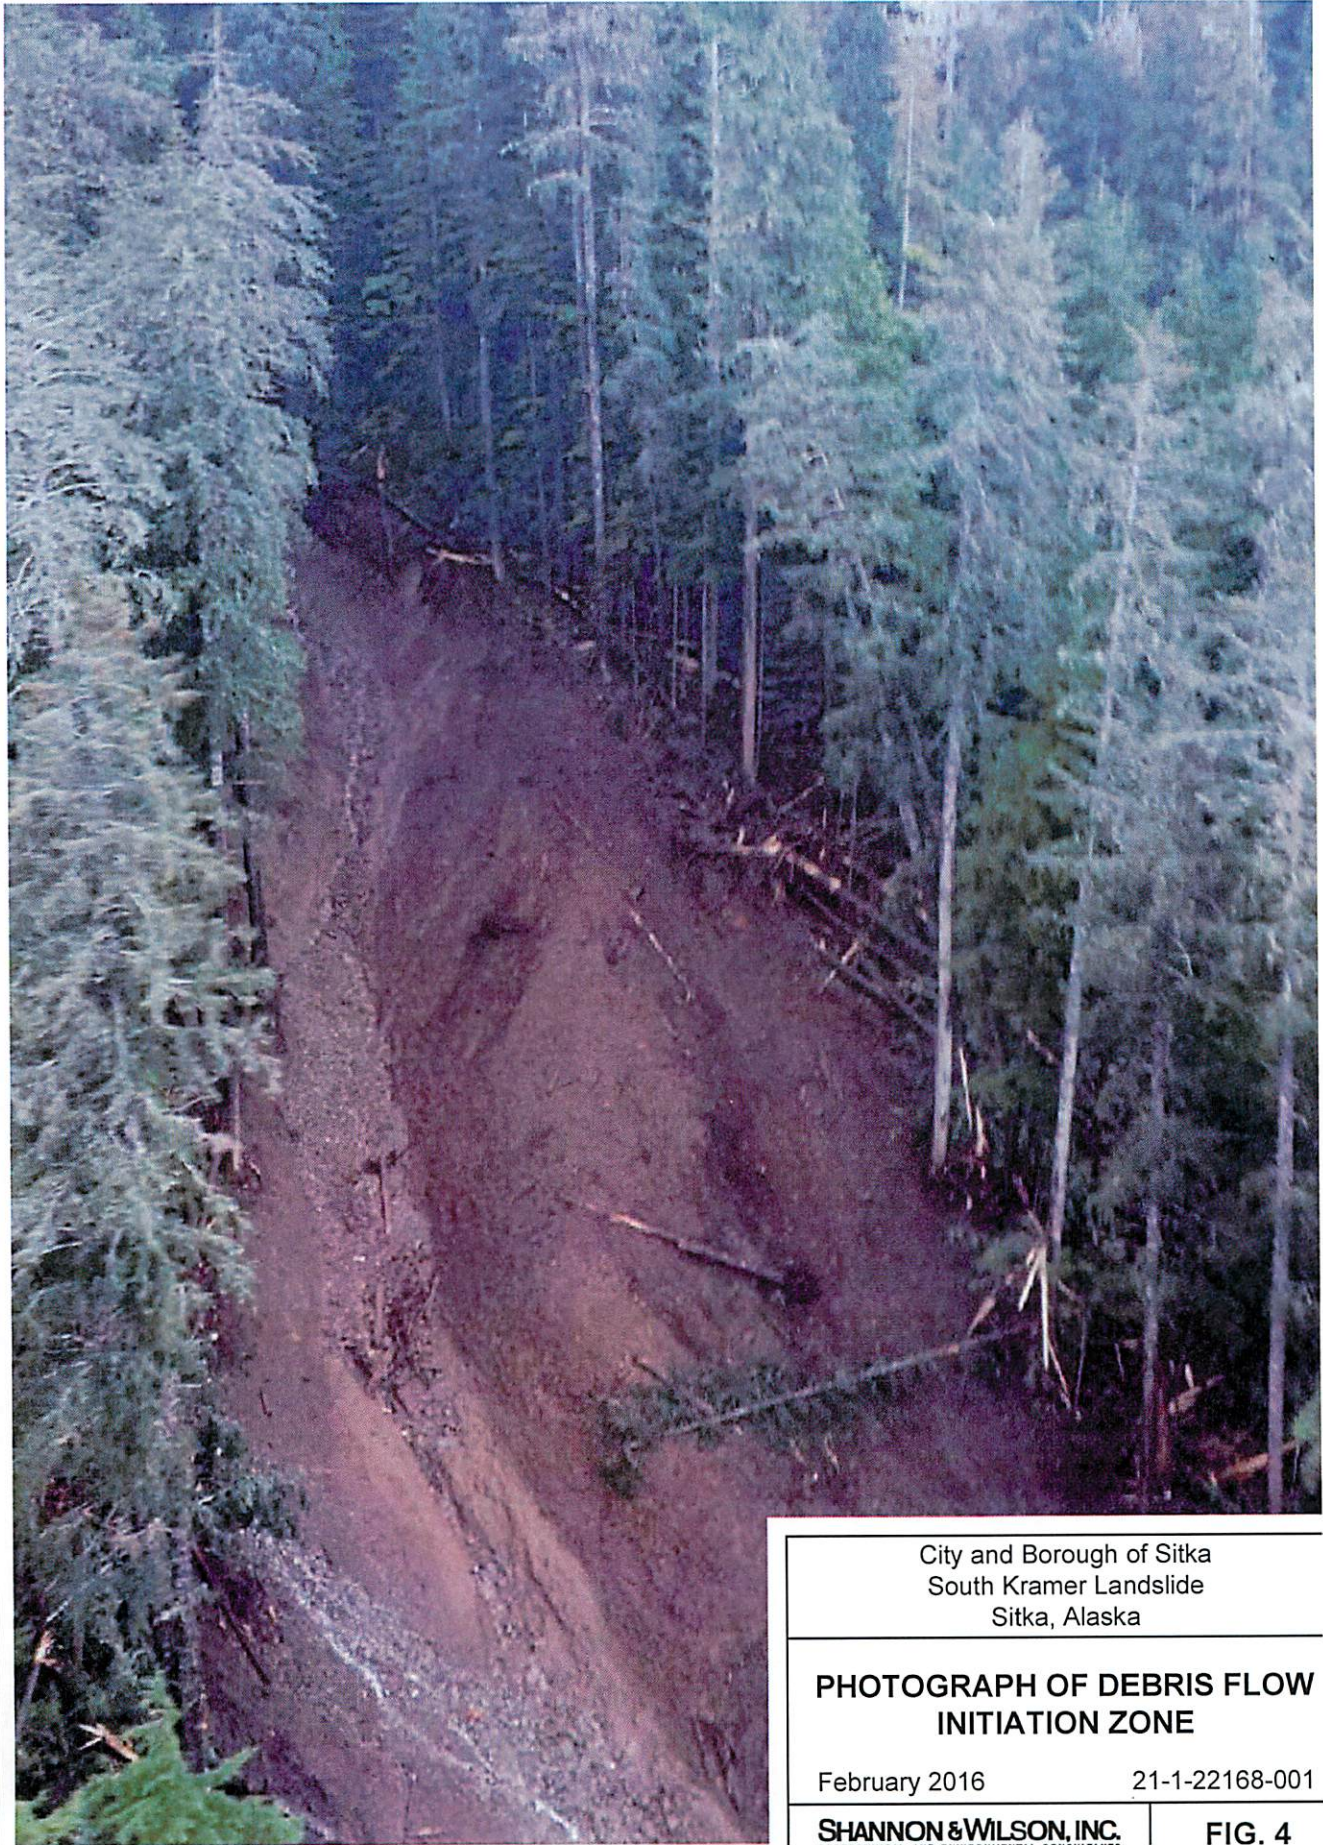
**FIG. 4**

**PHOTOGRAPH OF DEBRIS FLOW  
INITIATION ZONE**

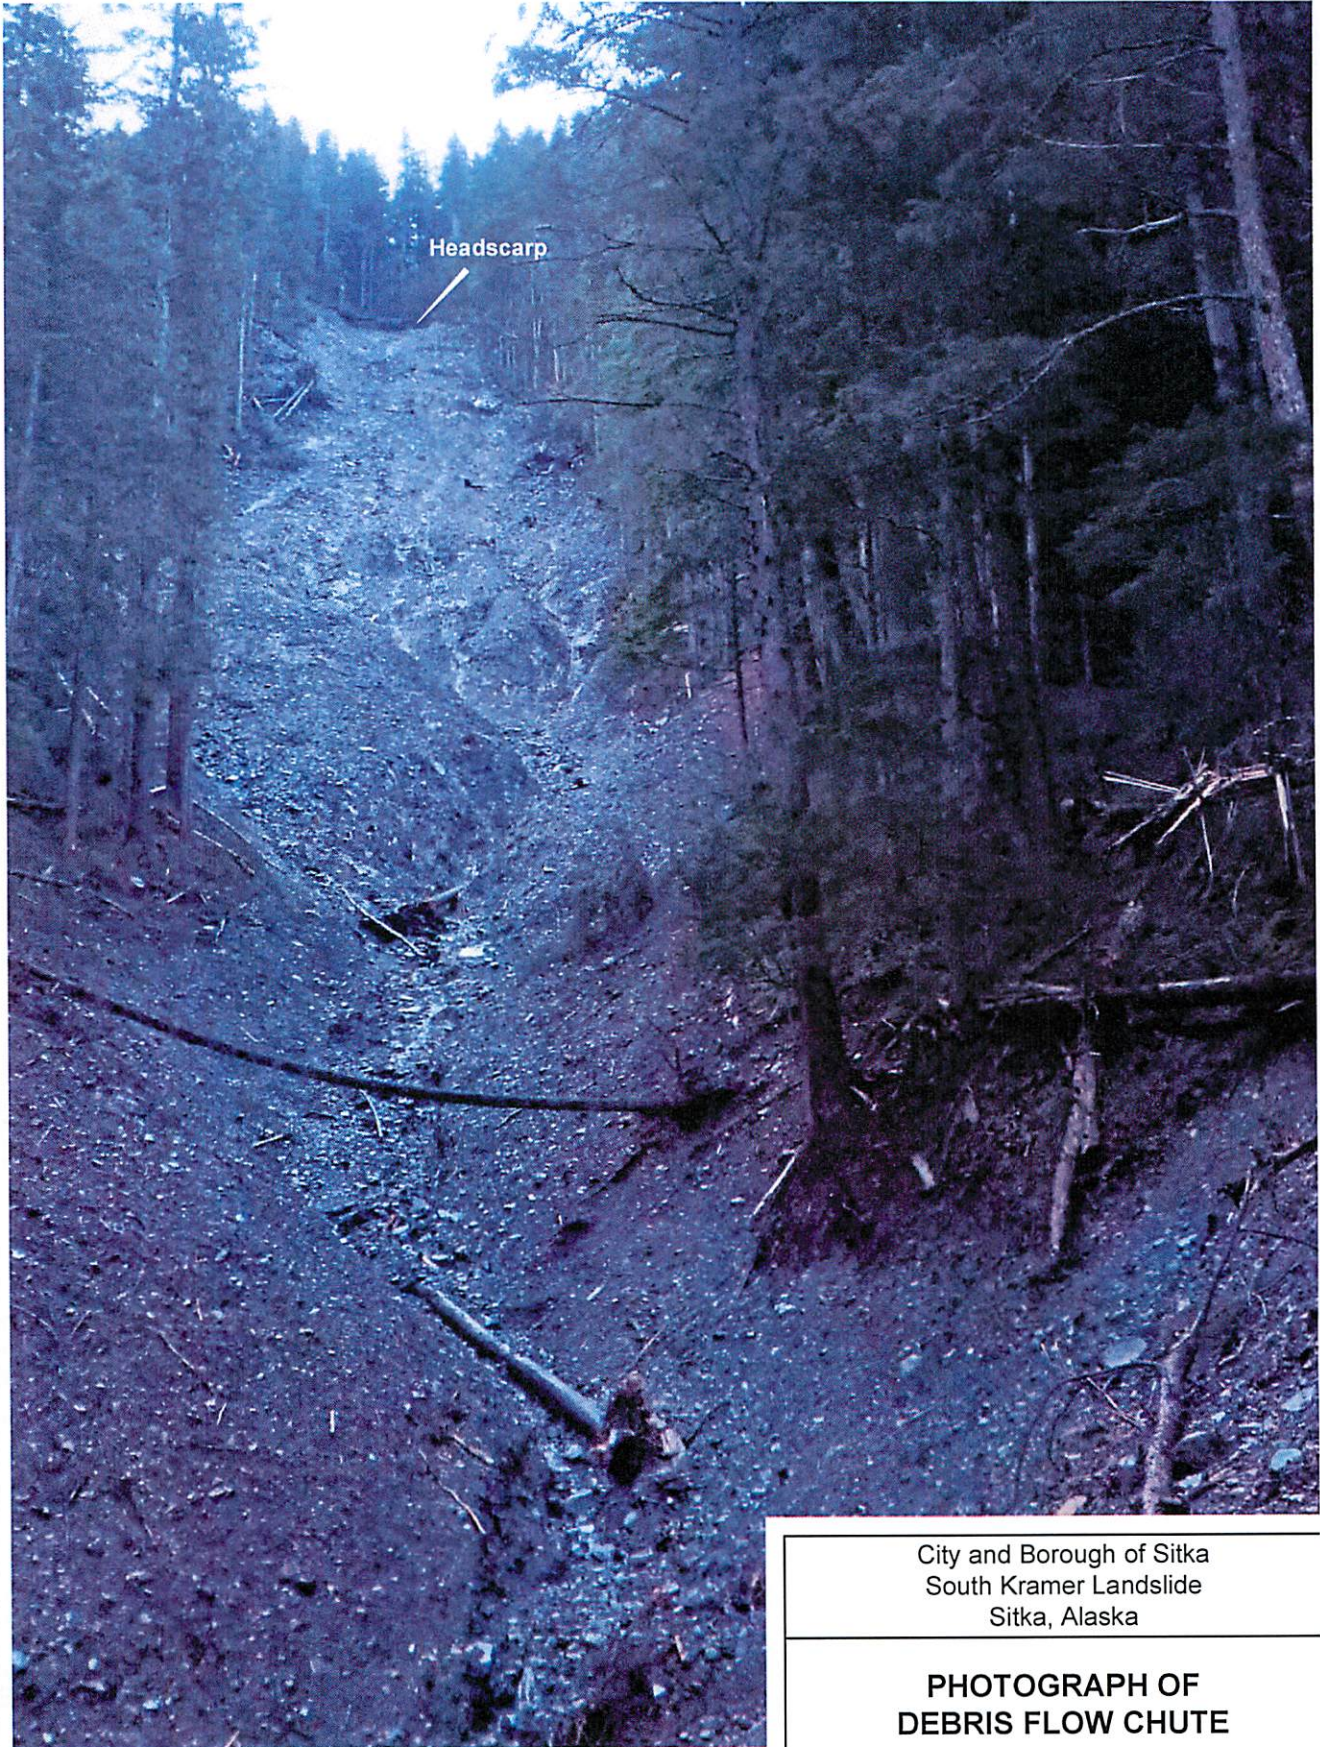
**FIG. 5**

**PHOTOGRAPH OF  
DEBRIS FLOW CHUTE**

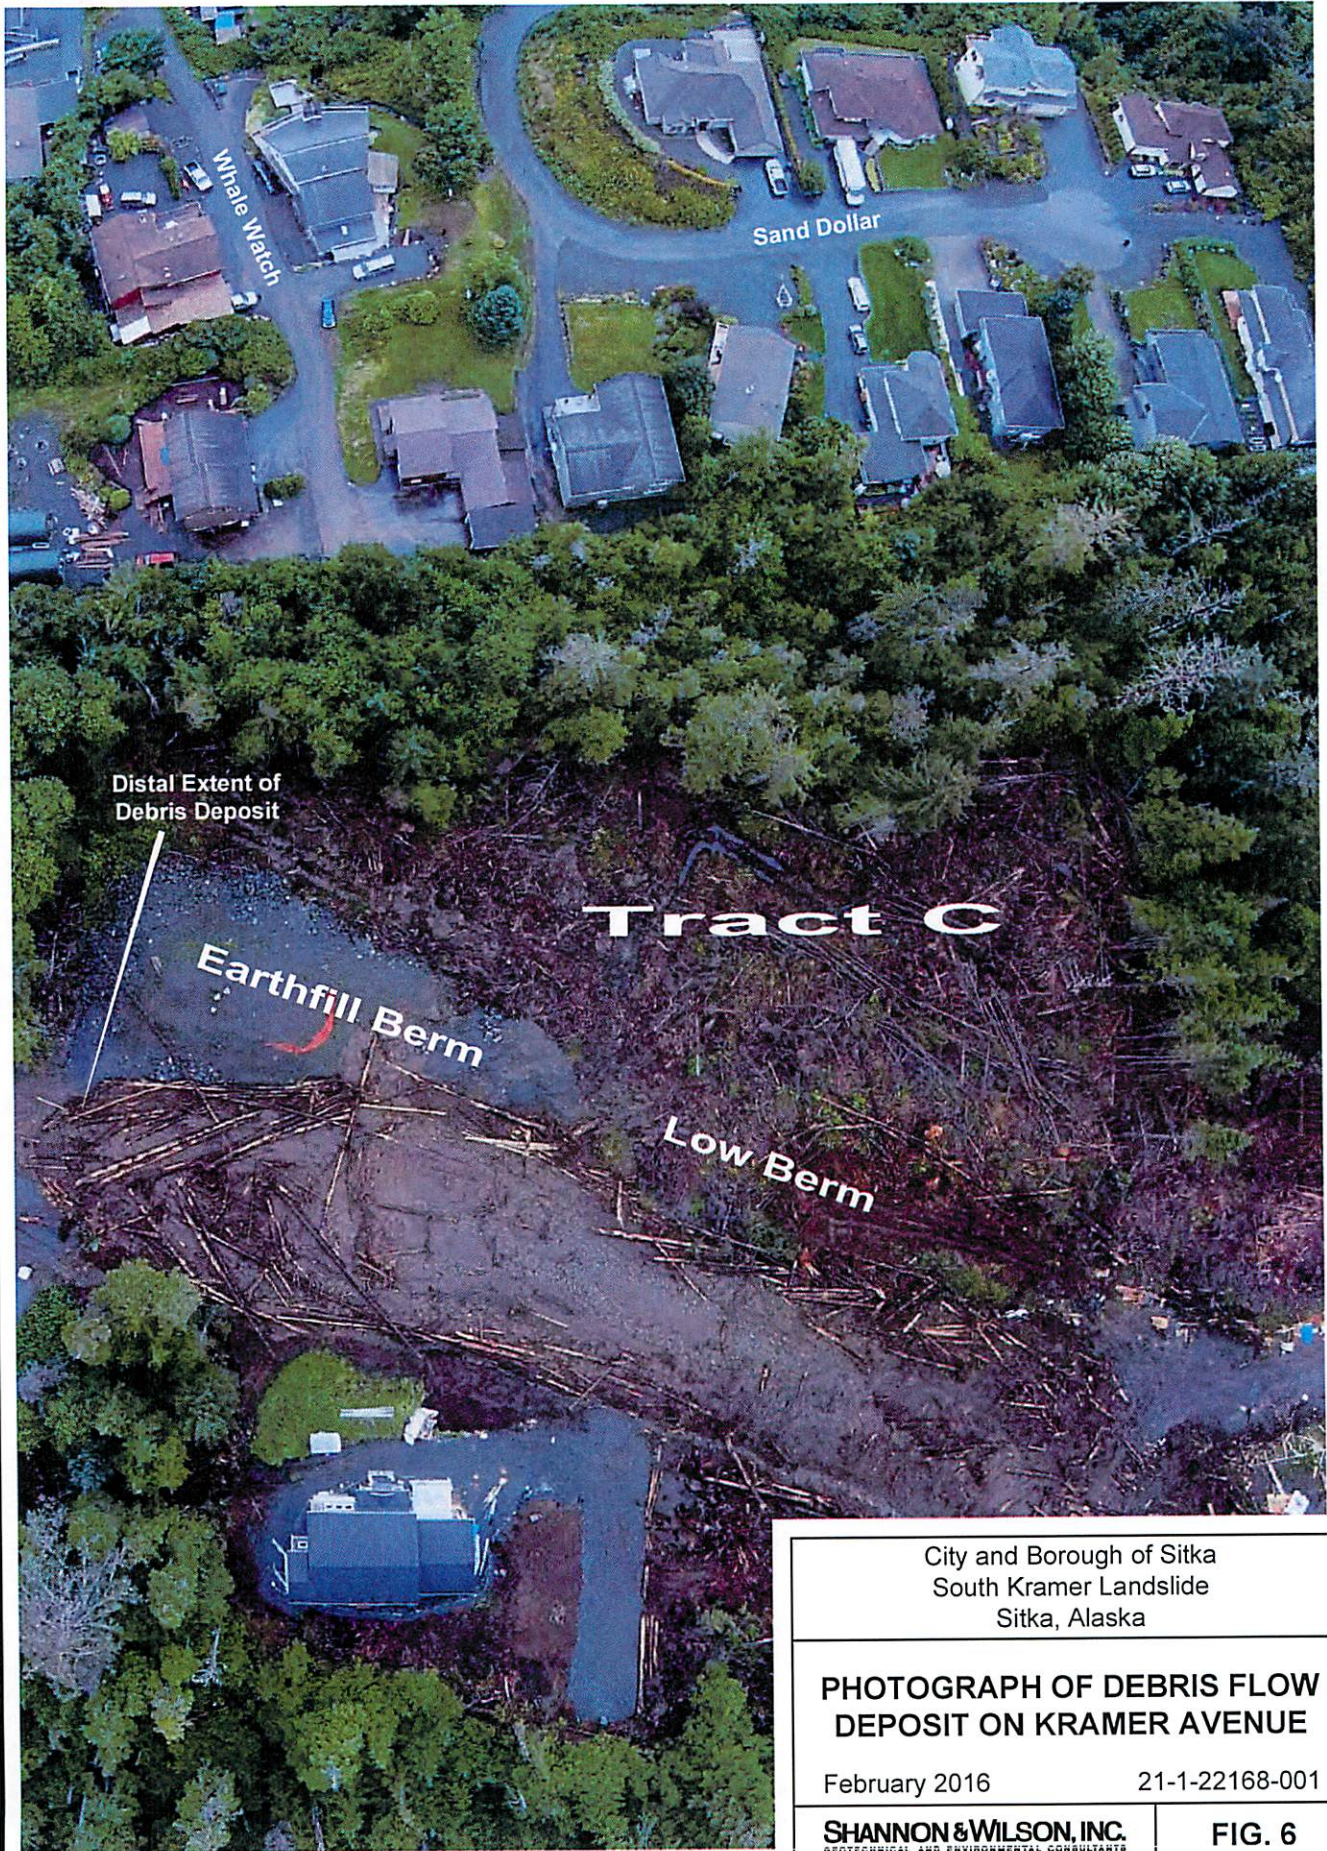
We understand that the more southerly earthfill berm (Figure 6) is a temporary stockpile of soil that was placed by the development contractor for future site grading in Tract C.

City and Borough of Sitka South Kramer Landslide Sitka, Alaska	
<b>PHOTOGRAPH OF DEBRIS FLOW DEPOSIT ON KRAMER AVENUE</b>	
February 2016	21-1-22168-001
<b>SHANNON &amp; WILSON, INC.</b> GEOTECHNICAL AND ENVIRONMENTAL CONSULTANTS	<b>FIG. 6</b>
