# ELECTRICAL ASSESSMENT REPORT

Facility: Sitka Community Hospital  
Location: 209 Moller Avenue  
Sitka, AK 99835

Site Visit: April 18, 2016  
Report date: May 17, 2016

Prepared By: Brad Adcock, P.E.  
AWA Electrical Consultants, Inc.  
[brad@awaelec.com](mailto:brad@awaelec.com)

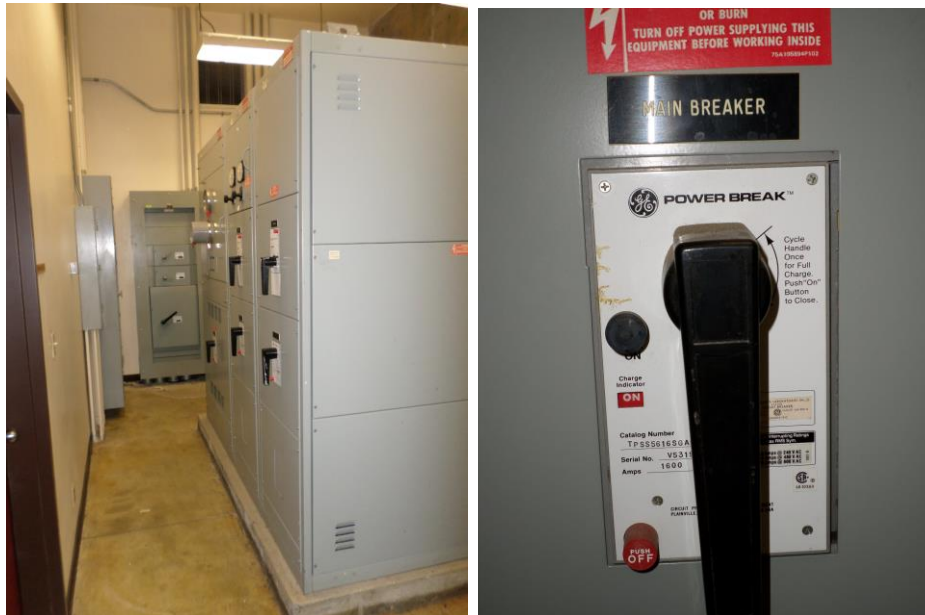
The existing switchboard is old (35 years) but in **FAIR** condition. The lifespan of the existing equipment is estimated at around 50 years, so there is some useable life left in the equipment.

- The working clearance does not appear to meet current code, (NEC 110.26), which requires two entrances at **either end** of the electrical room.
- Ground Fault Protection of the main switch, and second level overcurrent devices is not provided per NEC 517.17.

No recommendation to replace at this time. Significant upgrades or modifications may trigger code required upgrades.

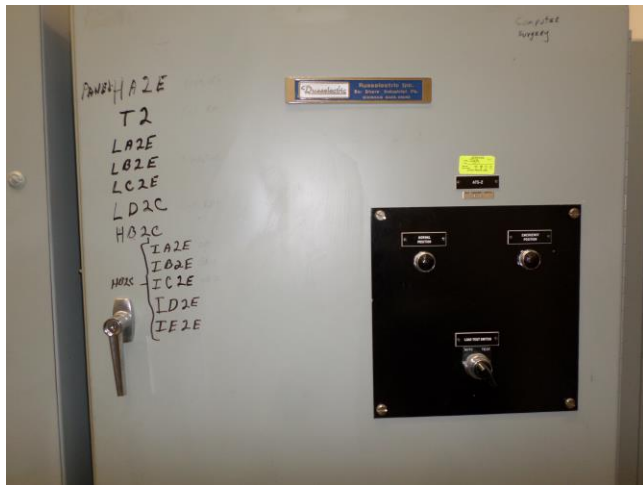
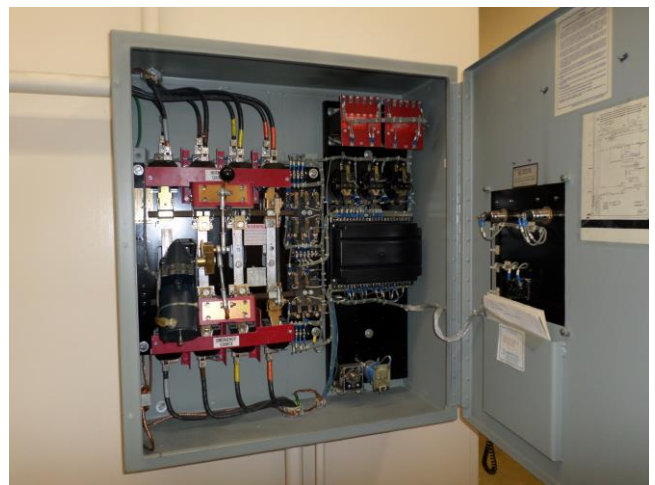
### ATS Switch ATS 2E

The existing Automatic Transfer Switches (ATS's) are old, and in **POOR** condition. The components and contacts within the switch are showing signs of age, and should be replaced. The level of reliability is low for continued operation during a normal power failure.

1. **Replace Automatic Transfer Switches:** Considering the ATS's condition, and are the weak point of failure of the overall emergency system, we would **recommend these be replaced with new.**

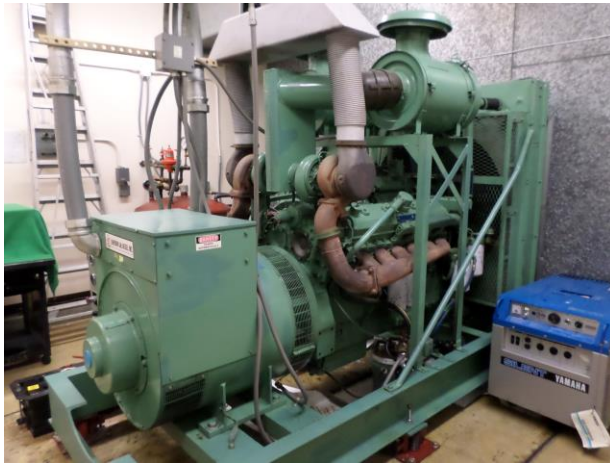
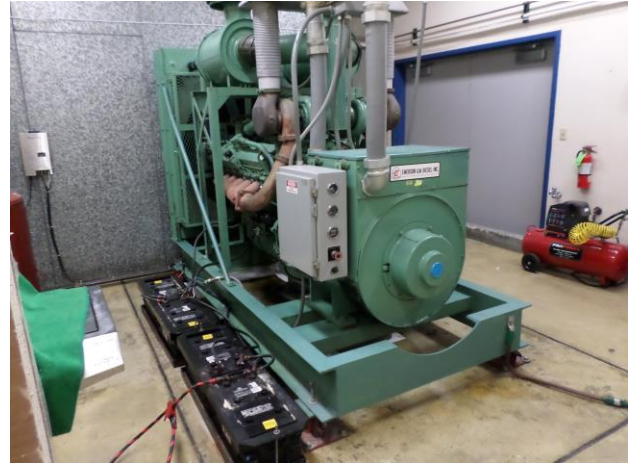
The generator is old (1981) but in **GOOD** condition, and is well maintained.

No recommendation for replacement/upgrade at this time.

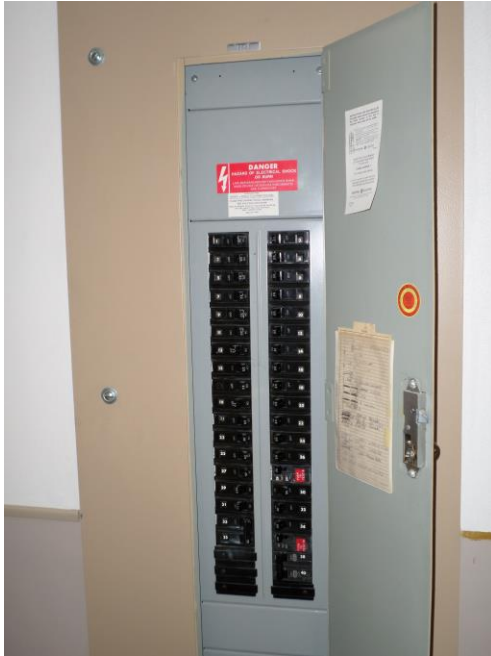
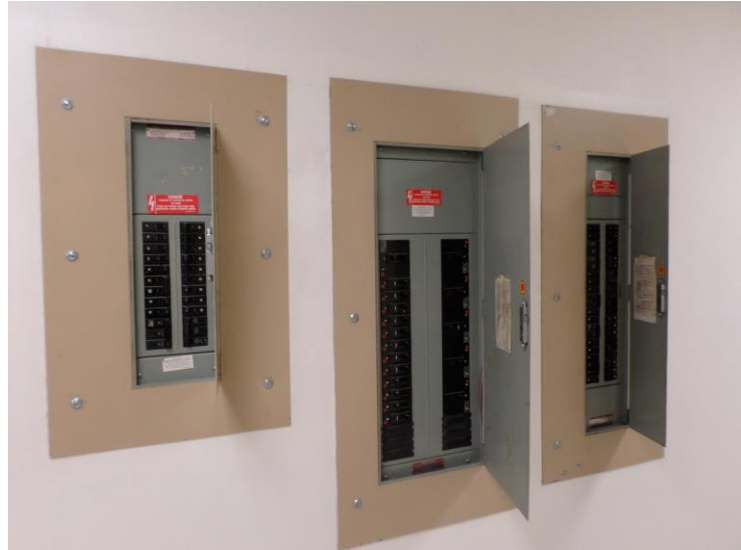
The branch panels are old but in **FAIR** condition. There is minimal spare breaker capacity in general. The existing panels appear to be adequate for present hospital needs. However if additional circuits are needed, we would recommend replacing panels with new panels that have more capacity (54, 66).

There are a few Isolated Power System panels serving Operating rooms that appear to be causing nuisance tripping/alarming at the Line Isolation Monitor (LIM). System replacement with newer IPS's is an option to mitigate nuisance tripping/alarming, or replacement with grounded system, pending further investigation of the type of procedure being done.

Recommend replacing IPS/LIM with newer updated systems, or removal and replacement with grounded systems, and utilizing GFCI for various required circuits. **Further investigation of OR room function is required to confirm removal of systems.**

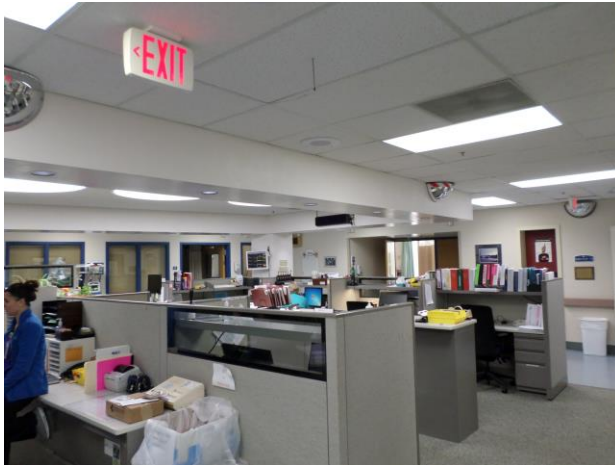
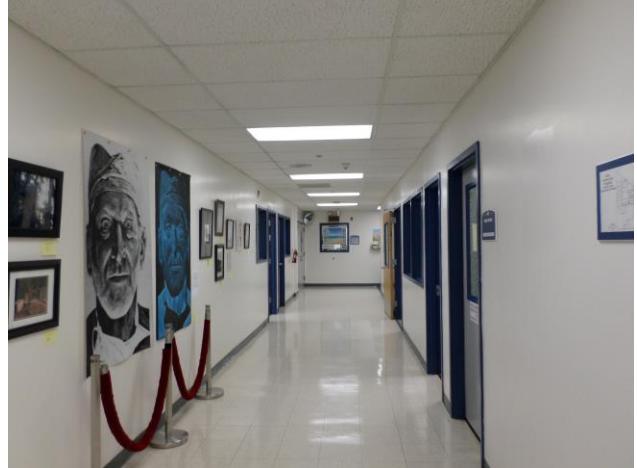
The condition of the light fixtures are **FAIR**, and provide an adequate level of lighting for standard hospital use.

There is no recommendation for lighting replacement at this time. However, there may be opportunities to replace/retrofit existing fluorescent lighting with LED, and the local utility company may offer rebates to help pay for replacement cost. This has not been investigated.
