Crescent Harbor Lightering Float Condition Assessment

Condition Summary Report

January 21, 2020

City and Borough of Sitka, Alaska

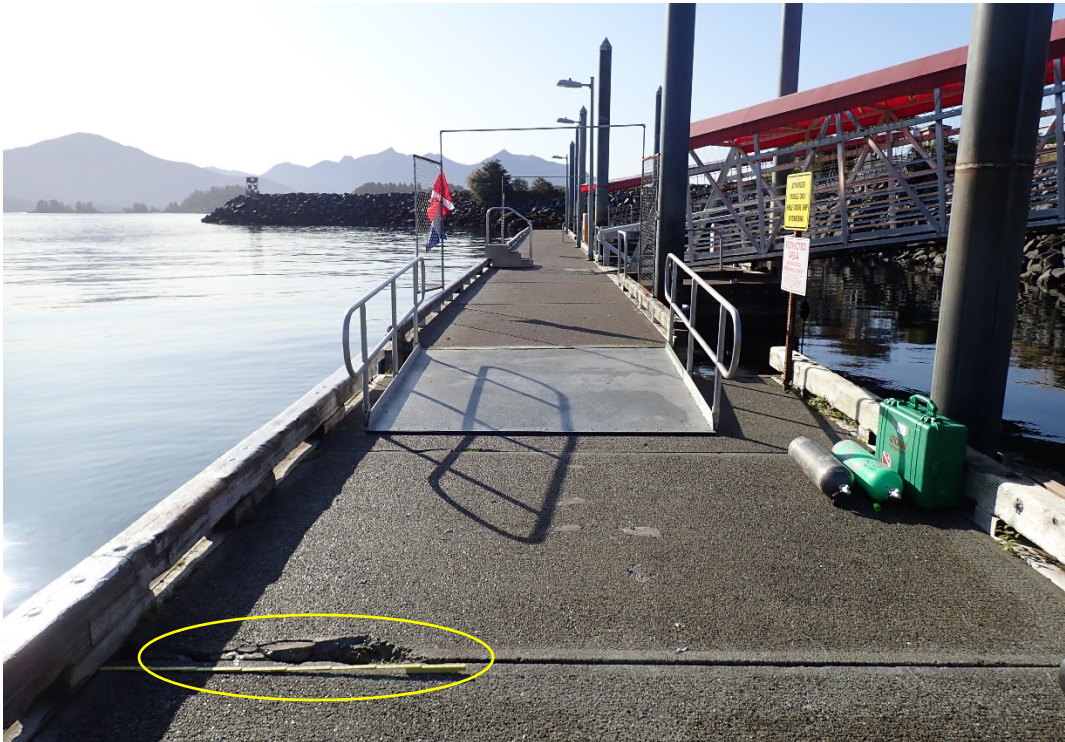
There is one topside spall with exposed and corroded reinforcing steel located on the northern edge of Float 6 at the east end that measures 44 inches long x 8 inches wide x 8 inches deep (see Photographs 1 and 2; photographs are presented in Section 4). The concrete floats typically exhibit moderate scaling on topside and underside with pitting up to 3/8 inch deep (Photographs 3 and 4).

Photograph 1: View of the Lightering Float looking south with spall in the foreground.

The concrete floats are in fair condition. The concrete scaling on the topside and underside is not a significant structural concern. However, there are various concrete, timber, and connection hardware defects that should be repaired. The spall with corroded reinforcement steel on the northern edge of Float 6 (Photographs 1 and 2) should be repaired by removing the unsound concrete, cleaning the exposed reinforcement, and placing an epoxy grout suitable for marine applications to prevent further deterioration of the steel reinforcement.

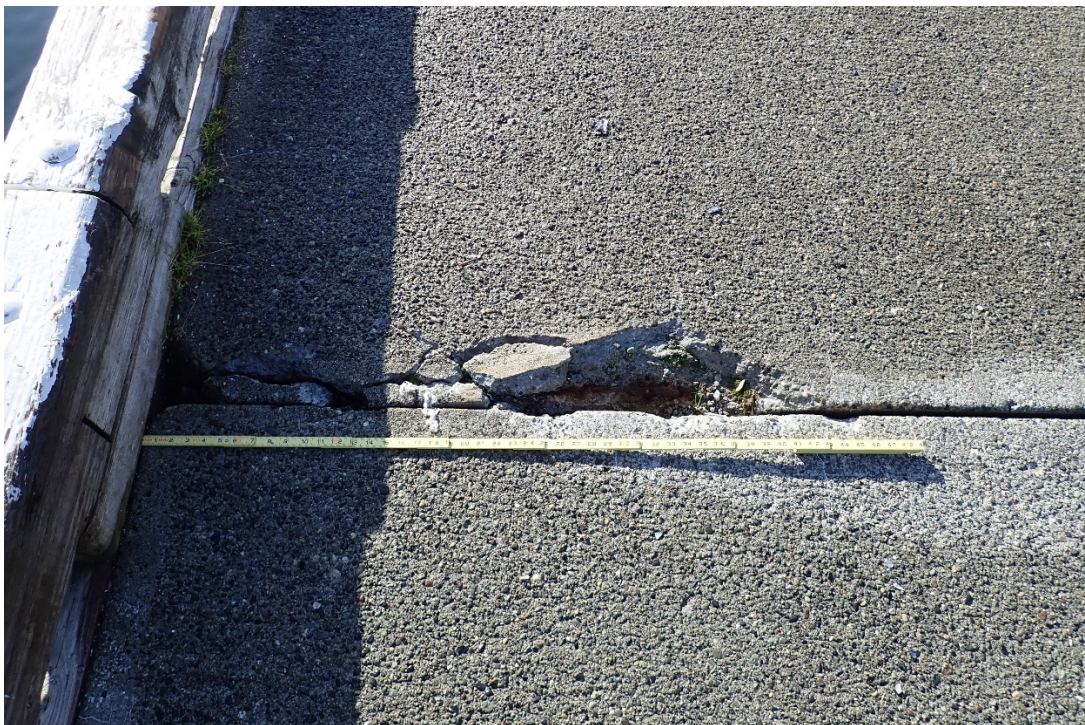
Photograph 2: Close up view of spall with exposed reinforcement on north edge of Float 6.

02.01.01 Float 6 Concrete Spalling Repair	1.00 LS	538.40 /LS	280.00 /LS	750.00 /LS	1,568.40 /LS	1,568	3,667.83 /LS	3,668
		02.01.02	Float 7 Missing Timber Chock and Deteriorated Lower Timbers								
			Float 7 Replace Missing Timber Chock and Remove and Replace Deteriorated Lower Timbers, Including Hardware	1.00 ls	4,845.60 /ls	1,200.00 /ls	7,500.00 /ls	13,545.60 /ls	13,546	31,736.22 /ls	31,736

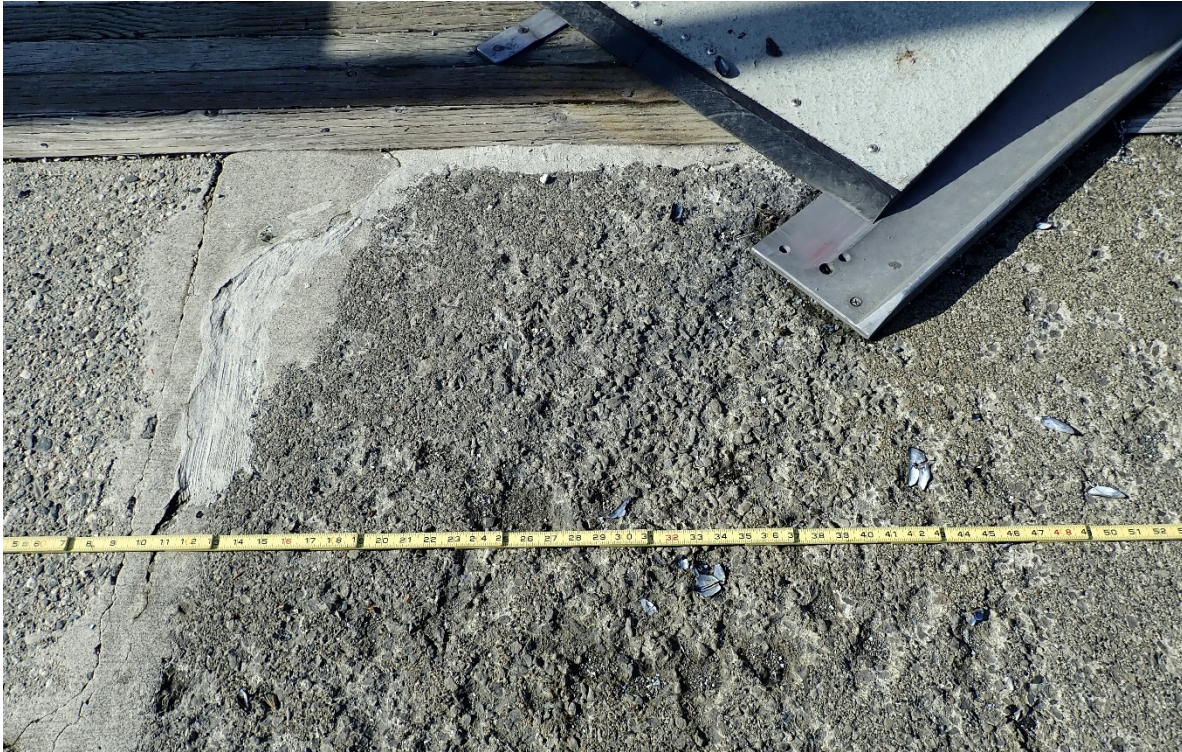
Photograph 3: View of scaling on topside of north gangway float.

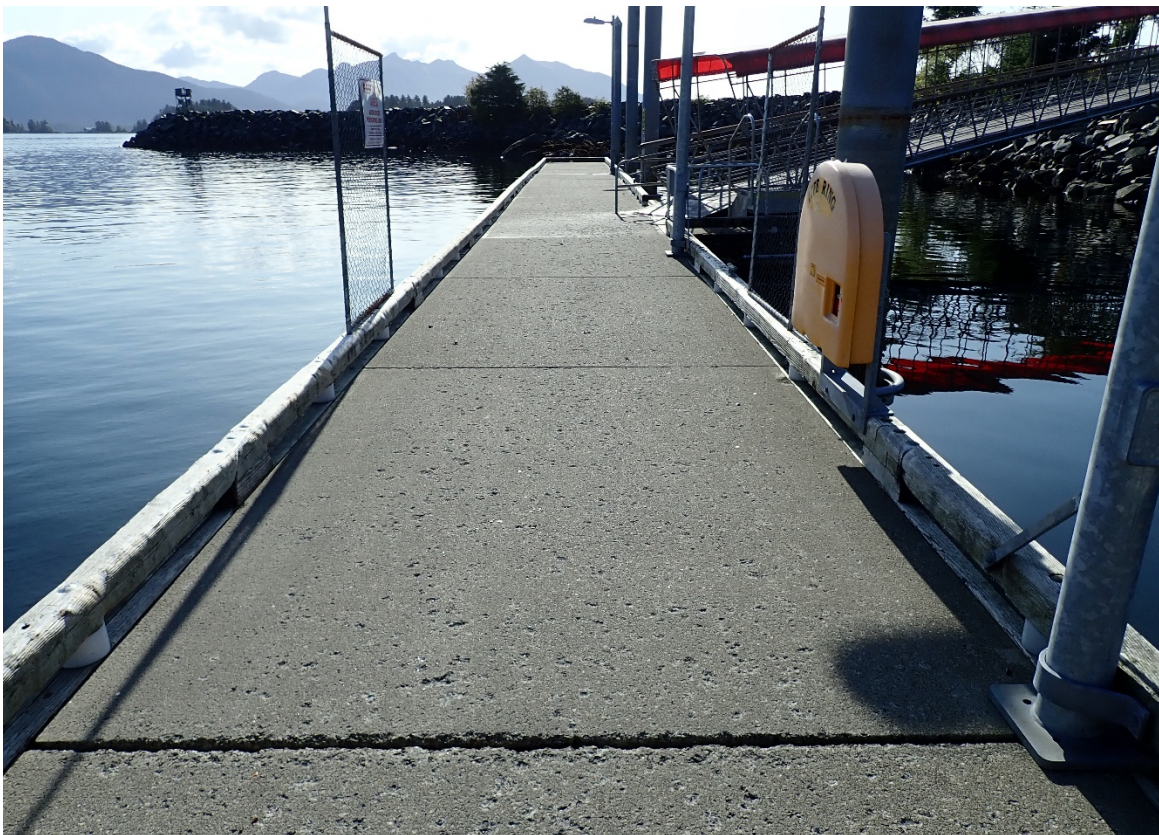
Photograph 4: View of topside scaling on south section of Lightering Float.

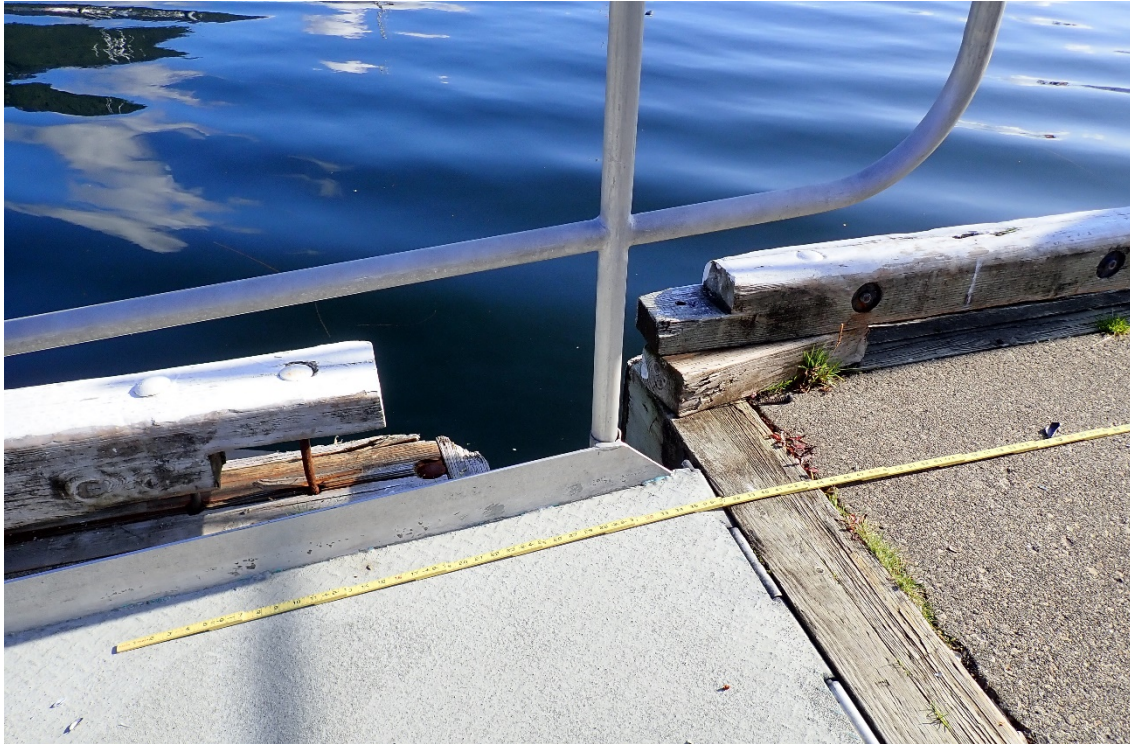
The timber rail to concrete float connection hardware typically exhibits moderate corrosion. There is an area of 20 percent timber section loss on the eastern face of Float 2 extending from the northern edge 5 ft to the south. There is a missing timber chock at the southeast corner of the northern section and the lower timber member at this location is severely deteriorated (Photograph 5). The connection hardware at this location exhibits severe corrosion.

Photograph 5: View of the missing timber chock at southeast corner of Float 7.

The missing timber chock and the severely deteriorated lower timber member located at the southeast corner of Float 7 (Photograph 5) should be replaced, along with the connection hardware.

02.01.02 Float 7 Missing Timber Chock and Deteriorated Lower Timbers	1.00 LS	4,845.60 /LS	1,200.00 /LS	7,500.00 /LS	13,545.60 /LS	13,546	31,736.22 /LS	31,736

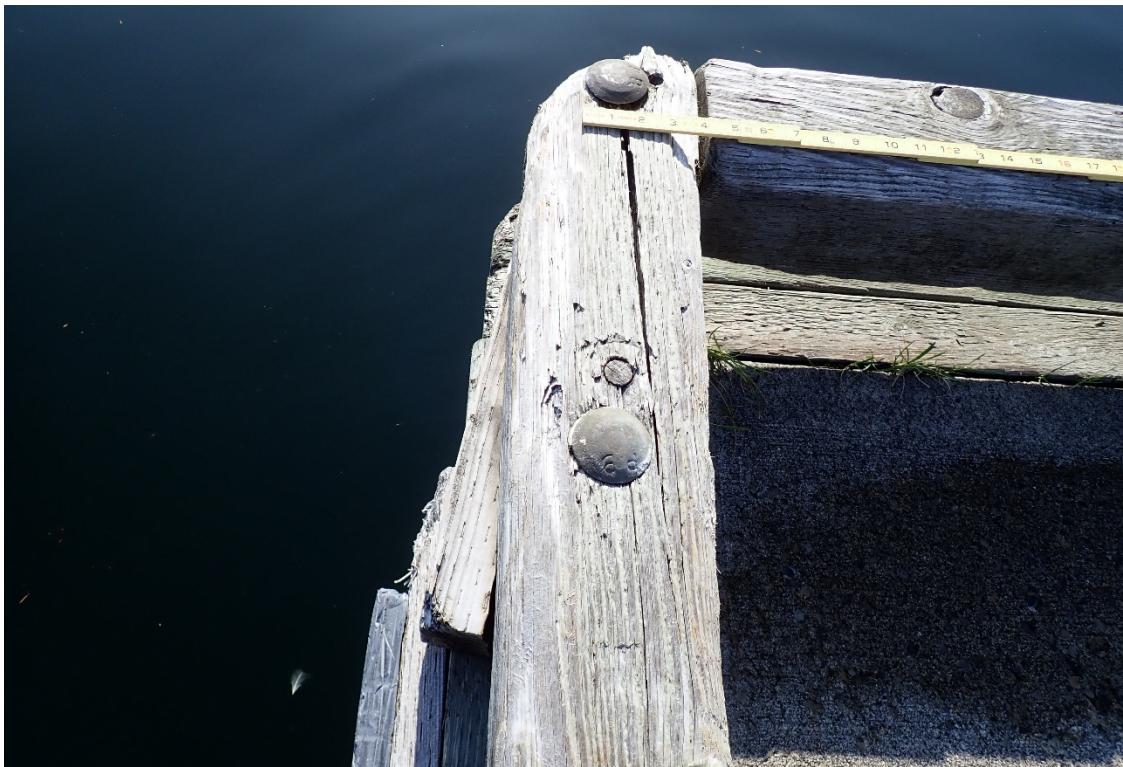
The timber chock and upper rail at the southeast corner of the southern section (Float 22) is split and the vertical connection hardware is loose at this location (Photograph 6).

Photograph 6: View of the split upper rail and chock at the southeast corner of Float 22.

The split timber chock and vertical connection hardware at the southeast corner of the south section (Float 22; Photograph 6) should be replaced.

02.01.03	Float 22 Replace Split Timber Chock								
			Float 22 Remove and Replace Split Timber Chock and Vertical Connection Hardware	1.00 ls	1,615.20 /ls	400.00 /ls	3,500.00 /ls	5,515.20 /ls	5,515	12,814.34 /ls	12,814

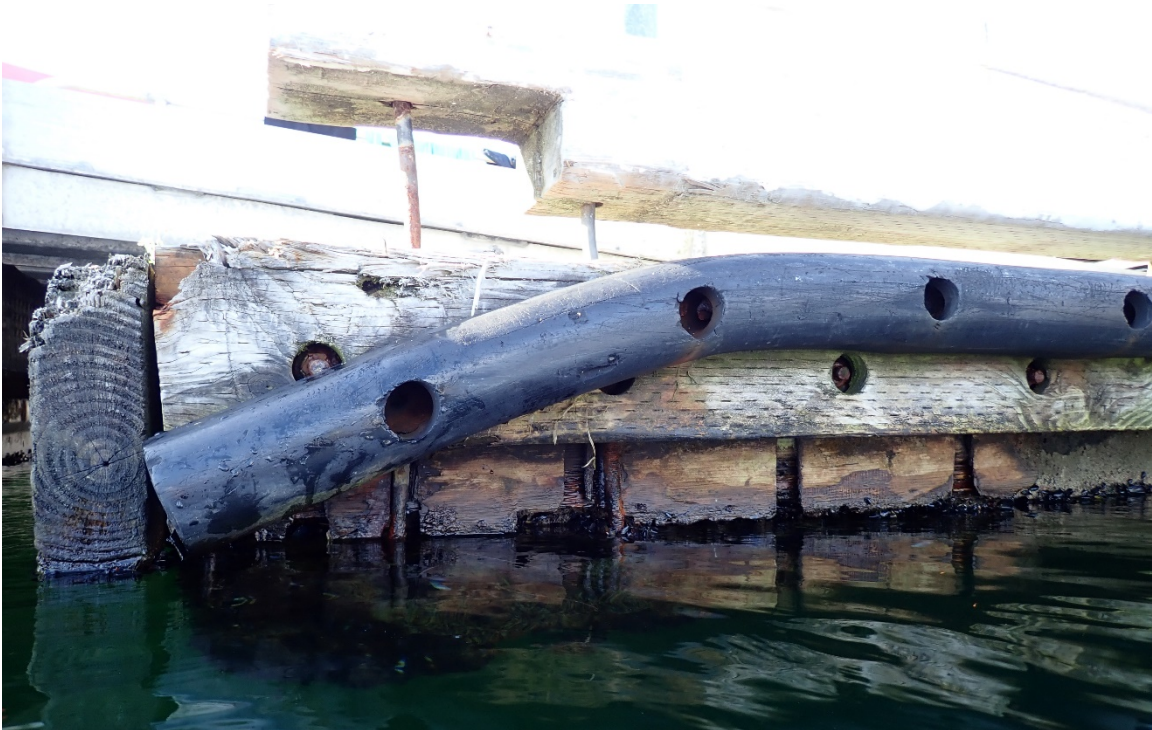
The rubber 'D' fender on the east side of Floats 7 and 8 is detached at both ends for approximately 20 inches at each end (Photograph 7). The rubber 'D' fender connection hardware exhibits major corrosion.

Photograph 7: View of the detached rubber 'D' fender at the southeast corner of Float 7.

The rubber 'D' fender and connection hardware on the east side of Floats 7 and 8 (Photograph 7) should also be replaced.

02.01.04 Floats 7 and 8 Replace Rubber "D" Fender	1.00 LS	3,230.40 /LS	800.00 /LS	5,000.00 /LS	9,030.40 /LS	9,030	21,157.49 /LS	21,157
			02.01 Concrete Floats	1.00 LS	10,229.60 /LS	2,680.00 /LS	16,750.00 /LS	29,659.60 /LS	29,660	69,375.88 /LS	69,376

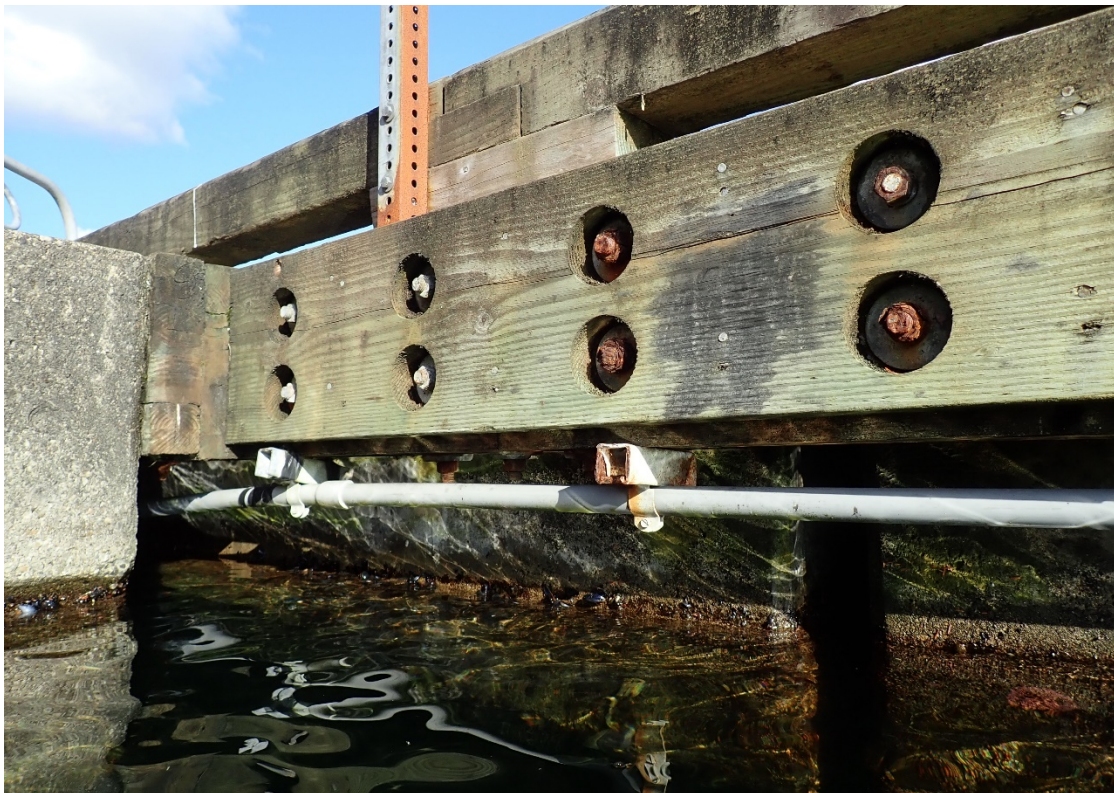
The timber rail to concrete float connection hardware on the southern section (Floats 8 through 22) exhibits moderate to major corrosion on the eastern side where exposed. Most of the connection hardware on the eastern side is covered by the plastic fender. The connection hardware on the western side ranges from minor to major corrosion (Photograph 8).

Photograph 8: View of typical conditions on the western fascia of the Lighter Float.

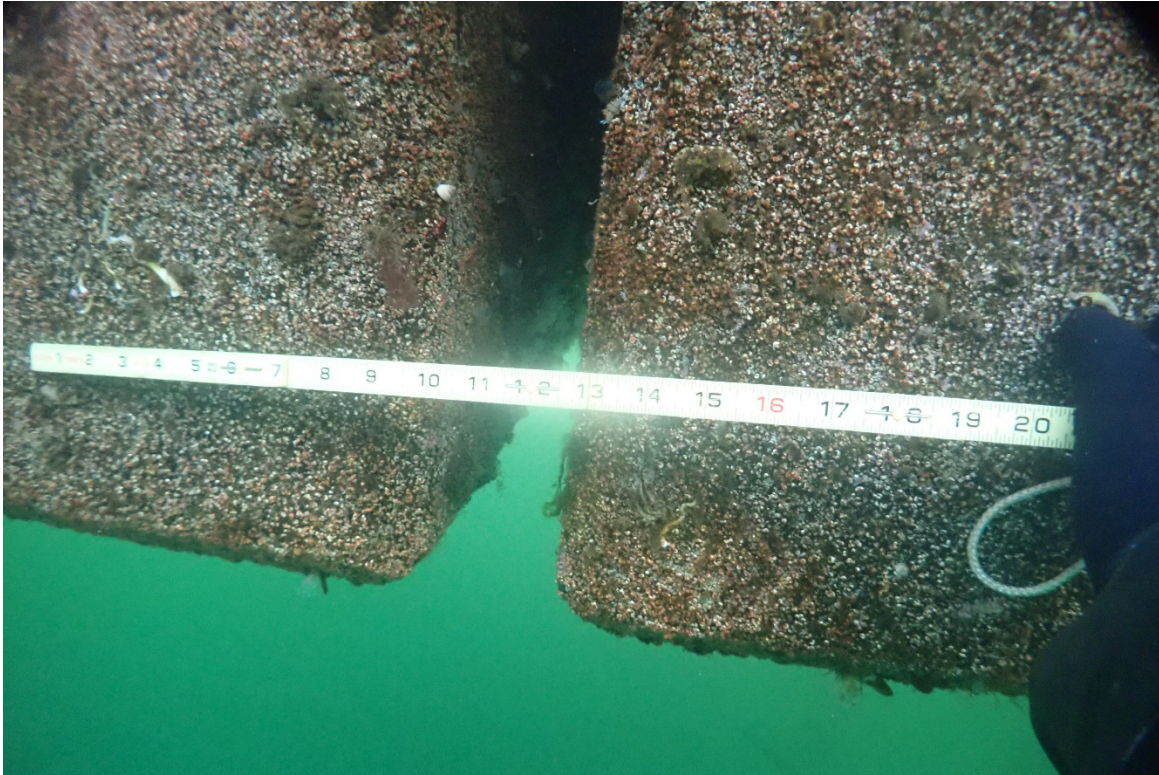
Photograph 9: View of typical concrete float condition below water.

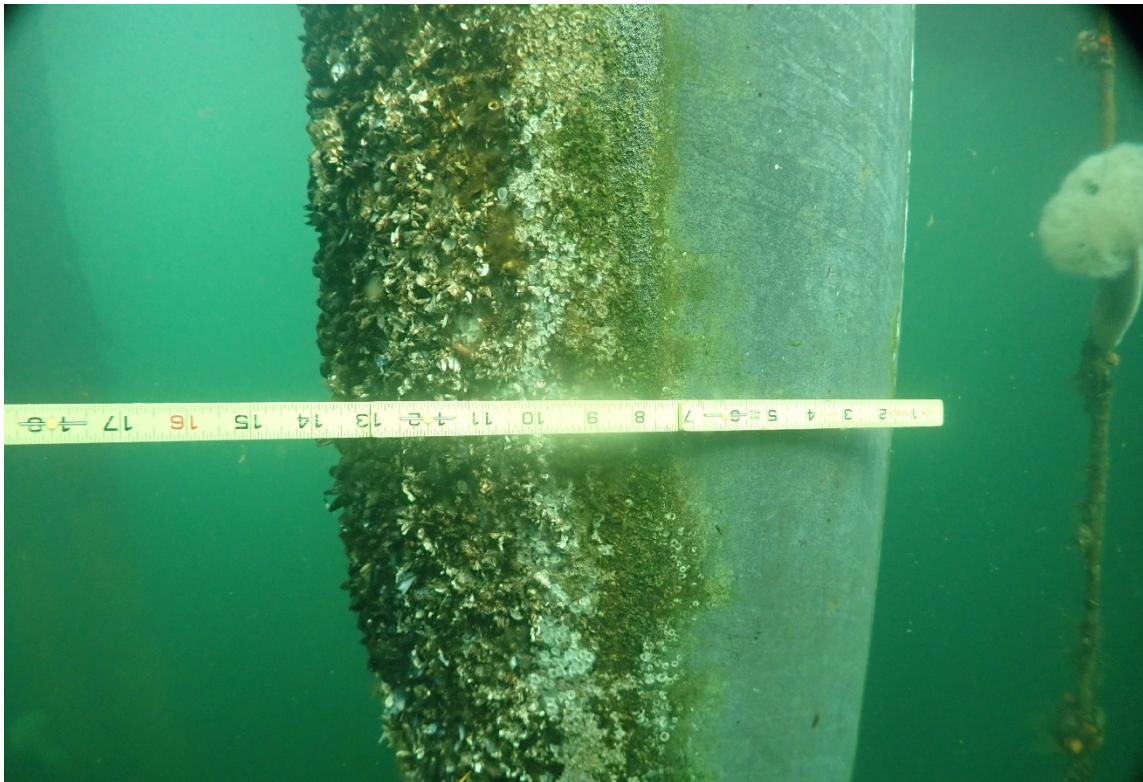
The galvanized steel lightering float piles do not exhibit any significant corrosion or damage (Photograph 10). The piles are cathodically protected with one anode on each pile. The anodes are installed near the mudline, approximately 36 ft below the tops of the piles, and the anode at Pile 1 is partially buried. The anodes are 24 inches long with approximately 5-inch x 5-inch section remaining. The anode connection hardware exhibits minor corrosion (Photograph 11).

Photograph 10: View of typical galvanized steel pile condition below water.

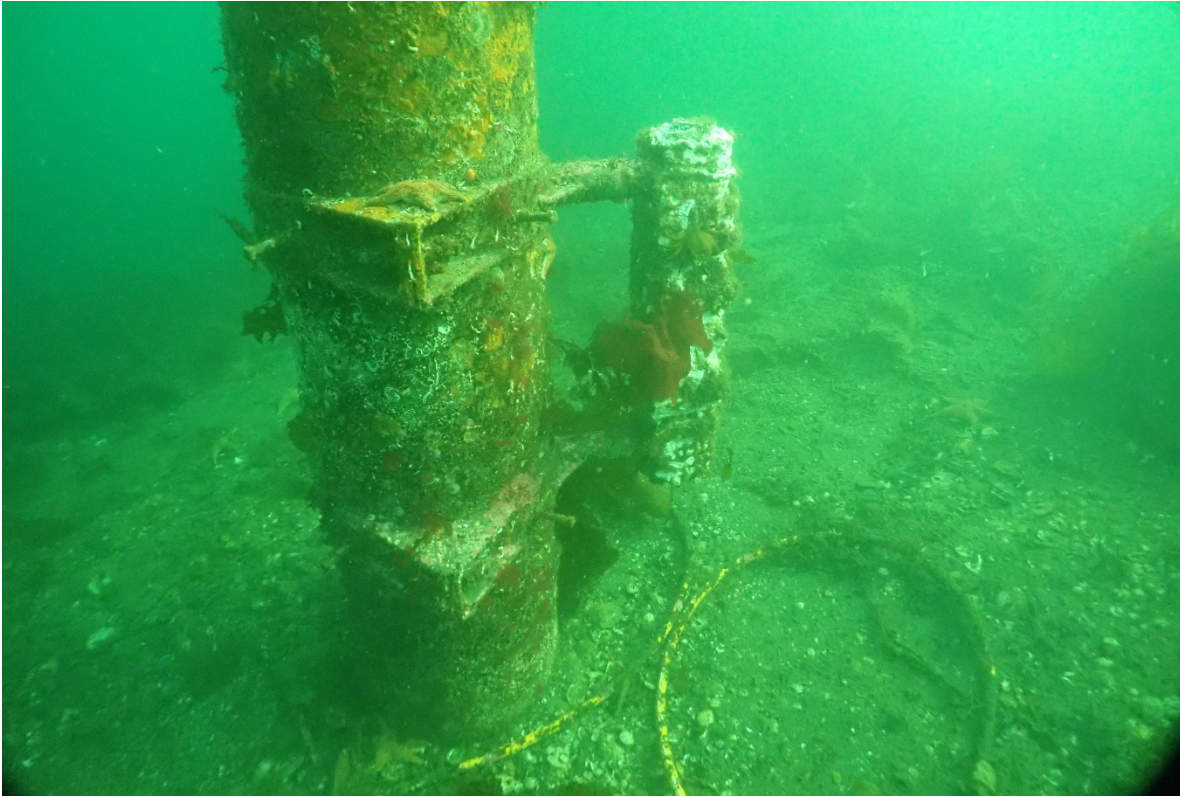
Photograph 11: Underwater view of typical anode and bracket on a Lightering Float pile.

The galvanized steel Lightering Float piles are in good condition. There is significant remaining section on the pile anodes, and therefore they do not yet require replacement.

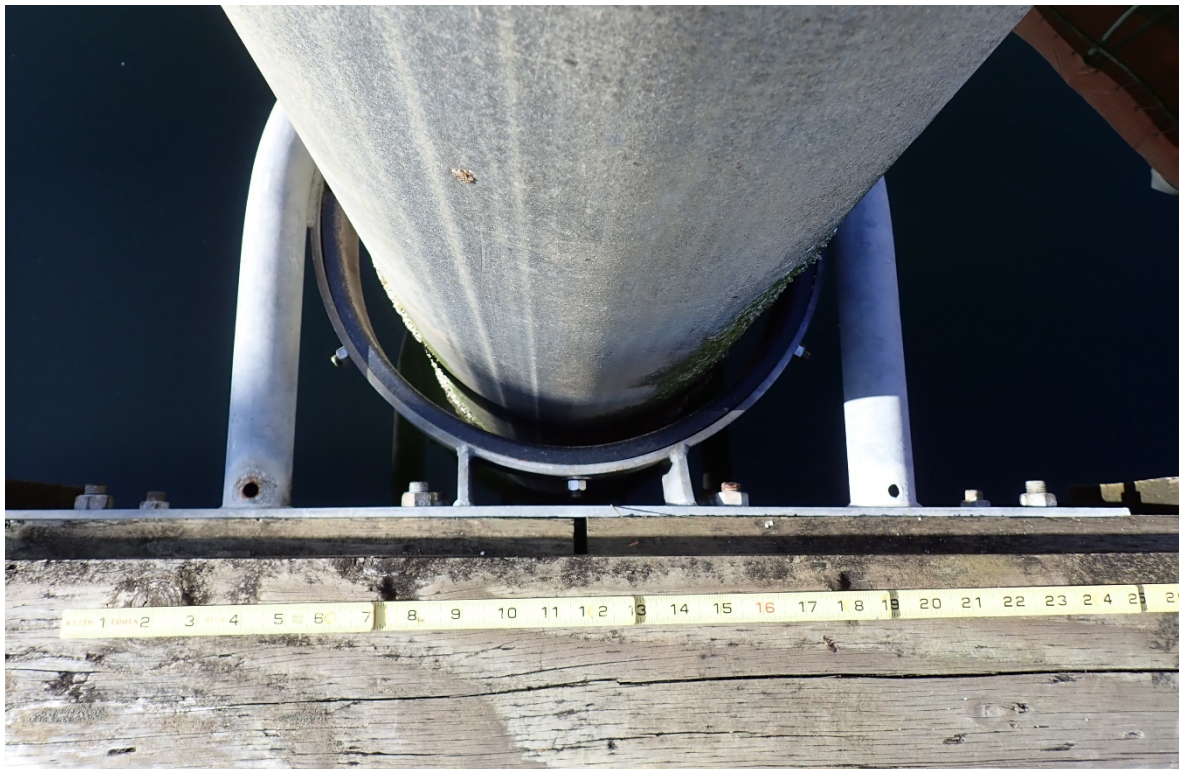
The pile guides are in fair to satisfactory condition. The pile guides are installed upside down at Piles 3, 5, 7, and 9 (Photograph 12). The level of surface corrosion damage ranges from minor to moderate (Photograph 13). Minor movement of the piles was evident when load from the lightering float was applied.

Photograph 12: View of pile guide installed upside down with weep holes on top surface.

The pile guides are in fair to satisfactory condition. The pile guides installed improperly (Photograph 12) should be addressed by drilling new weep holes in the bottom of the tubular members to prevent water from pooling within. The new holes should be drilled using the existing holes in the top as guides. The bare steel or damaged galvanized surfaces at the weep holes should be repaired with zinc-rich paint suitable for marine environments.

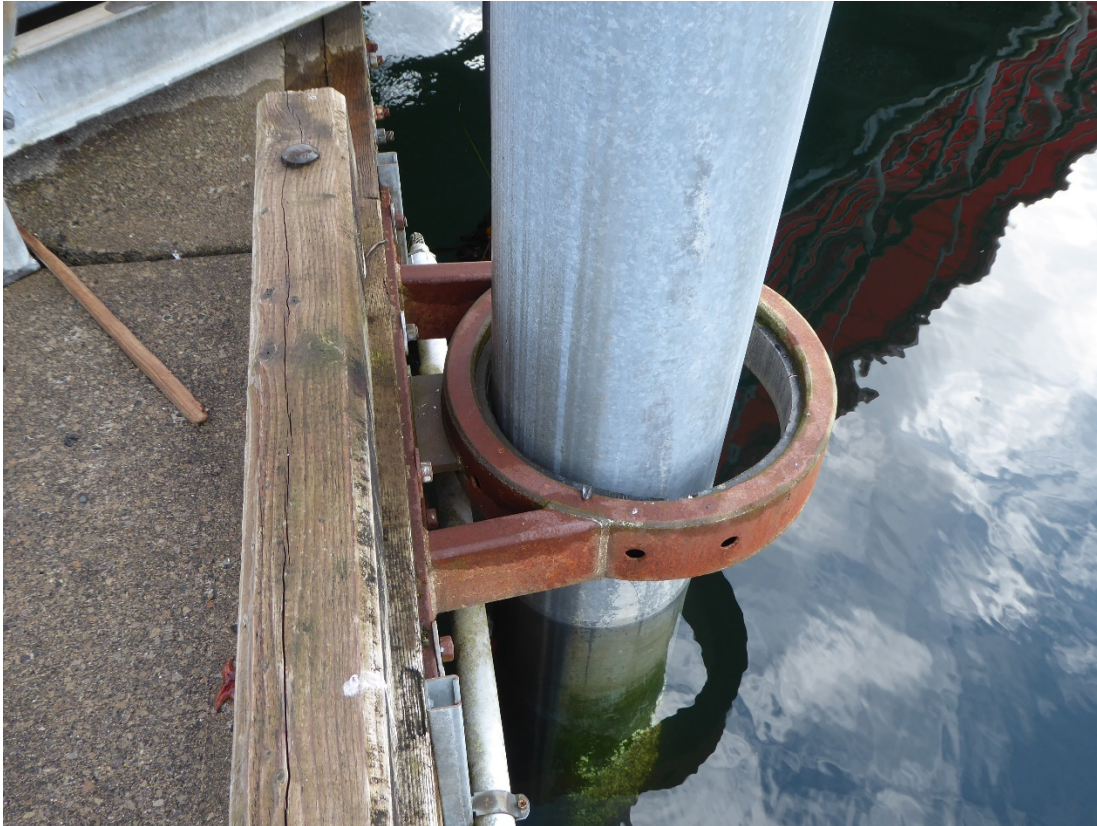
Photograph 13: Moderate corrosion at pile guide.

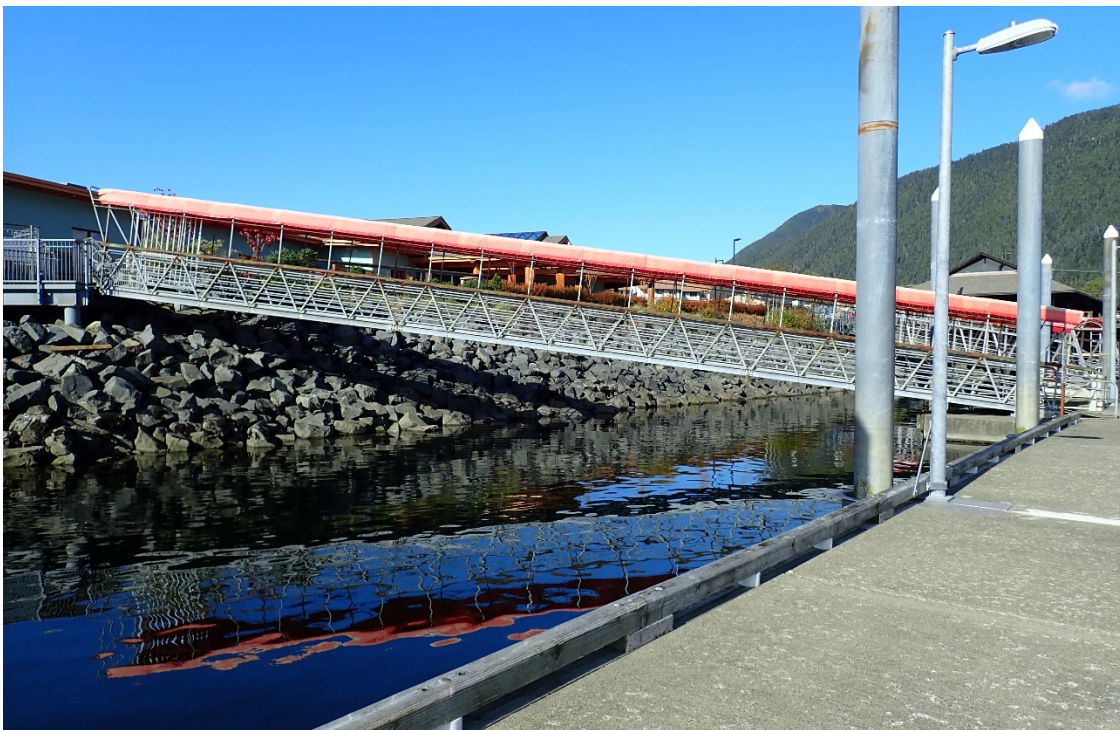
The north and south gangways do not have significant deterioration or damage. The south gangway exhibits light surface corrosion on the railings (Photographs 14 and 15).

Photograph 14: View of South Gangway with light surface corrosion on rails.

The gangways are in good condition. No action is required at this time.

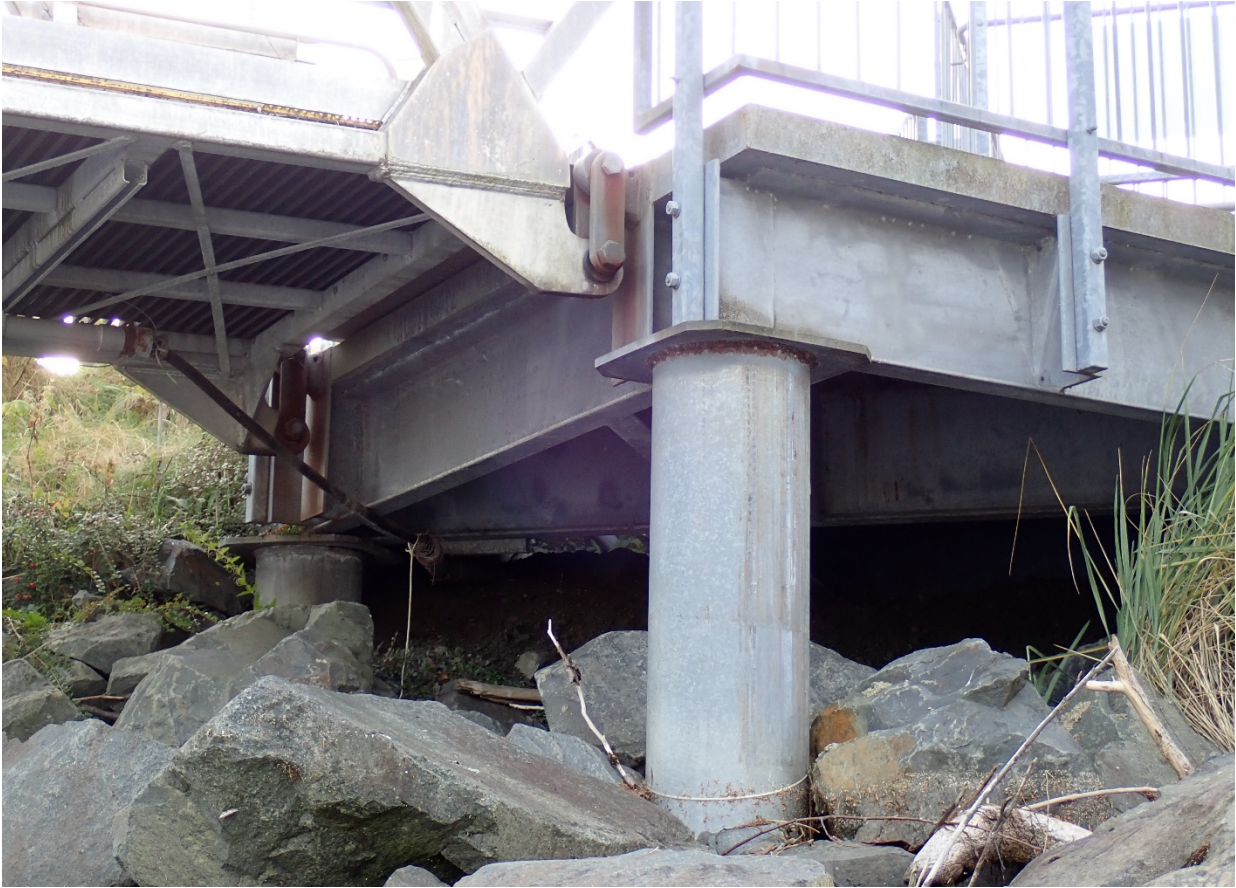
Photograph 15: View of the North Gangway abutment and connection hardware.

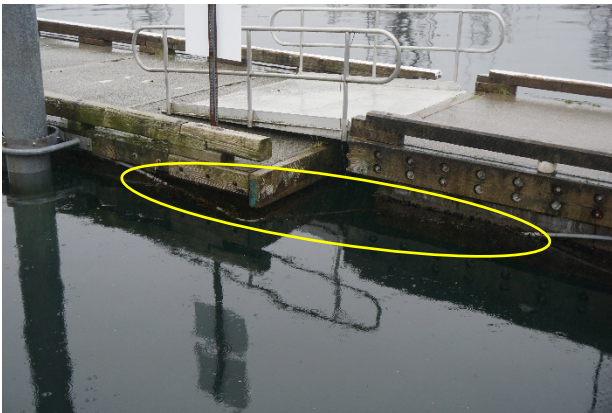
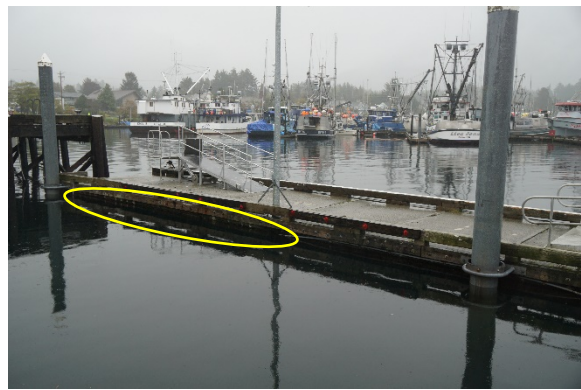
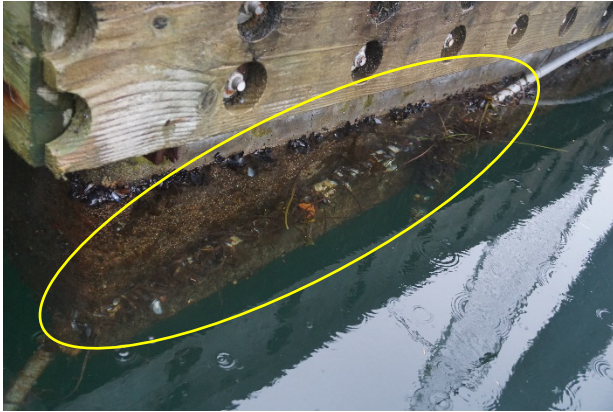
Feeder and branch cables lack support in locations where the routing conduit is broken or unfastened (Photographs 16 through 18). Feeder and branch cables also have insufficient support at transitions of conduit and are subject to chafing, especially where cables are encrusted with marine life (Photographs 19 through 21).

Photograph 16: Unfastened conduit.

Photograph 17: Unfastened conduit.

Photograph 18: Unfastened conduit.

Replace the broken and unfastened conduit on the lightering floats (Photographs 16, 17 and 18).

02.03.02 Lightering Float Receptacles Ground Fault Protection	1.00 LS	1,183.70 /LS	280.00 /LS	2,000.00 /LS	3,463.70 /LS	3,464	8,098.56 /LS	8,099
		02.03.03	Lightering Float Conduit								
			Replace Broken and Unfastened Conduit	1.00 ls	1,775.54 /ls	280.00 /ls	2,500.00 /ls	4,555.54 /ls	4,556	10,717.02 /ls	10,717

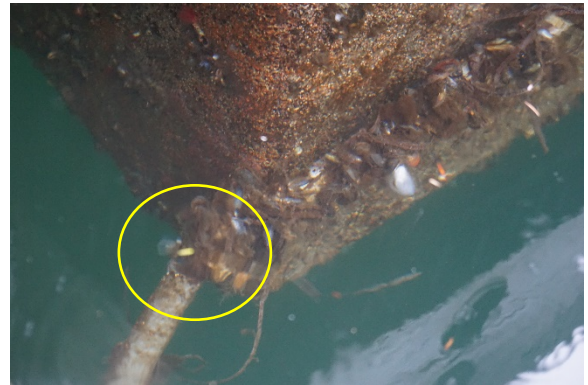
Photograph 19: Cable unsupported and subject to chafing.

Reroute the feeder and branch circuit power cable conductors to be under the floats for protection from damage in accordance with the NEC 2017 Article 555.13.

Replace the feeder and branch circuit conductors as required to facilitate replacement of the damaged conduit and rerouting of the conductors to be underneath the floats.

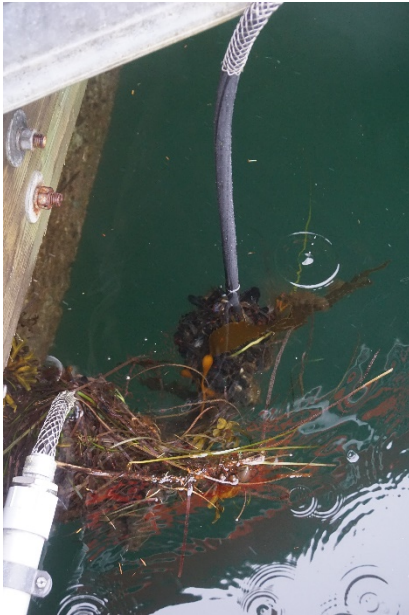
Photograph 20: Cable weighted by encrusted marine life.

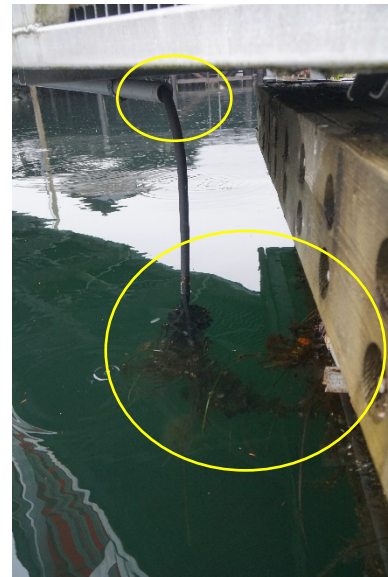
Photograph 21: Cable weighted by encrusted marine life and subject to chafing.

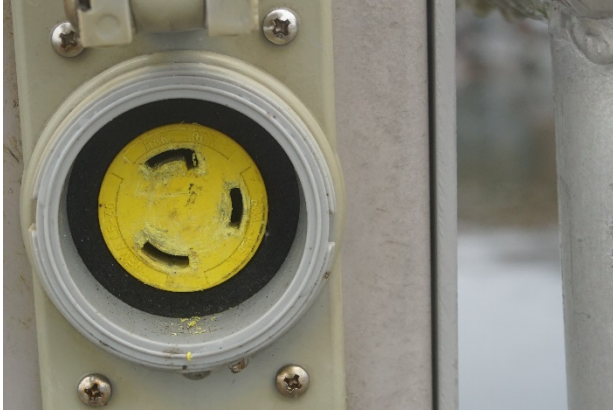
Shore power receptacles on the floats are 30-amp rated and mounted on either side of the two shore power pedestals. The receptacle connectors show evidence of rough usage (Photograph 22) and minor arcing at the terminals.

Photograph 22: Worn receptacle.

Replace the shore power receptacles and OCPDs with ground fault protection equipped units in accordance with the NEC 2017 Article 555.3.

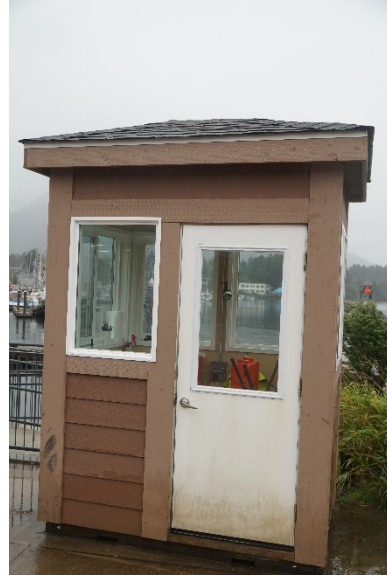
Photograph 23: Harrigan Centennial Hall parking area outbuilding (shack).

Equip the feeder supplied outbuilding (shack) (Figure 23) with a grounding electrode in accordance with NEC 2017 250.32 (A). The existing (feeder) circuit that supplies the structure feeds a small load-center branch circuit panel inside the outbuilding (Photographs 24 and 25). Alternatively, the shack power supply could be rewired as a branch circuit with local disconnect switch.

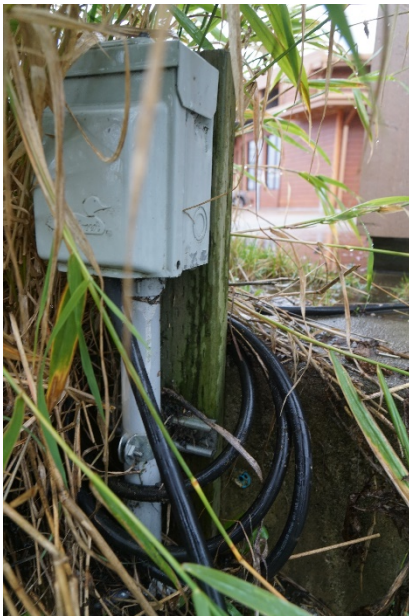
Photograph 24: Receptacle feeding outbuilding.

Replace the on-shore outdoor wet location receptacle located near the parking area of Harrigan Centennial Hall with a ground fault protection equipped unit or install a ground fault protected branch OCPD for the receptacle in accordance with NEC 2017 210.8(B)(4) (Photograph 24).

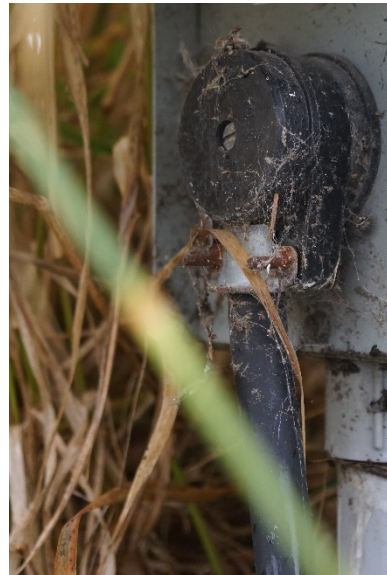
Photograph 25: Outbuilding feeder plug with spider webs and plant debris accumulation.

Replace the cord and plug feeder for the outbuilding (shack) with permanent wiring in accordance with NEC 2017 400.12(1 & 7), alt. Temporary Attractions 525.20(E). The outbuilding plug connector is apparently left in place for long periods as it has accumulated spider webs and plant debris (Photograph 25). This structure is a relocatable building with a base frame notched for forklift transport – it is not a vehicle or travel trailer. This existing implementation is a permanent installation for electrical code considerations. The feeder cord is easily subject to physical damage if building is (re)located anywhere that extends the supply cord away from the supply receptacle.
