Re: Sitka's Natural Hazards

## Sitka landslide in Alaska – the potential power of simple geomorphic mapping

**TANK SITE #2 PHOTOGRAPHS**  
WHITCOMB HEIGHTS SUBDIVISION GEOTECH  
SITKA, ALASKA

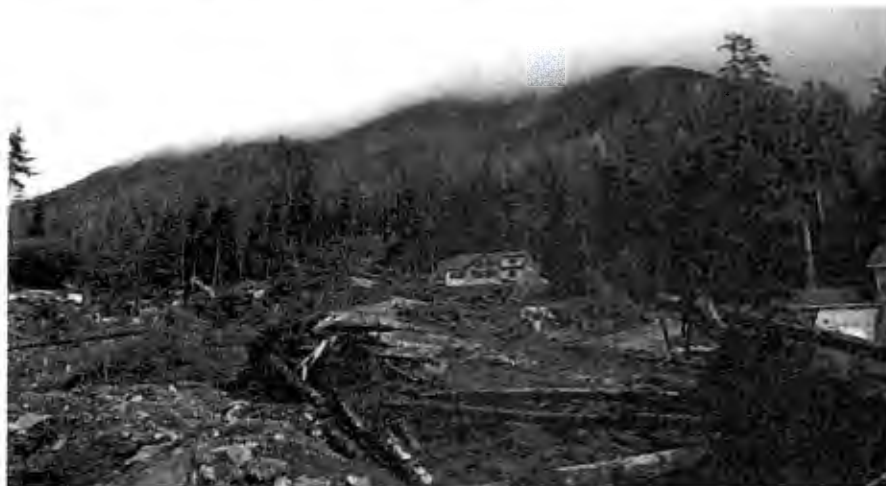
It is clear that this is a flow type slide that has originated on the steep forested flanks of Harbor Mountain. The landslide tore through a new housing development on the so-called benchland area of Sitka, which it had been hoped would provide a solution to the housing problems faced by the town. There is a good account of the disaster declaration for the landslides in Sitka on [KTVA Alaska](#), and of the likely implications of the landslides in an article on the [Alaska Dispatch News website](#). Part of the development of the housing project included the construction of a water tower. The [geotechnical report for this project](#) is also available online and makes interesting reading. This is a part of the [documentation](#) that was provided for the auction of lots in the housing subdivision.

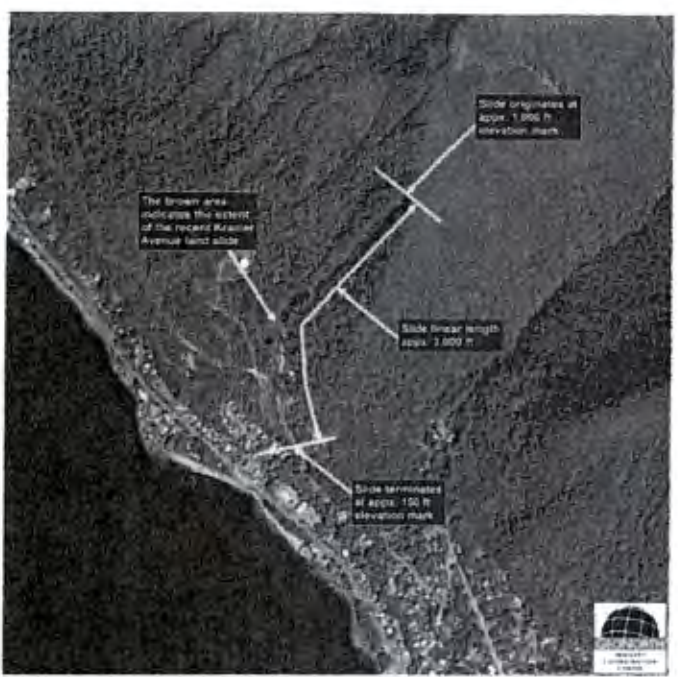
A few things to note here. First, it was lucky that the landslide didn't travel a little further. Second, and more importantly, the landslide started very close to a ridge in a forested section of the slope, possibly as a reasonably small landslide that appears to have entrained debris to become a high energy flow. Thirdly, the water tank is clearly visible on the image. And fourthly, the slope appears to have very interesting geomorphology, with multiple gullies. So let's take a look at the Google Earth image, which is of a high quality for this site:

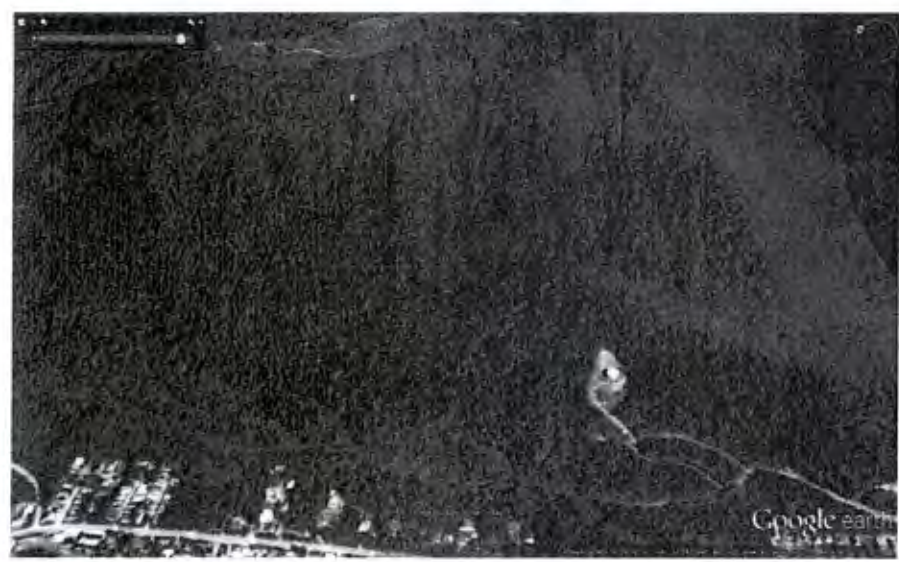
It is clear that the slope is characterised by multiple incised channels, many of which extend from the ridgeline. Note that at least some have a broader crown area and then a narrow track. These look to me to be classic debris flow channels, at least some of which come extend down to the roads associated with potential housing developments. The Sitka landslide itself is very close to one of these channels, and may even have occupied one. And interestingly, the geotechnical report identifies "ancient landslide" deposits:

To me as a geomorphologist, the presence of those gullies on the slope, and their shape, is enough to ask serious questions about the site. Combined with ancient landslide deposits in the vicinity of the houses themselves, my concern would increase. And note that the ancient landslide deposits lie above glacial drift (i.e. the remains from a recent ice age), and ash from one or more volcanic eruptions. This suggests to me that these landslide deposits might not be very ancient in geological terms.

I would also add that, of course, knowing that this is a slope that is prone to landslides does not necessarily preclude development of the benchland area of Sitka, but appropriate mitigation would be essential.

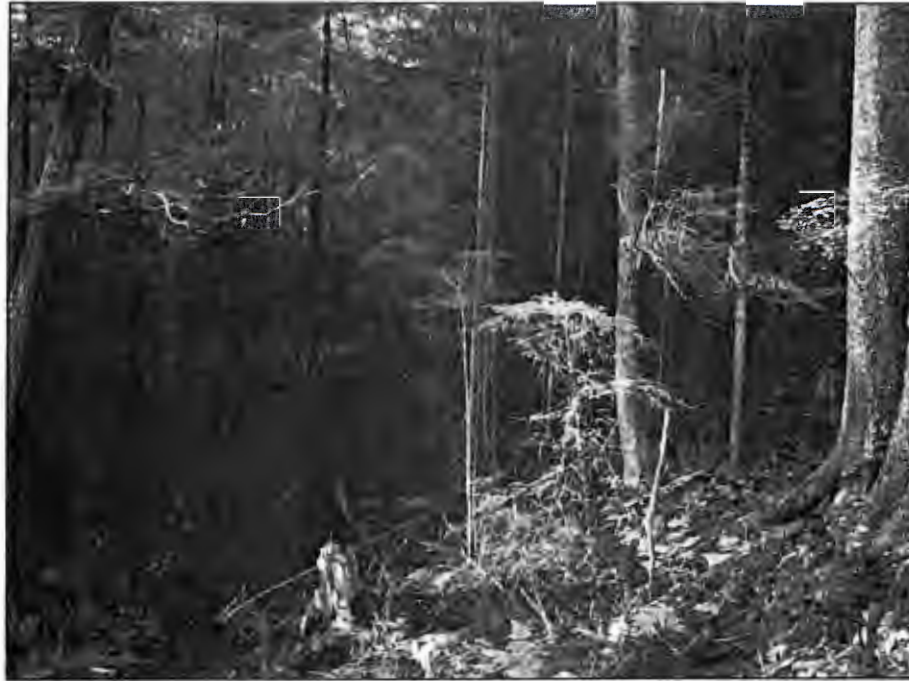
**PHOTO 1:** Proposed Tank Site #2 is located in an area dominated by thick landslide and volcanic ash deposits. Trees in background of photo are unstable due to near saturated ground conditions.

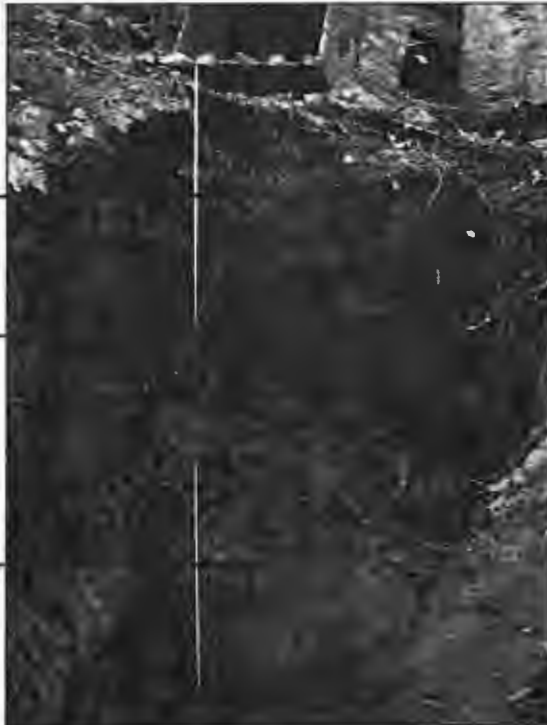
0 ft to 1 ft:  
Organics

1 ft to 5 ft:  
Ancient Landslide,  
rich in organics

5 ft to 11 ft:  
Ancient Landslide,  
rich in glacial till

11 ft to 19 ft:  
Ancient Landslide,  
dominantly volcanic ash

**PHOTO 2:** Test Pit TP-20 at proposed Tank Site #2. Three separate landslide strata are visible composed of varying materials. Glacial till encountered at 23 ft depth.
