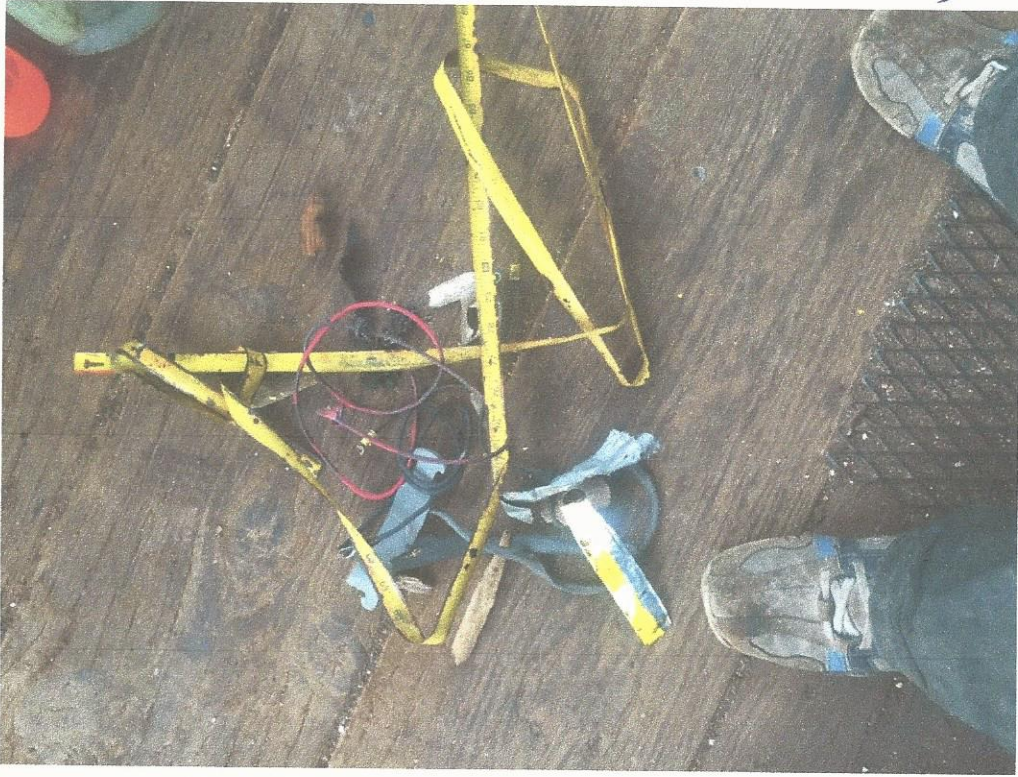
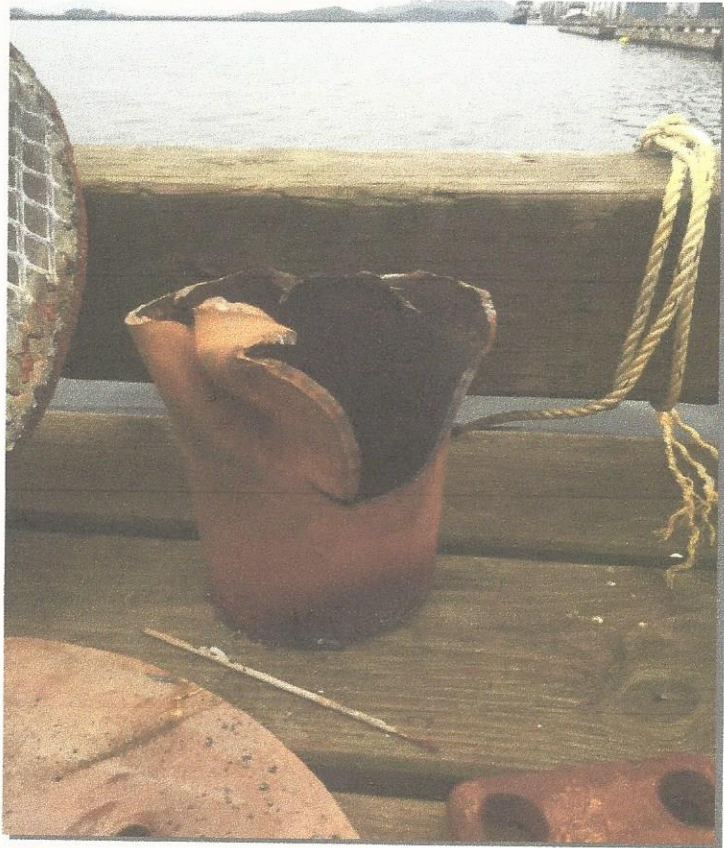
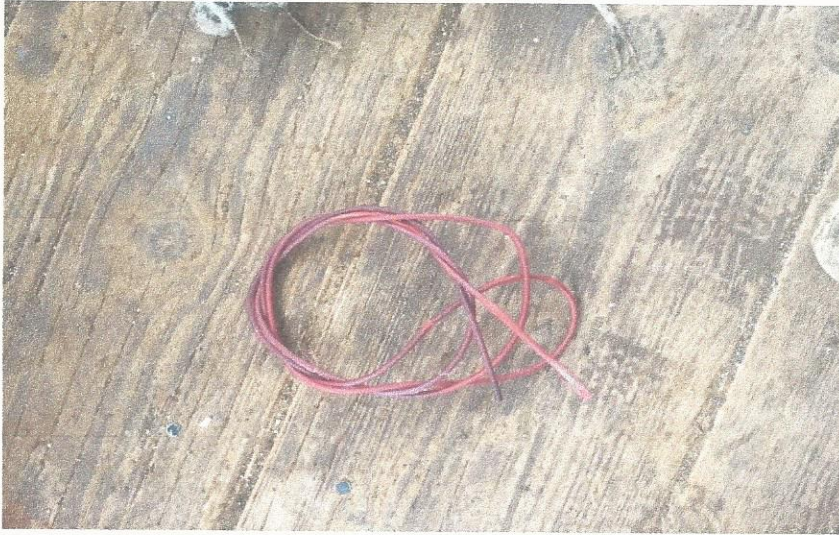
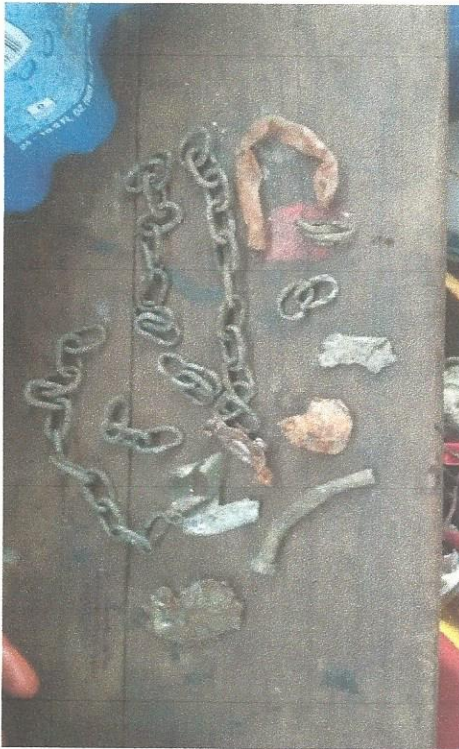
Exhibit E - Pictures

Impacts of debris – bigger issue than slightly lower annular velocity – Impacting on foreign material/s (such as metals, wires, etc.) is one of the causes for significantly reduced bit life and or catastrophic failure modes (as seen on your bit (letter sent on this). Impacting on foreign material can and will cause quick failures leading to reduced bit life/low footage. Where lower up-hole velocities generally will cause the product to wear but will get some decent footage on them before worn out if the operation is not adjusted accordingly.

Looking at the pictures sent, it is evident that there is steel and foreign material in the holes being drilled. As carbide is extremely hard, (properties outlined below), impacting on steel objects will lead to instant and or rapid carbide/tooling failures. When this occurs and the carbide on the bit fail/break, others may be damaged upon removal of the broken carbide/s from the hole. Any broken carbide on the bit will also put additional load on the remaining carbide increasing the chance of sheer failures from overloading.
