GEOTECHNICAL REPORT

# Debris Flow Hazard and Risk Analysis - Gavan Hill Public Facilities

SITKA, ALASKA

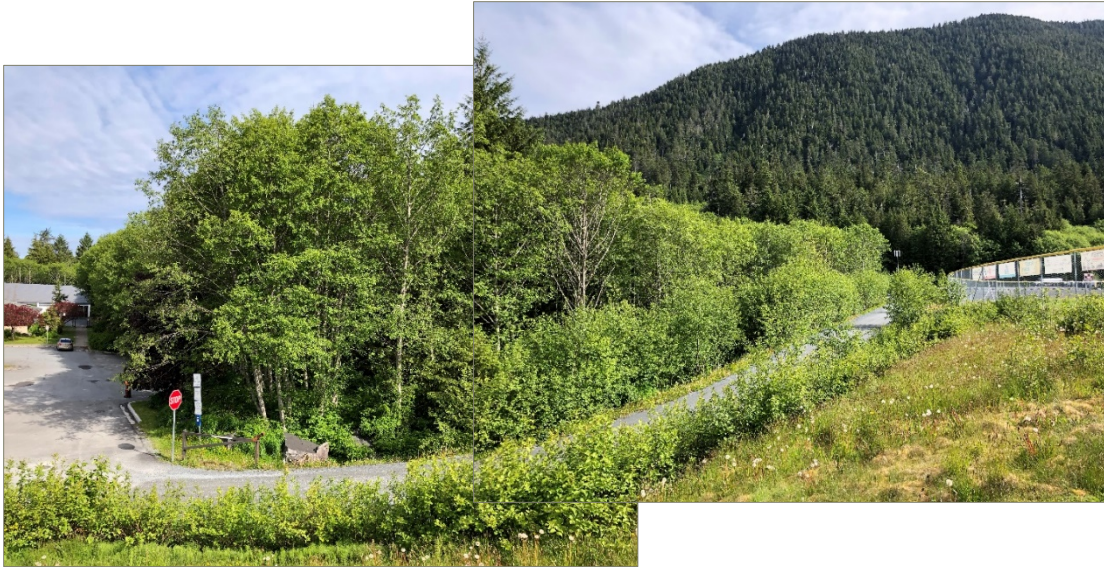
Exhibit 3-1: View to North of Watersheds Behind the Elementary School and the Recreation Fields

The elementary school is located on flat and gently sloping terrain southwest of Gavan Hill. A low-lying area is present north of and about 10 to 15 feet below the school and its paved parking lot. The low-lying area is vegetated with numerous deciduous trees and a few conifers with trunks that are typically 6 to 12 inches diameter (diameter at breast height [dbh]), and occasional larger trees (14 to 24 inches dbh). The understory vegetation is typical of wet areas, including skunk cabbage and salmon berry. This low-lying depression (Exhibit 3-5) forms a natural “barrier” for potential debris flow events.

A short distance to the northeast of the school are the recreation fields, consisting of ball fields, a parking area upslope, and a materials staging area. The recreation fields are constructed on a covered landfill and formed into a relatively flat surface, which are generally free of vegetation except grasses. The parking area, materials staging area, and the gently inclined road leading from the elementary school to the recreation parking area have gravel surfaces. A minor drainage ravine that is about 2 to 3 feet deep is present between Gavan Hill and the fields. The ravine is at about elevation 80 to 95 feet, and approximates the limit of the forested, hillside terrain.

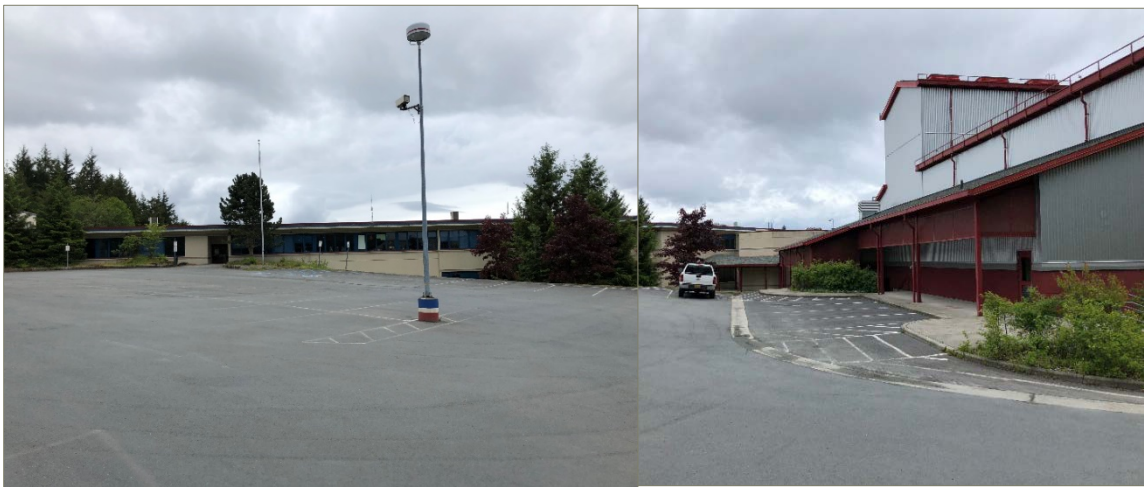
Exhibit 3-2: View South of the North-Facing Wall of the High School and Vegetated Terrain that is Upslope of Topographic Depression (Photo Left) and the Center for Performing Arts (Photo Right). Note the Distance Across the Parking Lot to the Wall of the High School Building that is Exposed to Potential Debris Flow Runout from Gavan Hill.

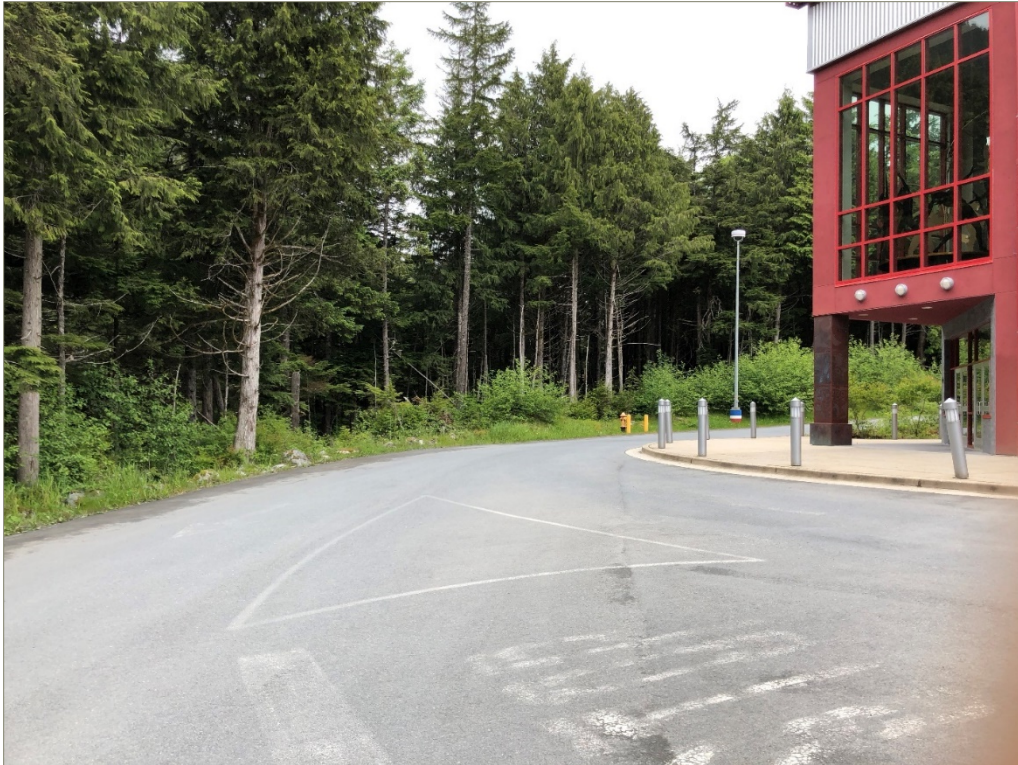
Exhibit 3-3: View Southeast of Driveway to North of Center for Performing Arts at the High School

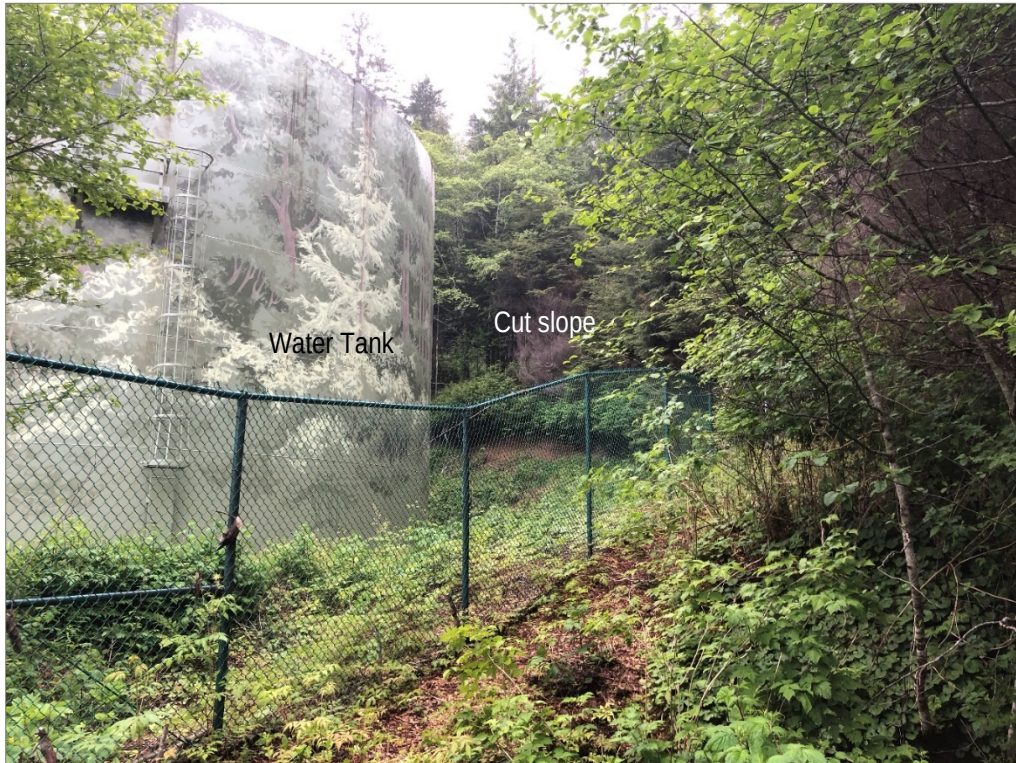
Exhibit 3-4: View to Northwest of Water Tank and Cut Slope

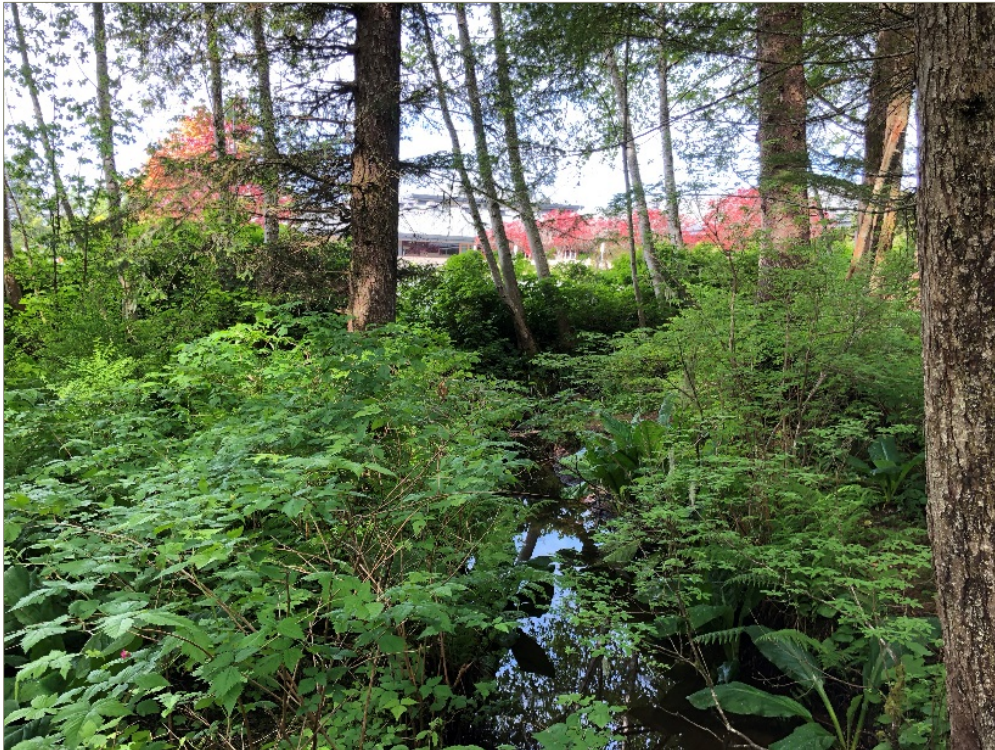
Exhibit 3-5: Low-Lying Stream Area in a Topographic Depression to North of the Elementary School

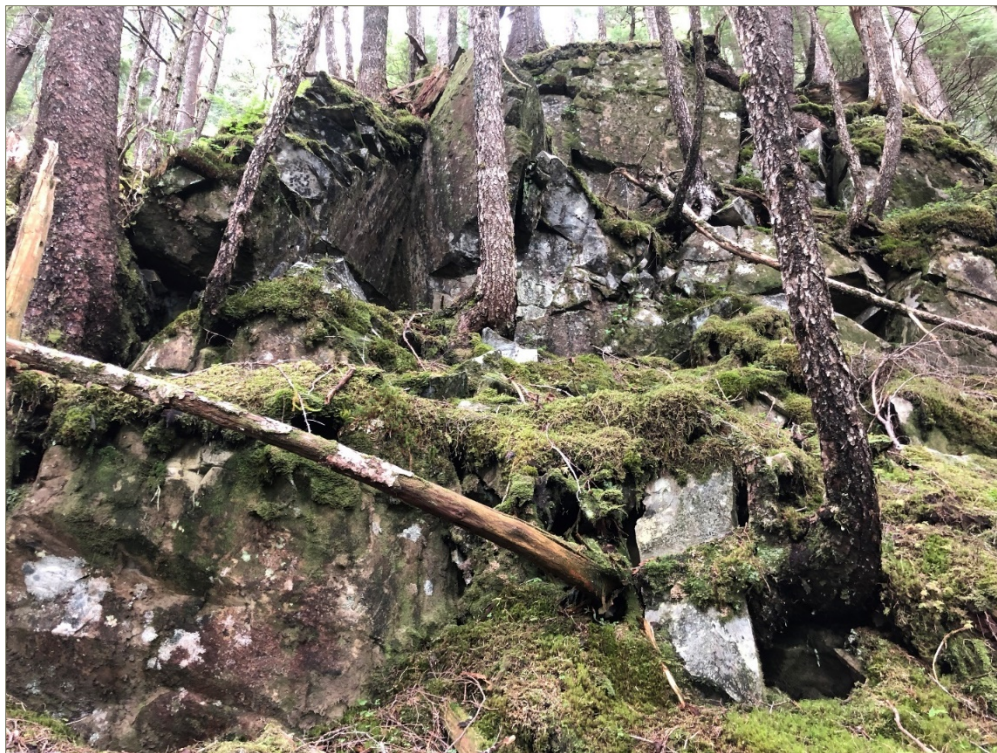
Exhibit 5-1: Intermittent Greywacke Outcrops in the Upper Terrain Above the Elementary School; Forest Duff Obscures Talus Deposits

**Talus and Scree** deposits occur locally, commonly below intermittent outcrops of greywacke that are present above about 800 feet in elevation. These deposits consist of clast-supported, angular to subangular gravel to boulders that may be locally infilled with silty sand and some organics. In some locations, talus and scree are intermittently overlain by 0.5- to 3-foot-thick muskeg and duff (Exhibit 5-1).

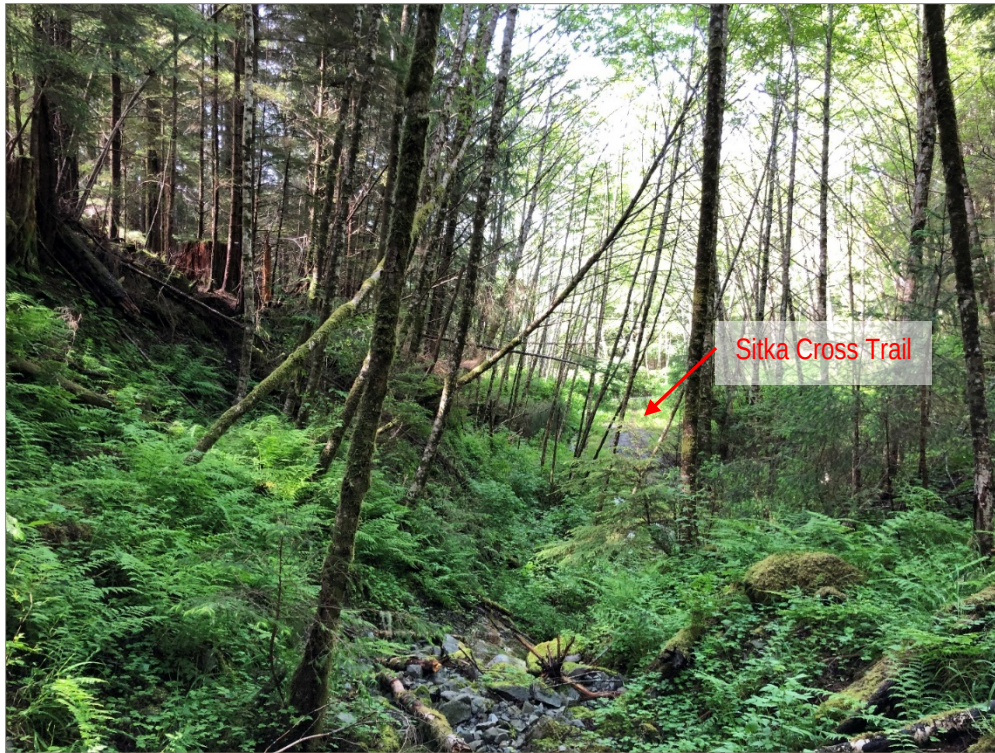
Exhibit 5-2: Low-Gradient Channel Mouth Exiting toward Sitka Cross Trail

In the terrain near the Sitka Cross Trail and behind the elementary school (Exhibit 5-2) and east to the high school, the channels are typically trapezoidal in shape and range in width from about 20 to 90 feet. Channel gradients are typically 15 to 30% slopes, with channel banks inclined 35 to 80% slope and 5 to 10 feet in height below an elevation of about 230 feet.

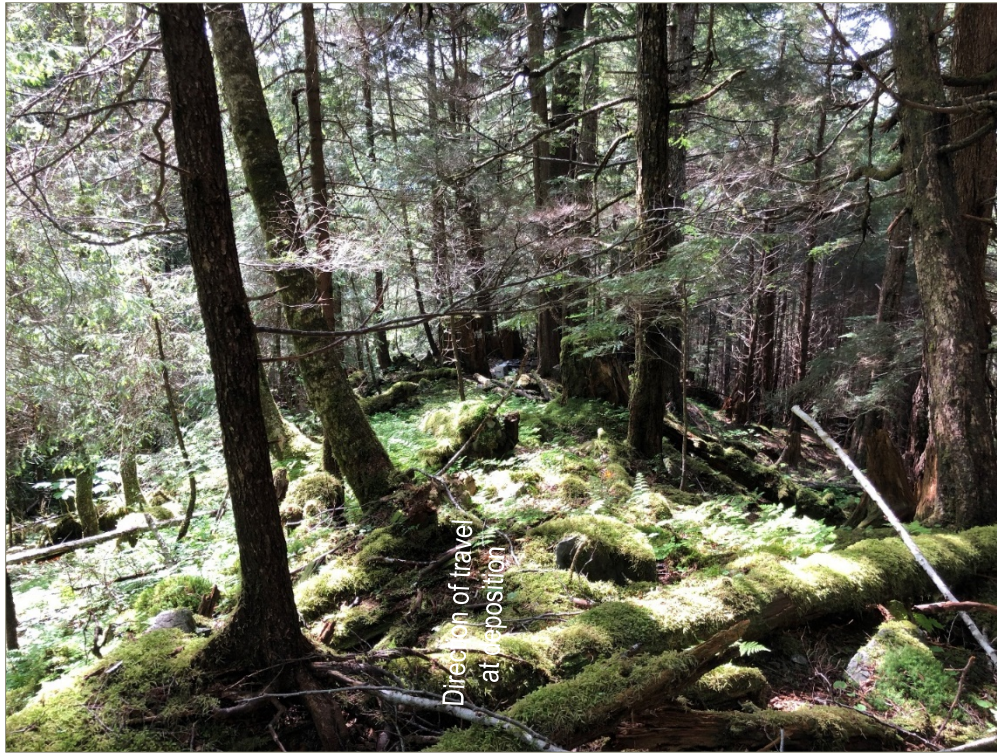
Exhibit 5-3: Convex, Elongate Landform with Boulder-Strewn Surface Indicative of Debris Flow Levee Morphology Above Left Bank of Stream Channel. Logged Old Growth Pines up to 5 Feet in Diameter (dbh) Were Observed on Levee Deposits, Providing Some Constraints on Age and Activity State of Deposits.

Debris flow levees (Exhibit 5-3) form during bank overtopping as debris flows begin to deposit but flow out of the channel banks. We observed debris flow levees in recent and historic deposits that tend to come to rest where channels lose confinement across a break in slope of the overall topographic profile. On Gavan Hill we observed debris flow levees

around elevation 400 to 500 feet. We also observed boulder front deposits and large woody debris dams, which indicate debris flow runout and deposition.

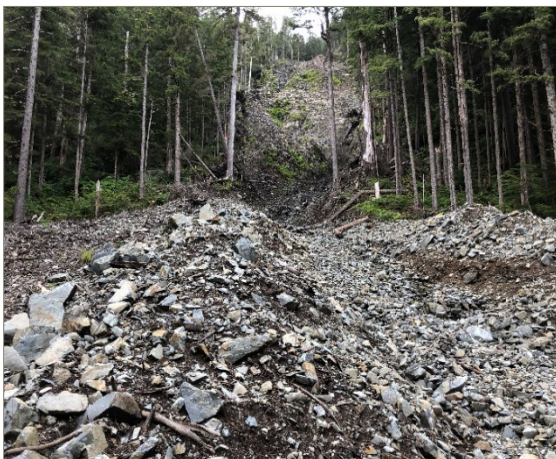
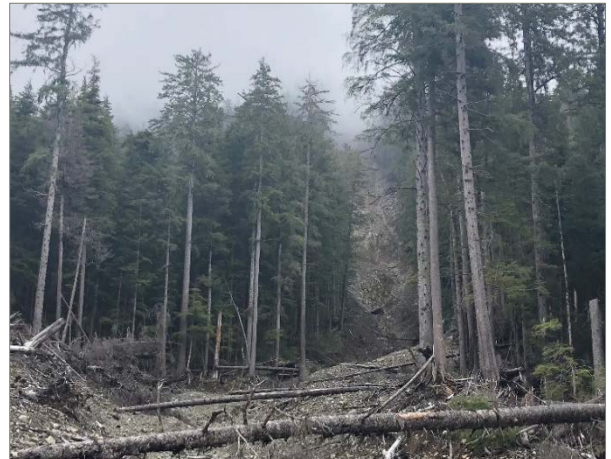
Exhibit 6-1: Left: North Kramer Avenue Debris Flow; Right: South Kramer Avenue Debris Flow. Both have Steep Initiation and Erosion Zones, Evidence of Multiple Surges and Levees, Extensive Woody Debris and Organics in Colluvial Debris Deposits.

- North Kramer Avenue debris flow (field observations; Exhibit 6-1; Landwehr and others, 2015),
- South Kramer Avenue debris flow (field observations; Exhibit 6-1; Shannon & Wilson, 2016a; Gould and others, 2015; Landwehr and others, 2015),
- Starrigavan Valley landslide (Dunbar, 2015),
- Sitka Cross Trail debris flow deposit (Exhibit 6-2), which is approximately 3,600 feet due north of the Sawmill Creek Road and Indian River Road intersection (this study),
- Gary Paxton Industrial Park (GPIP) debris flow (Shannon & Wilson, 2016b), and
- West Fork Sawmill Creek debris flows on the southeast slopes of Mt. Verstovia (Shannon & Wilson, 2016b).

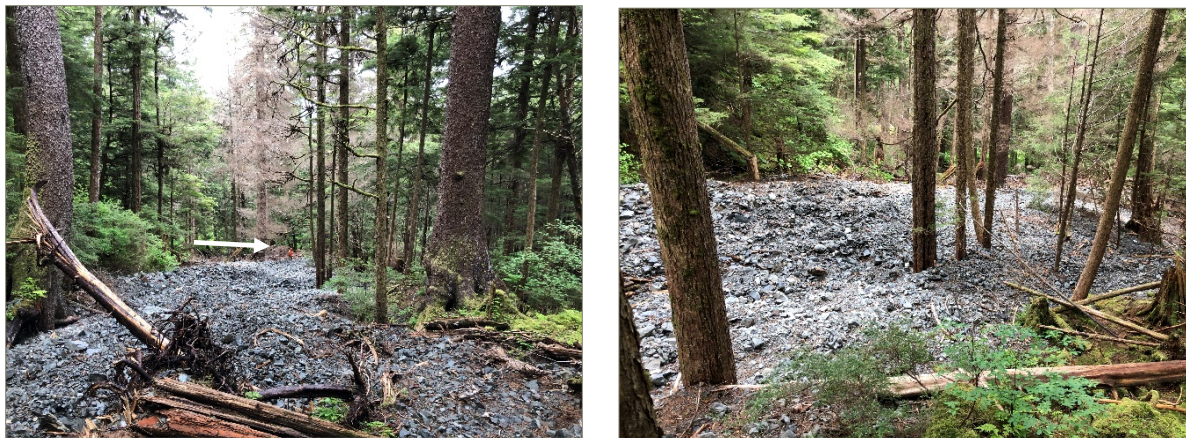
Exhibit 6-2: Left: View South of Stone Debris Flow Deposit Across Sitka Cross Trail to the East of the Study Area (Arrow Indicates Person for Scale). Right: View to East of Same Deposit.
