**SITKA SOUND
SCIENCE CENTER**

Sitka Geotask Force
Summaries
August 2015 Sitka Landslides

March 2016

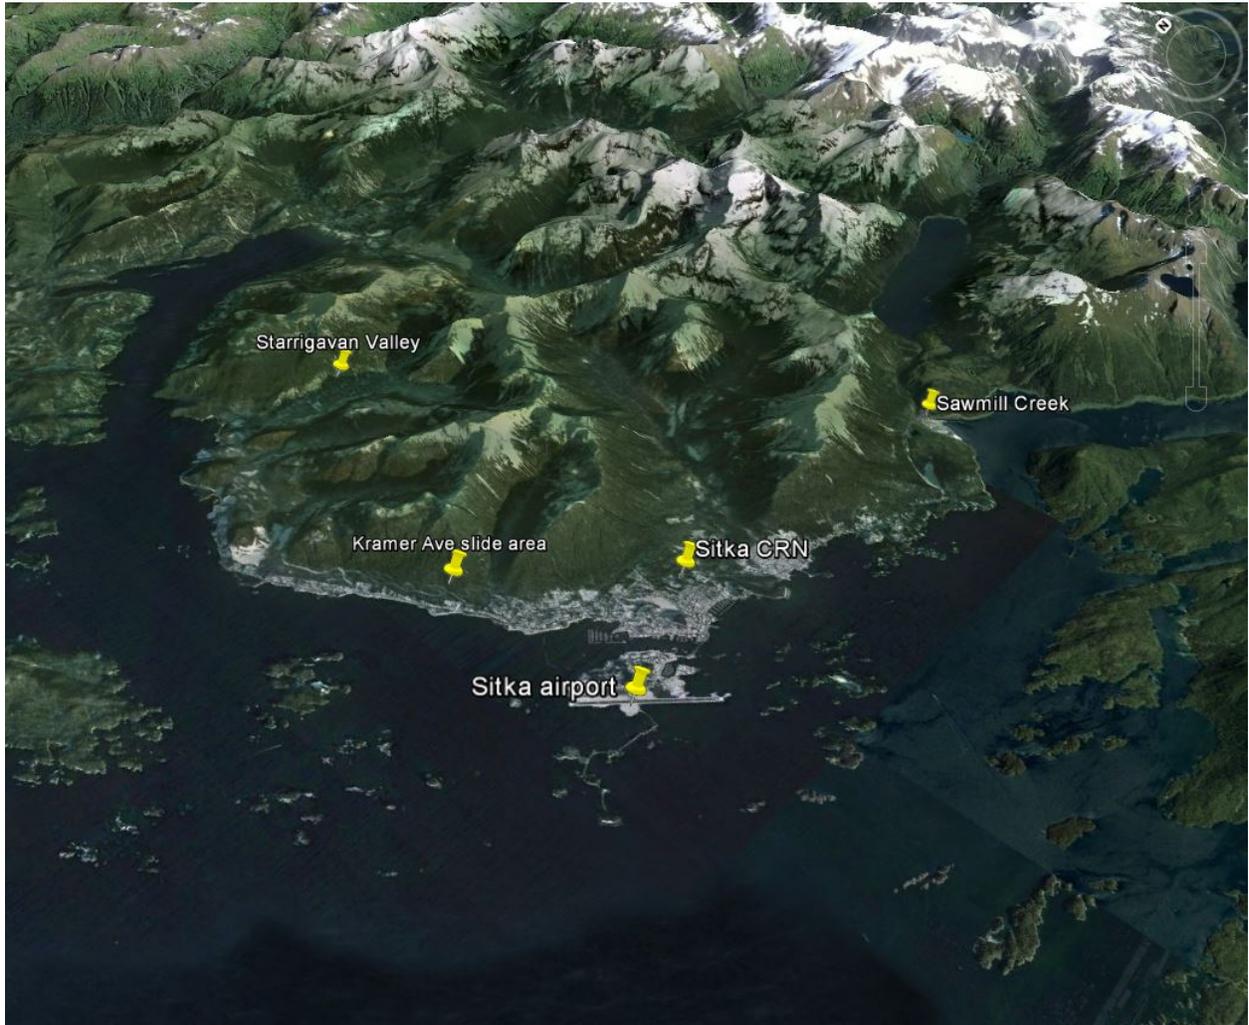
The topography around the Sitka area and Baranof Island is very steep with mountains towering 3000 to 4000 feet in less than a few miles, (figure 5).

Figure 5: Topography of the Sitka area

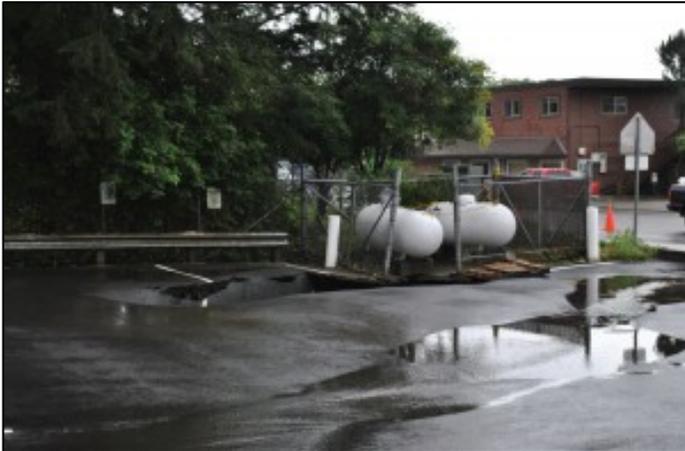
Photo 1- A sinkhole had opened up beneath a pair of propane tanks on Halibut Point Road. (Rebecca LaGuire, KCAW)

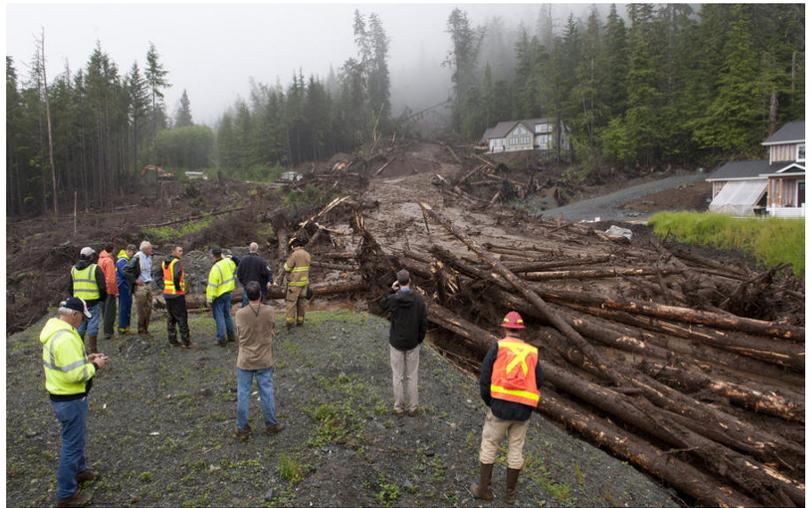
Photo 2- Kramer avenue debris flow.

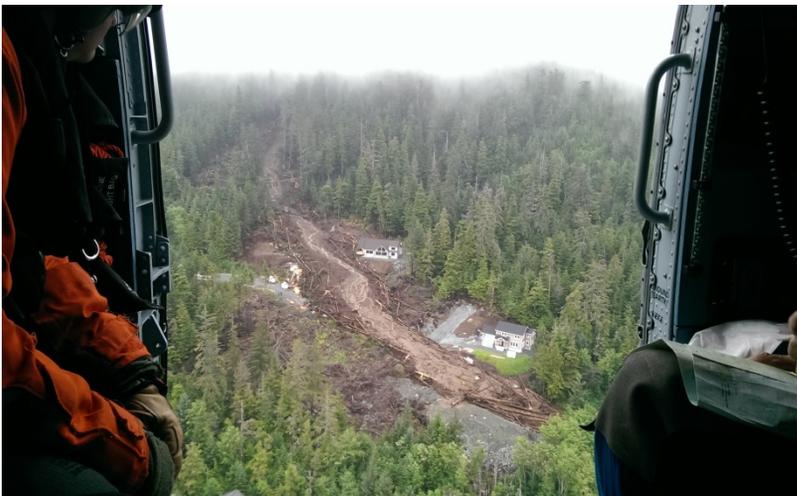
Photo 3- Aerial view of the Kramer Avenue debris flow. (Source: US Coast Guard)

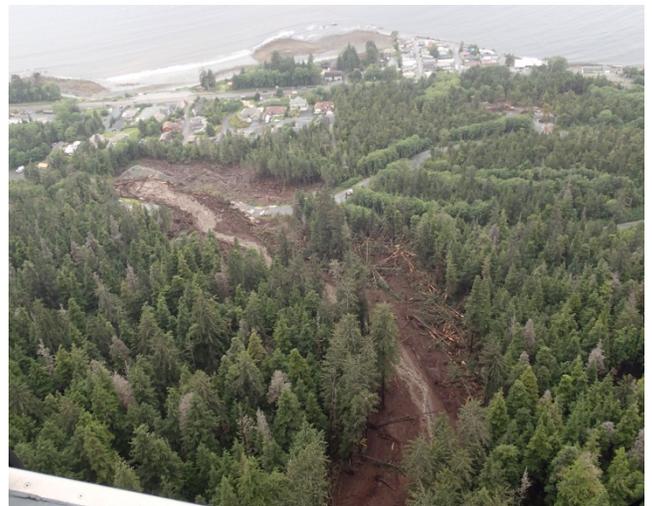
Photo 4 – Aerial view of Kramer Avenue debris flow. (Source: US Coast Guard)

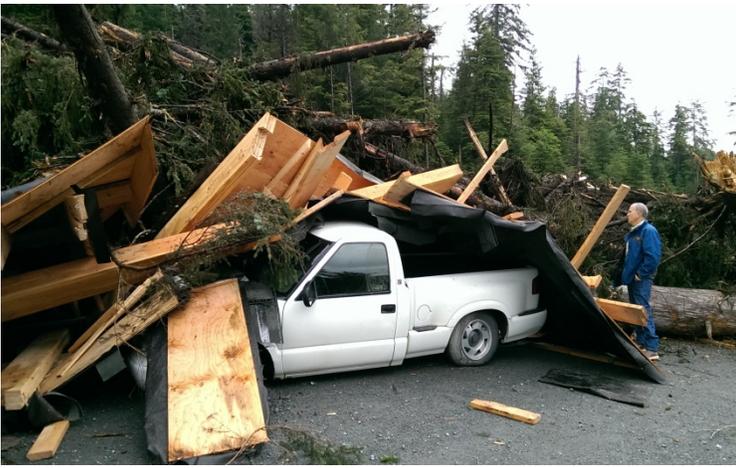
Photo 5 – Damaged done by Kramer Avenue debris flow. (Source: NWS)

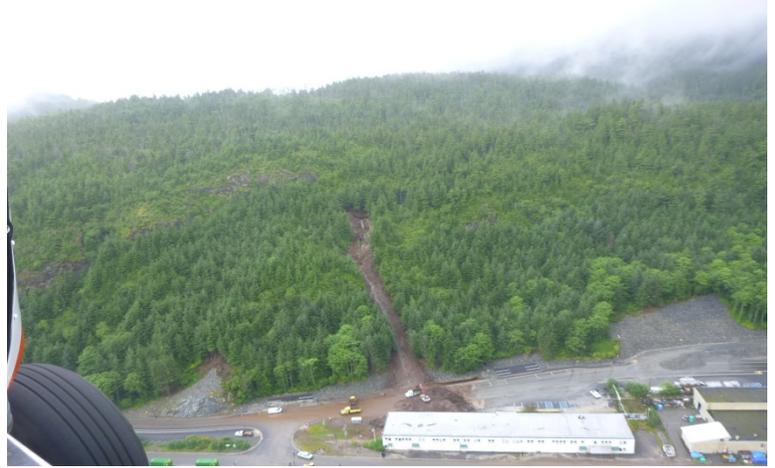
Photo 6 – Aerial view of debris flow at the Gary Paxton Industrial Park, (Source: US Coast Guard)

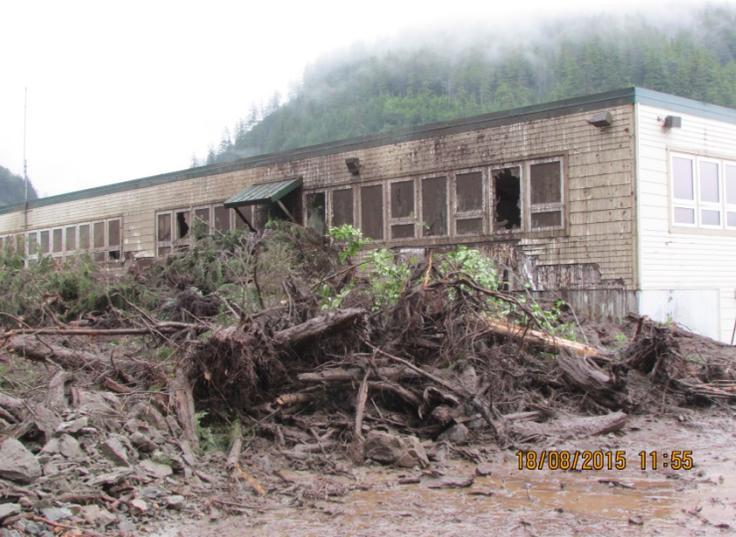
Photo 7 - damaged administration building at the Gary Paxton Industrial Park

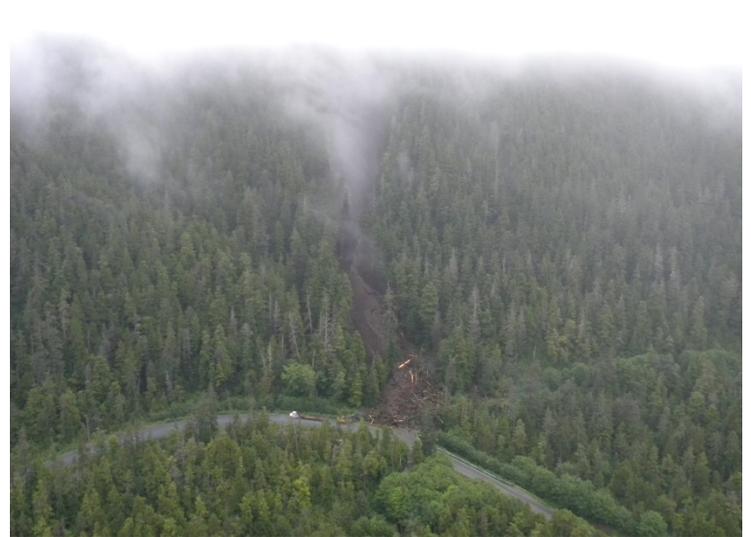
Photo 8-Other debris flow. (Source: US Coast Guard)

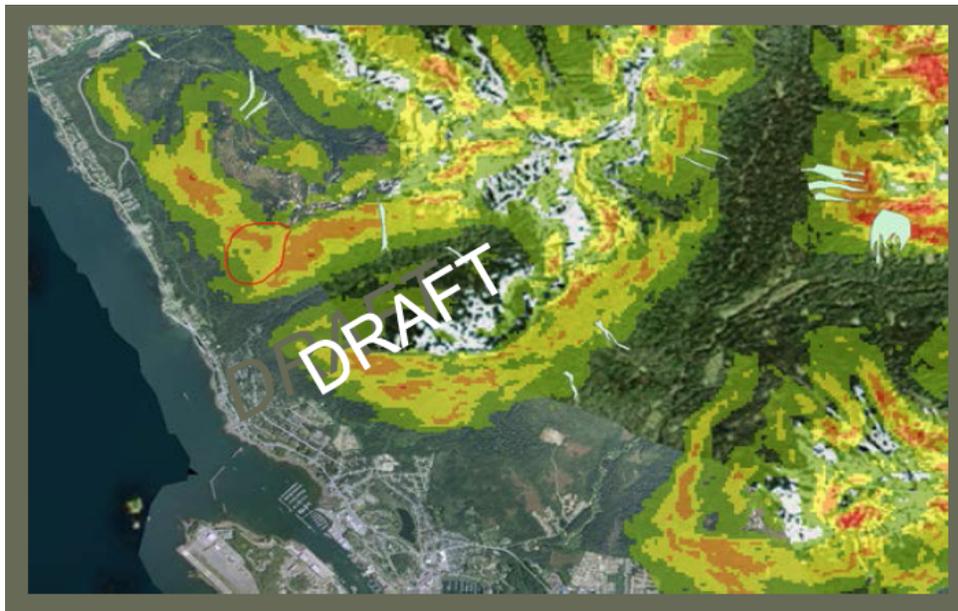
Figure 1. New landslide suitability map for southeast Alaska. Area around Sitka, AK, is shown, with the location of the Kramer landslide circled. Old landslides used in model construction can be seen in light green.

the south (the predominant storm wind direction). Ongoing work with the National Weather Service hopes to create a dynamic model which can incorporate forecasted wind directions into warning systems, as opposed to the static risk map which was constructed. A major limitation is it does not map

runout zones, focusing only on initiation points, and is thus not a complete map of landslide hazard.

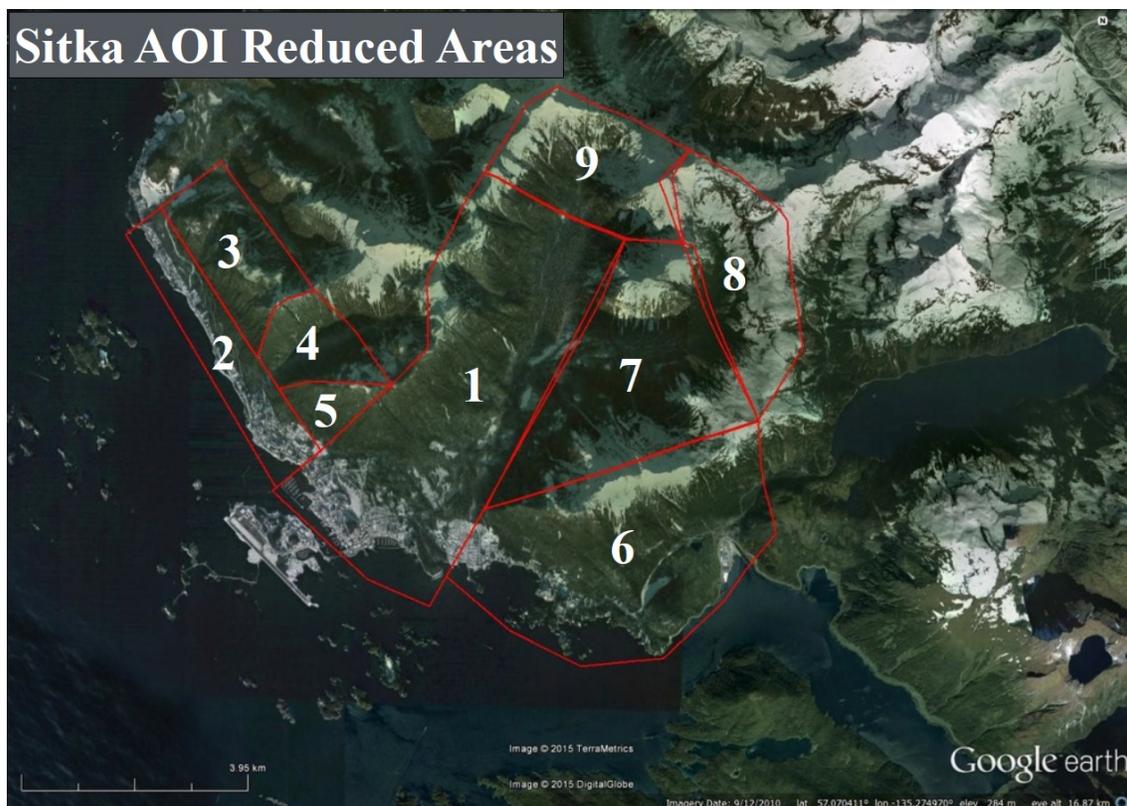
Figure 3: Prioritized LIDAR collection area specified by the DGGS/CRREL/NPS team.

With the cooperation of the NPS, DGGS has entered into an agreement (ICA-16-CRL-01) with CRREL to collect LIDAR data in priority areas around Sitka (Figure 3). Anticipated fieldwork will occur in May/June 2016, with data available to DGGS/NPS and the Geo-hazard Workgroup by mid-to-late summer 2016.
