**RE: West Woodbury Subd. Sanitary Sewer Extension**  
**West Woodbury Subd. Lot 3**  
**430 linear feet of sewer main**  
**Approval to Construct**

The approved project includes installation of approximately 430 linear feet of 8" PVC sewer main and 3 F&I Type A Sanitary Sewer Manholes on the subject property. This sewer extension will connect with the existing collection infrastructure and be discharged into the City and Borough of Sitka's Wastewater Treatment Plant.

## **RE: EVALUATION OF KRAMER LANDSLIDE RECURRENCE INTERVAL IN SITKA, ALASKA.**

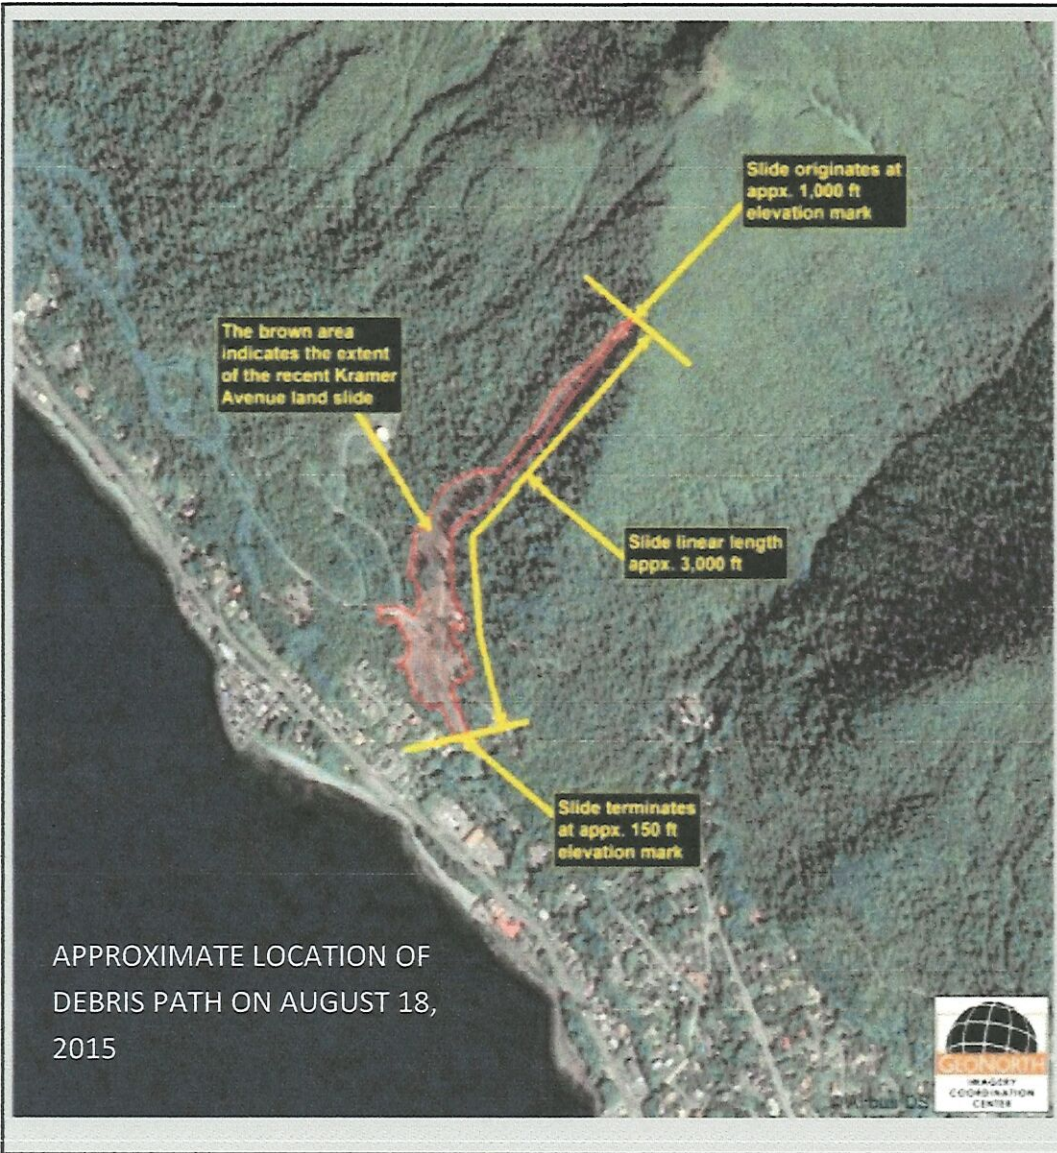
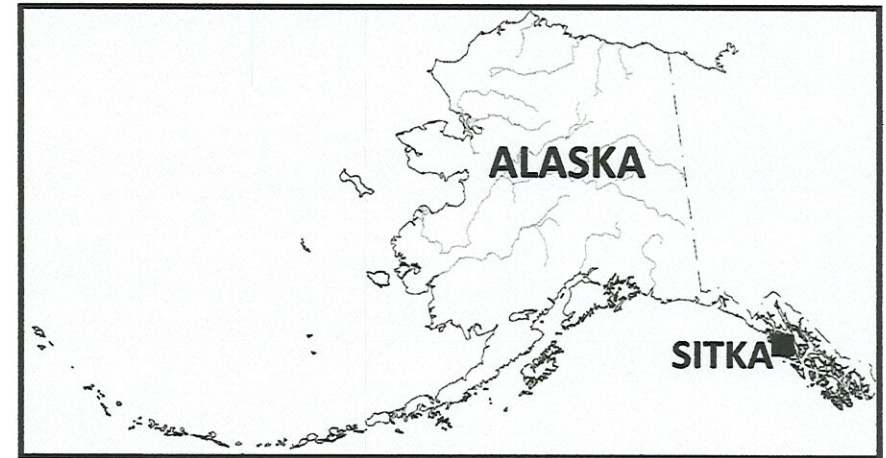
FIGURE NUMBER:  
**1**

Shannon and Wilson, Inc. (SWI) conducted an overview study of the Kramer Landslide, evaluating the debris flow impacting several residential lots along Kramer Avenue and resulted in the loss of three lives (See Figure 1 for debris path and location). SWI's study of the landslide is titled *South Kramer Avenue Landslide: Jacobs Circle to Emmons Street, Sitka, Alaska*, dated February 2, 2016. SWI's report separated their study area into three hazard zones (high, medium, and low). SWI's hazard zones were based on computer modeling, field reconnaissance, assessment of LiDAR hill shades, and professional judgement. Based on our field reconnaissance, assessment of LiDAR hill shades and our professional judgement, we believe that SWI very well defined the hazard zones associated with potential landslides in the same area. The North Tributary is in SWI's landslide high hazard zone.

FIGURE TITLE:  
**PROJECT SITE LOCATION**

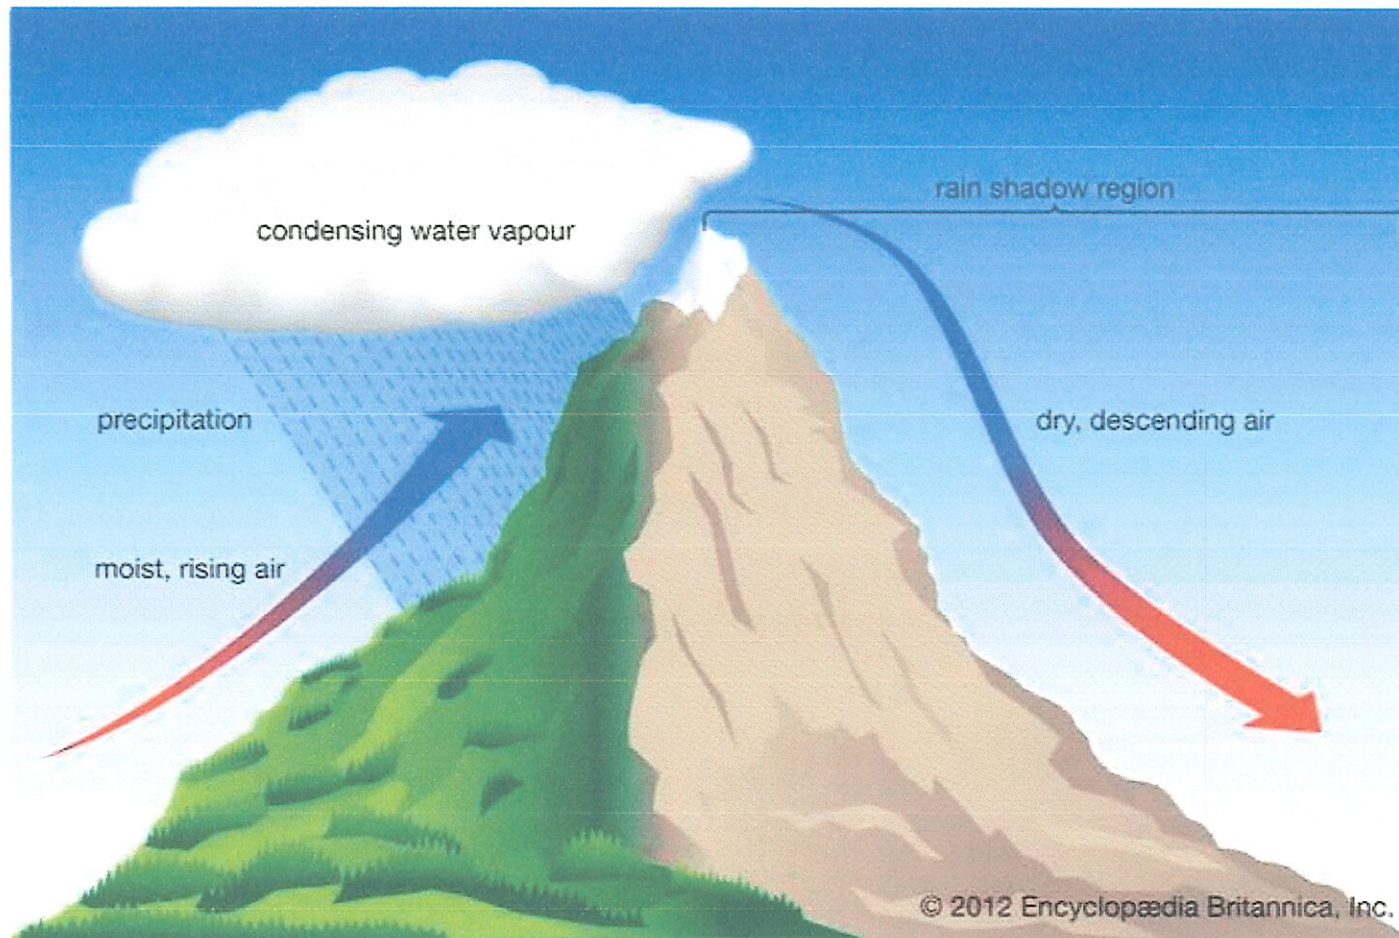
**FIGURE NUMBER:**  
**2**

Orographic concentration of precipitation is influenced by numerous factors, including slope inclination of the terrain, slope orientation, and static equilibrium of the atmosphere in the region. (Figure 2). Orographic effect occurs when the prevailing winds absorb moisture (in this case most likely from the ocean) and drive the moist air up the mountain where the temperature is significantly cooler. The colder air then causes the condensation of the moisture which leads to precipitation that occurs predominately on the ocean side of the mountain range. This is supported by the locations of the landslides that occurred throughout Sitka as all of them occurred on the ocean side.

When moist air is forced to raise in elevation (e.g. mountain side), the temperature of the air can be lowered to the point of condensation and precipitation; this precipitation is called orographic precipitation. This effect causes the intensity and volume of precipitant to be highly variable over short distances, both vertically and laterally. Additionally, the high intensity areas are not consistent between events.

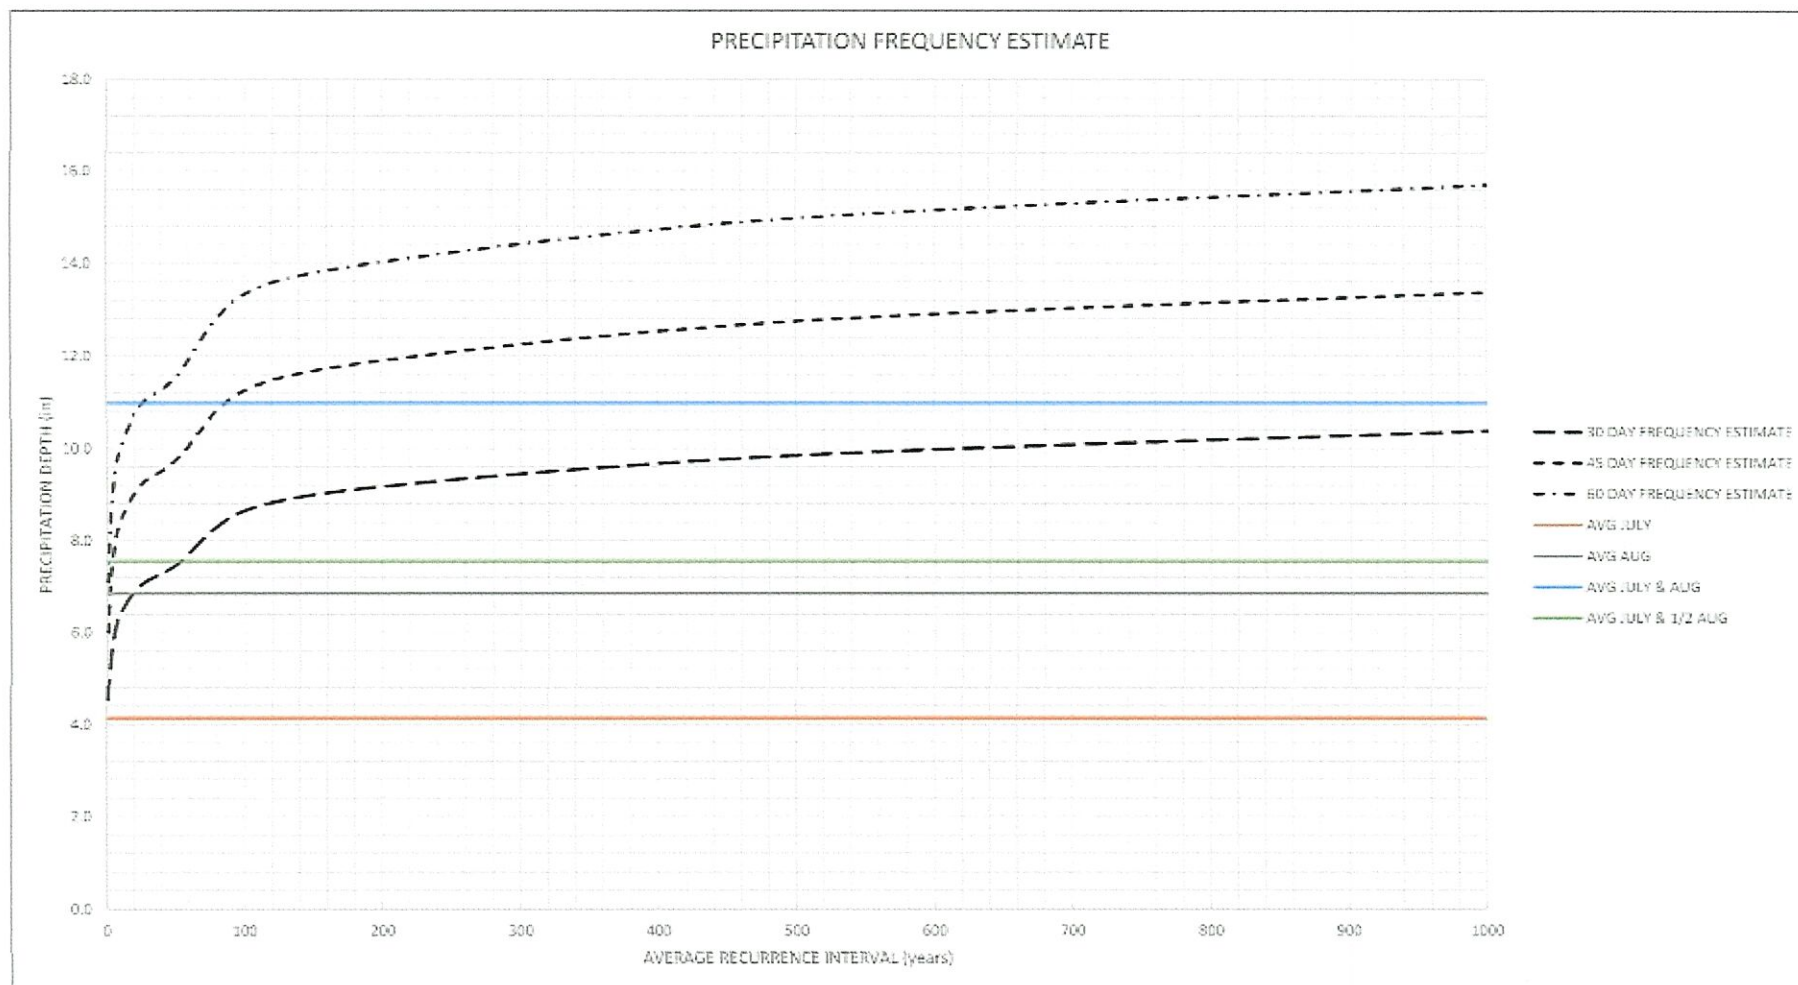
FIGURE NUMBER:  
**4**

FIGURE TITLE:  
**PRECIPITATION FREQUENCY ESTIMATE**

The seasonal range of precipitation were used to further refine the data the with the assumption that the snow/frozen ground conditions would not contribute to the slide. A defined start and end date of the useable precipitation year by the seasonal freeze probabilities is given by the western region climate center with a 90% probability.

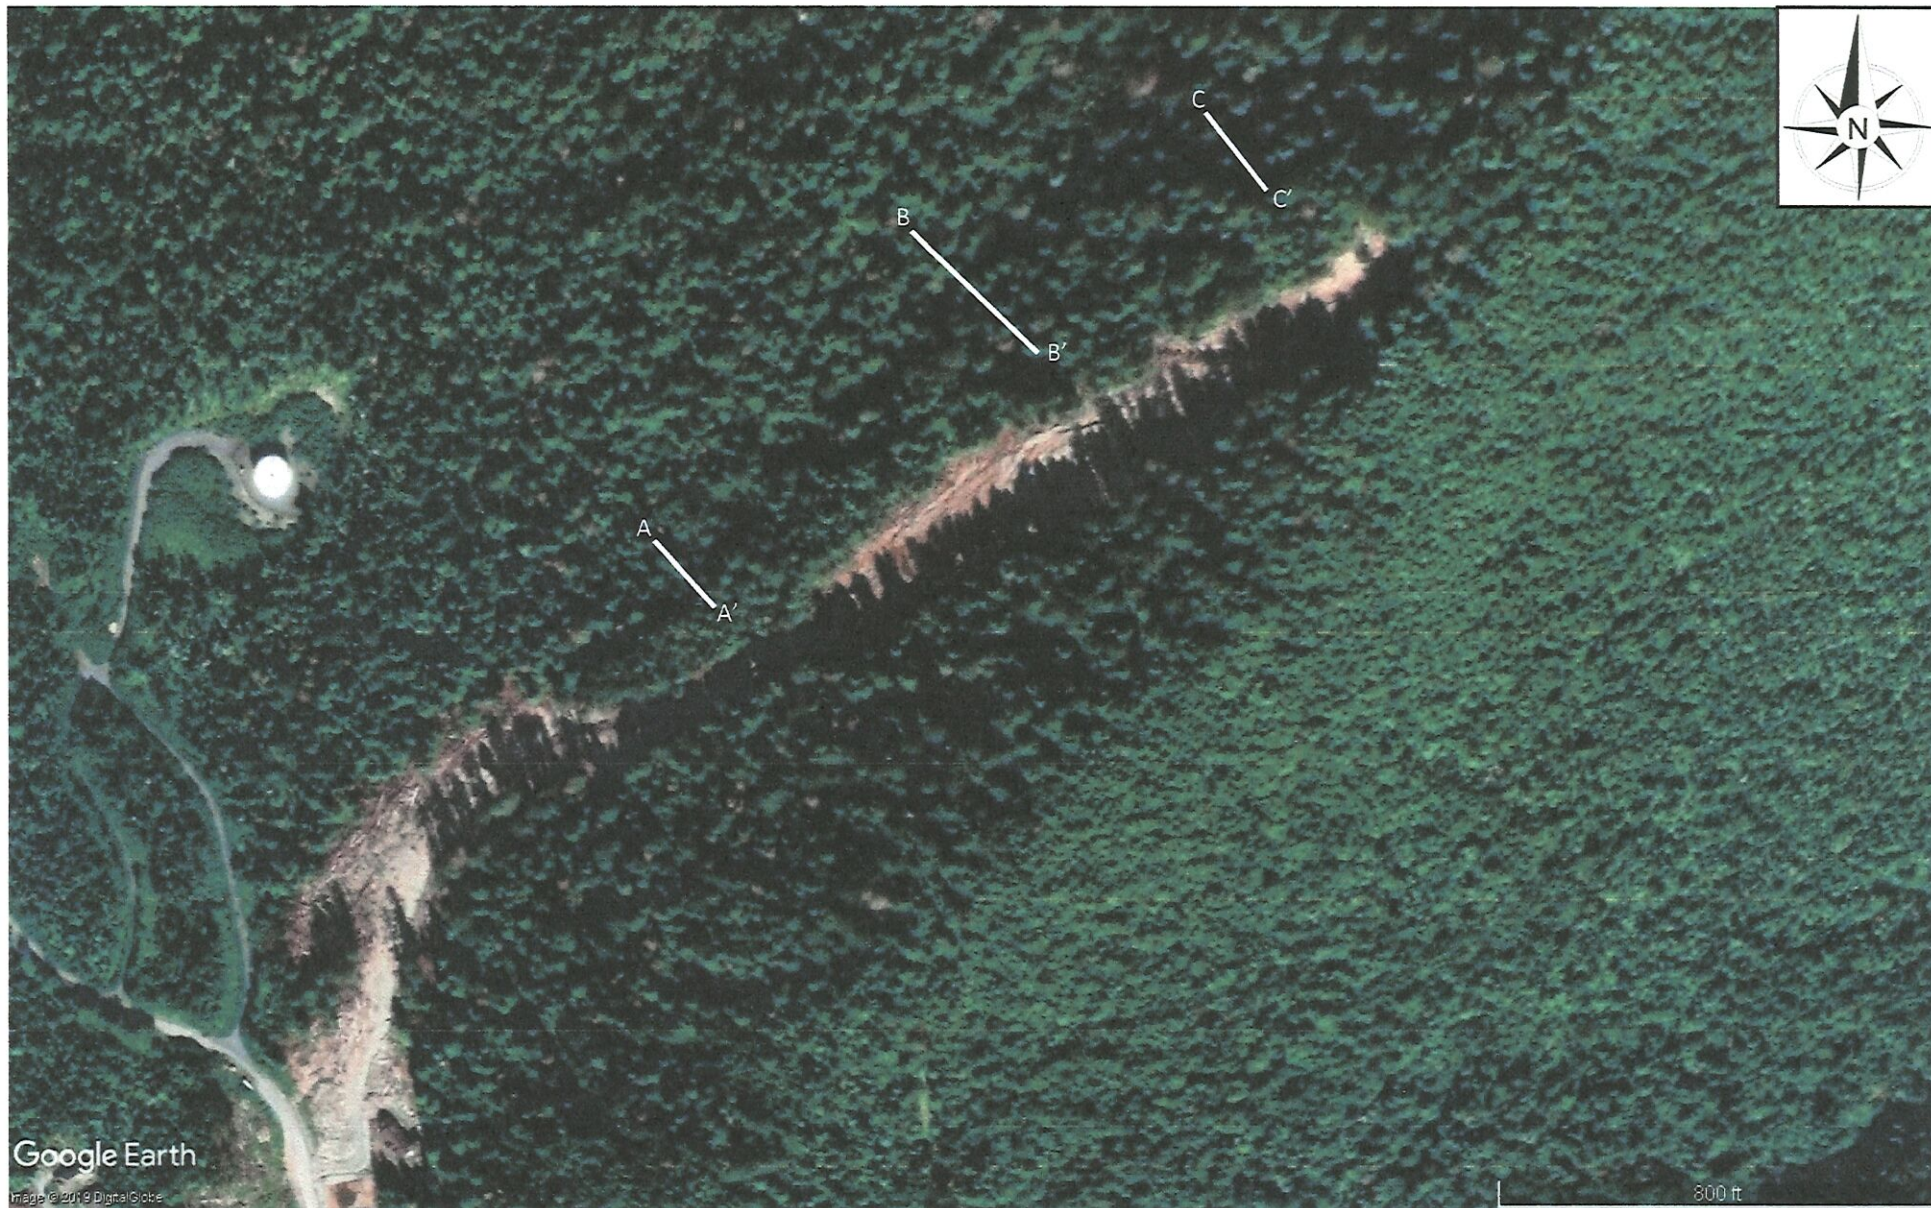
FIGURE NUMBER:  
**5**

FIGURE TITLE:  
**APPROXIMATE CROSS SECTION LOCATIONS**

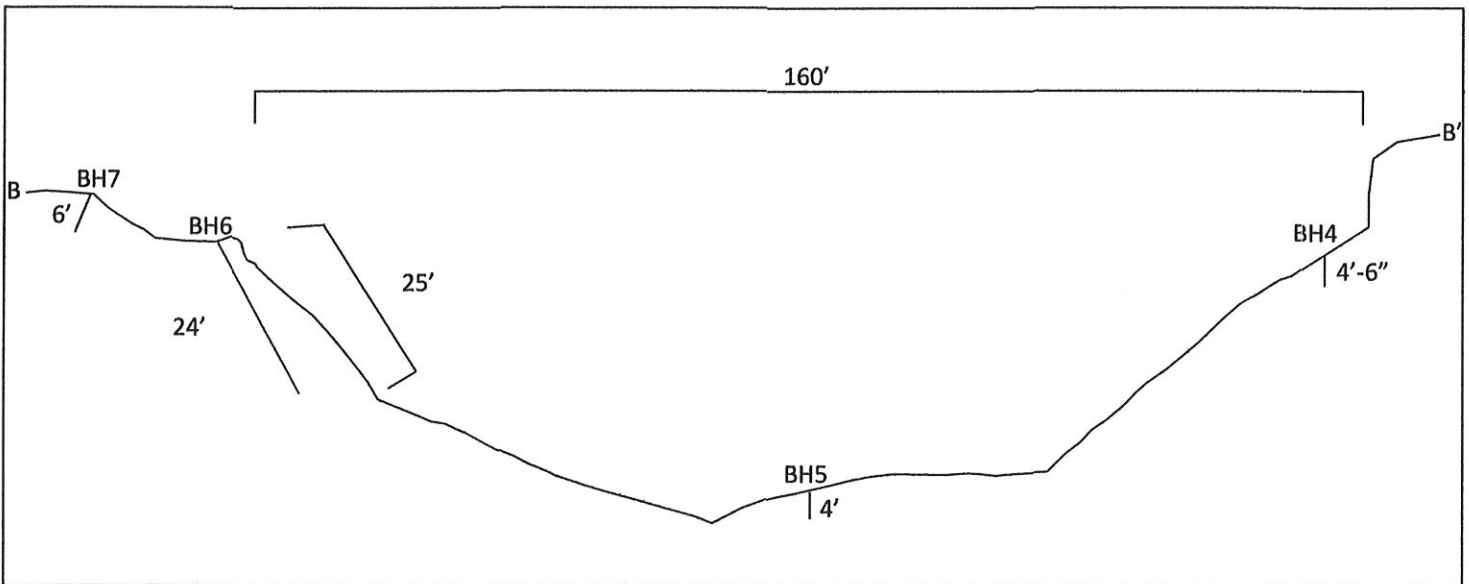
CROSS SECTION BB': ELEVATION 1,200' AT TOP
