February 2, 2016

21-1-22168-001

**RE: SOUTH KRAMER AVENUE LANDSLIDE: JACOBS CIRCLE TO
EMMONS STREET, SITKA, ALASKA**

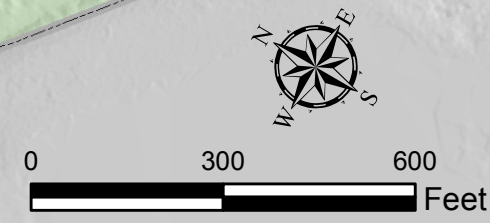
August 18th South Kramer Debris Flow

From aerial photographs and from field observations, it appears that the first pulse of the debris flow left the channel and plowed into the woods near elevation 240 feet, as indicated in Figures 2 and 3. This was likely the result of an upslope, straight segment of the channel and the debris wanting to maintain a straight line. After the first pulse, the bulk of the debris followed the existing channel that was directed toward the residence at 430 Kramer Avenue. The debris killed three people, and destroyed one residence and damaged another. Upon reaching Kramer Avenue, the debris encountered a low berm on the south side of the road that appears from photographs to have been 2 to 3 feet higher than Kramer Avenue. Farther south along the western side of Kramer Avenue, fill was mounded 8 to 10 feet high in an earthfill berm. When the debris flow encountered these berms, it turned southward down the road. It came to a stop about 400 feet from the point at which it reached Kramer Avenue, as shown in Figures 2, 3, and 6.

Groundwater is perched in this area. In the Golder report, groundwater levels ranged from 1.5 to 8.5 feet below ground surface. Numerous springs, as noted in Figure 3, emerge from the hillside. In some cases, they form the heads of through-going surface streams. In other cases, they infiltrate back into the ground and pop out farther downslope. In some areas, such as Tract C, most of the ground is covered with standing water, likely perched on ash or till.
